# Chang'e 4 Rover comes into view

February 9 2019

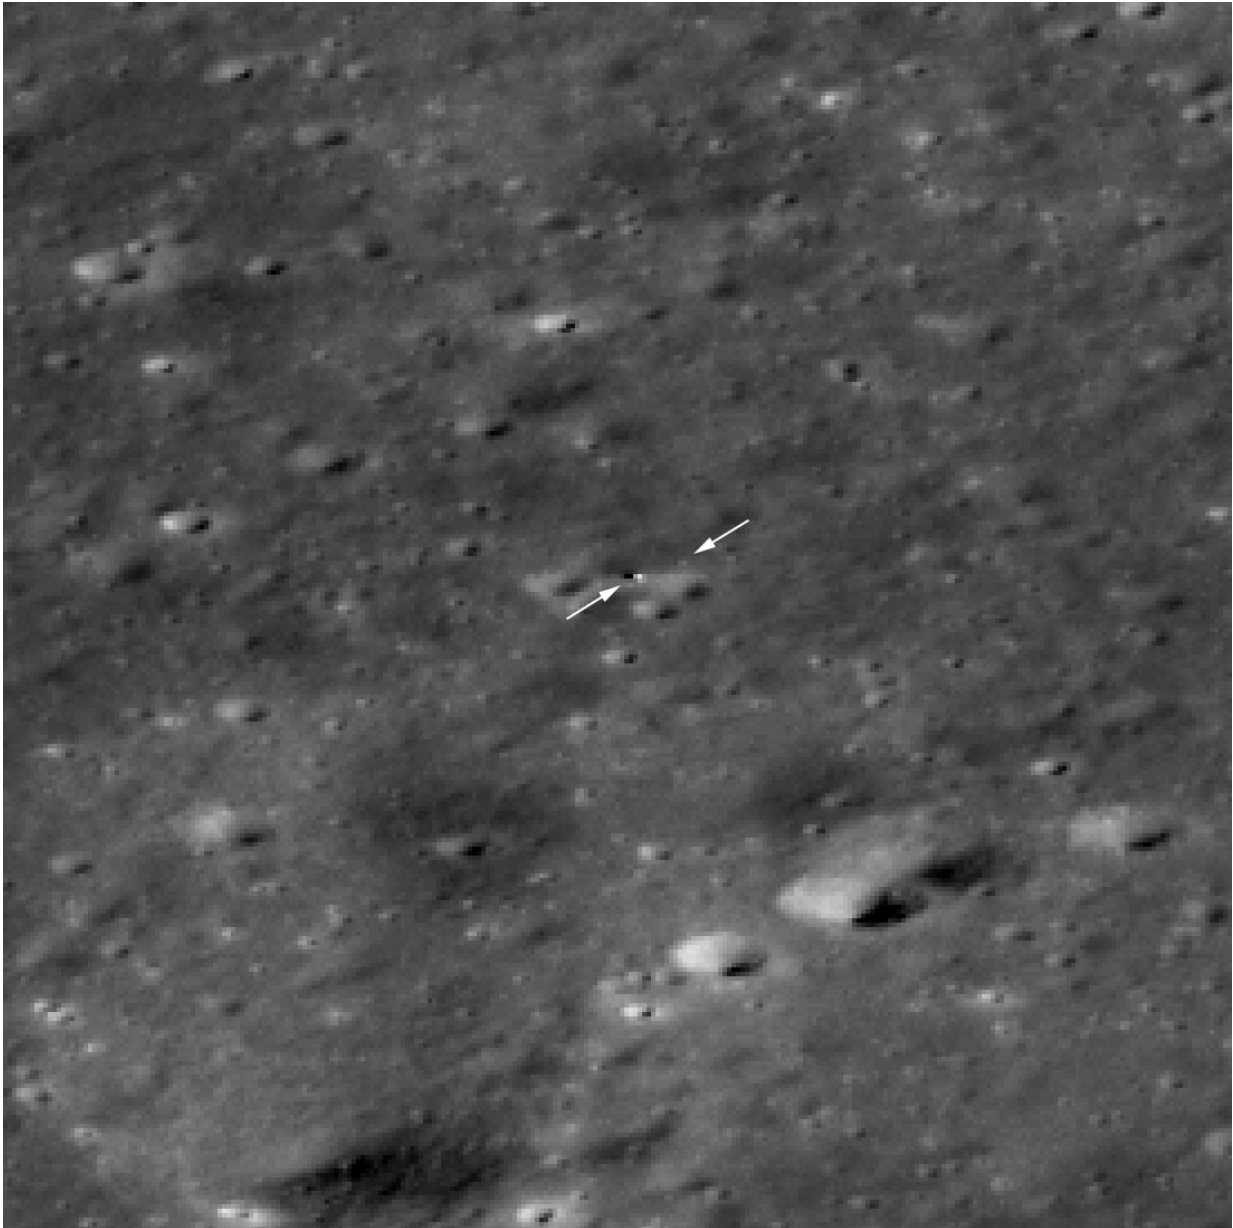
The Chang'e 4 rover is now visible to LROC! Just beyond the tip of the right

arrow is the rover and the lander is to the right of the tip of the left arrow. The image appears blocky because it is enlarged 4x to make it easier to see the two vehicles. North is to the upper right, LROC NAC M1303570617LR. Credit: NASA/GSFC/Arizona State University

On Jan. 30 2019, Lunar Reconnaissance Orbiter Camera (LROC) acquired a spectacular limb shot centered on the Chang'e 4 landing site, looking across the floor of Von Kármán crater. At the time, the Lunar Reconnaissance Orbiter (LRO) was more than 200 kilometers from the landing site so Chang'e 4 was only a few pixels across and the rover was not discernable. The following day LRO was closer to the site and again slewed (59 degrees this time) to capture another view. This time the small Yutu-2 rover shows up (two pixels) just north of the lander. Also, shadows cast by the lander and rover are now visible.

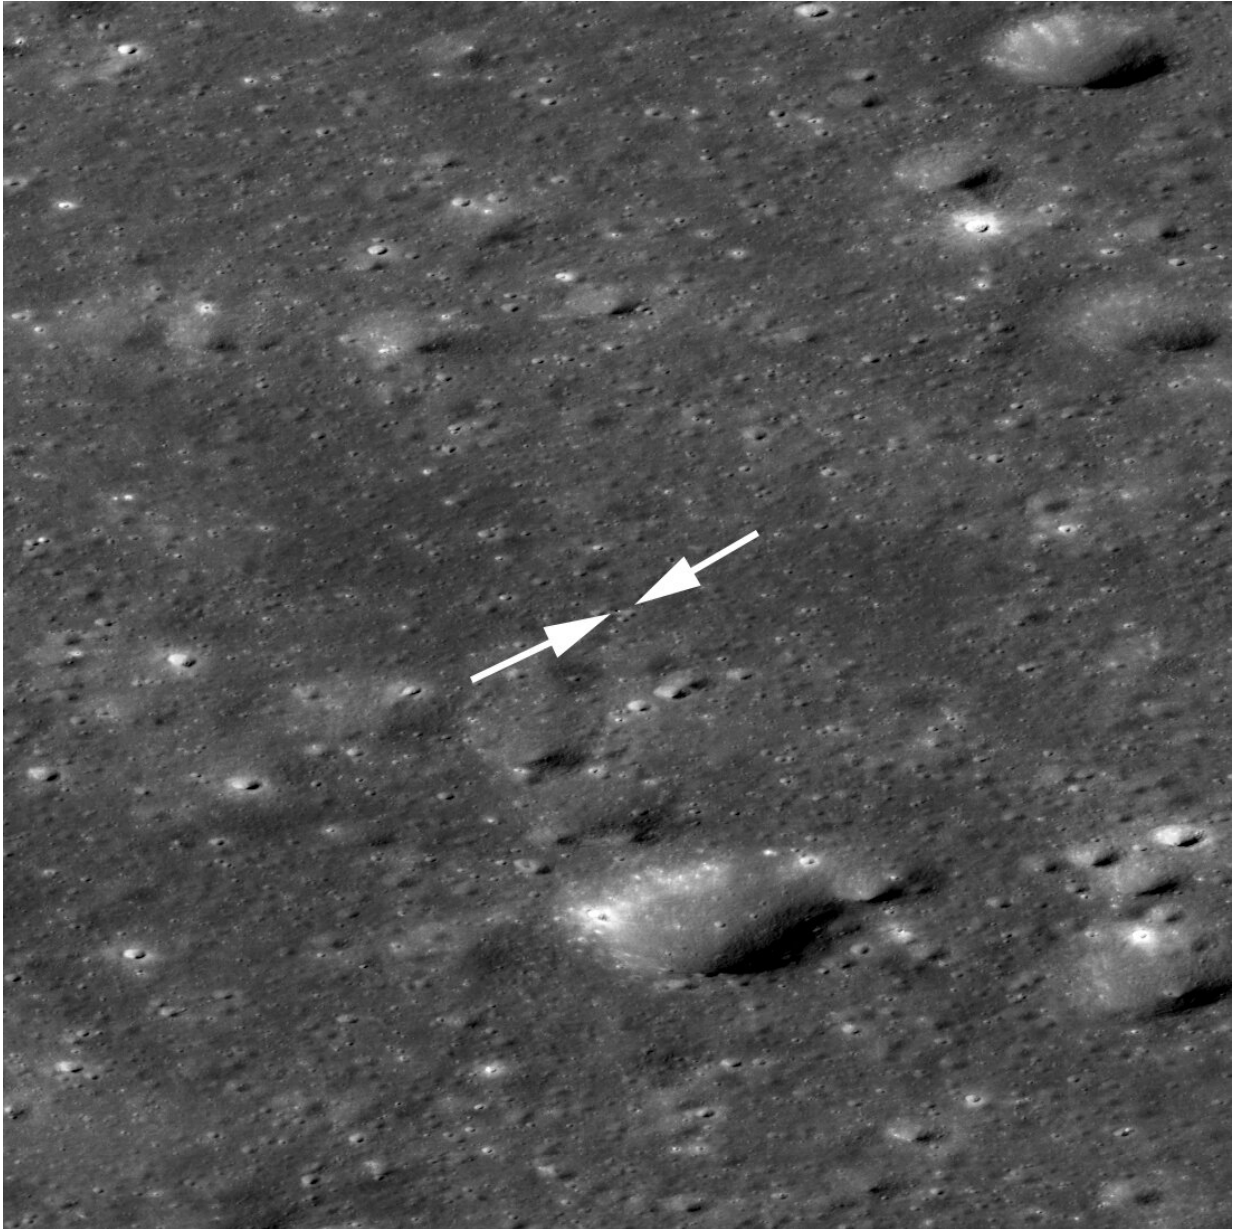
Chang'e 4 lander (near tip of left arrow) and rover (near tip of right arrow) nestled among craters on the floor of Von Kármán crater. Image is 1700 meters (5580 feet) wide across the center, LROC NAC M1303570617. Credit: NASA/Goddard/Arizona State University

Note also all of the small craters that have formed on top of larger ones.

Smaller impacts wear down and degrade larger craters over time. You can easily see a wide variety of crater degradation states, ranging from sharp and crisp (new) to highly degraded (old). As result of all of these impacts (small and large), the surface of the Moon consists of a very fine powder known as regolith, in which the Apollo astronauts made their distinct boot prints.
