Chang'e 4 Rover comes into view

February 9 2019

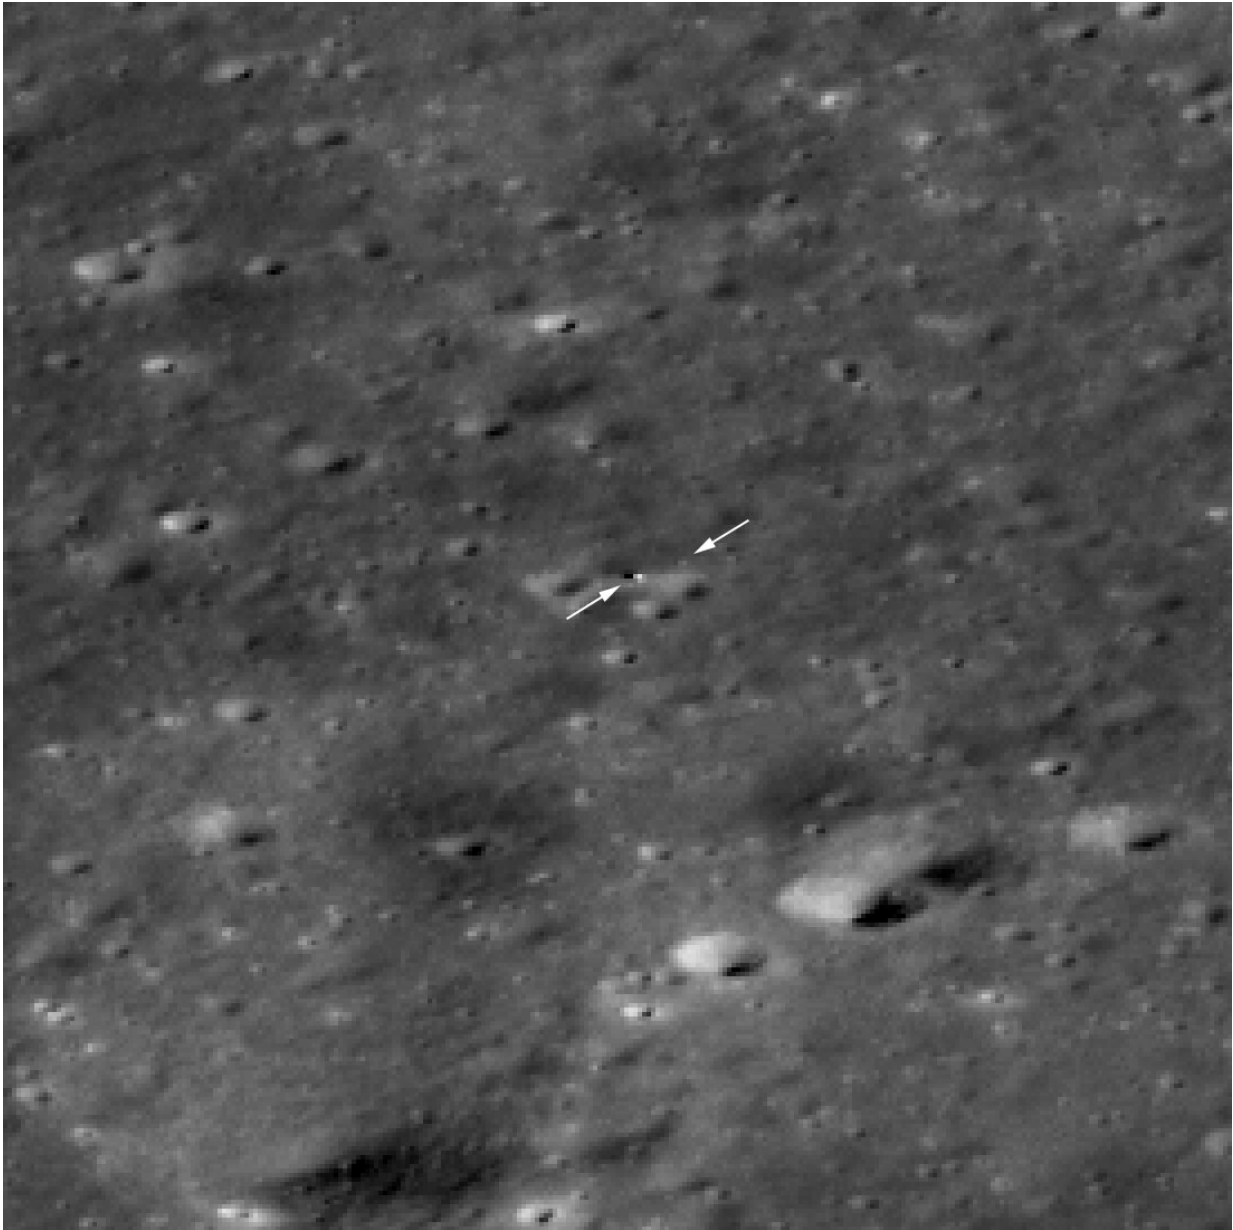
The Chang'e 4 rover is now visible to LROC! Just beyond the tip of the right

arrow is the rover and the lander is to the right of the tip of the left arrow. The image appears blocky because it is enlarged 4x to make it easier to see the two vehicles. North is to the upper right, LROC NAC M1303570617LR. Credit: NASA/GSFC/Arizona State University

On Jan. 30 2019, Lunar Reconnaissance Orbiter Camera (LROC) acquired a spectacular limb shot centered on the Chang'e 4 landing site, looking across the floor of Von Kármán crater. At the time, the Lunar Reconnaissance Orbiter (LRO) was more than 200 kilometers from the landing site so Chang'e 4 was only a few pixels across and the rover was not discernable. The following day LRO was closer to the site and again slewed (59 degrees this time) to capture another view. This time the small Yutu-2 rover shows up (two pixels) just north of the lander. Also, shadows cast by the lander and rover are now visible.

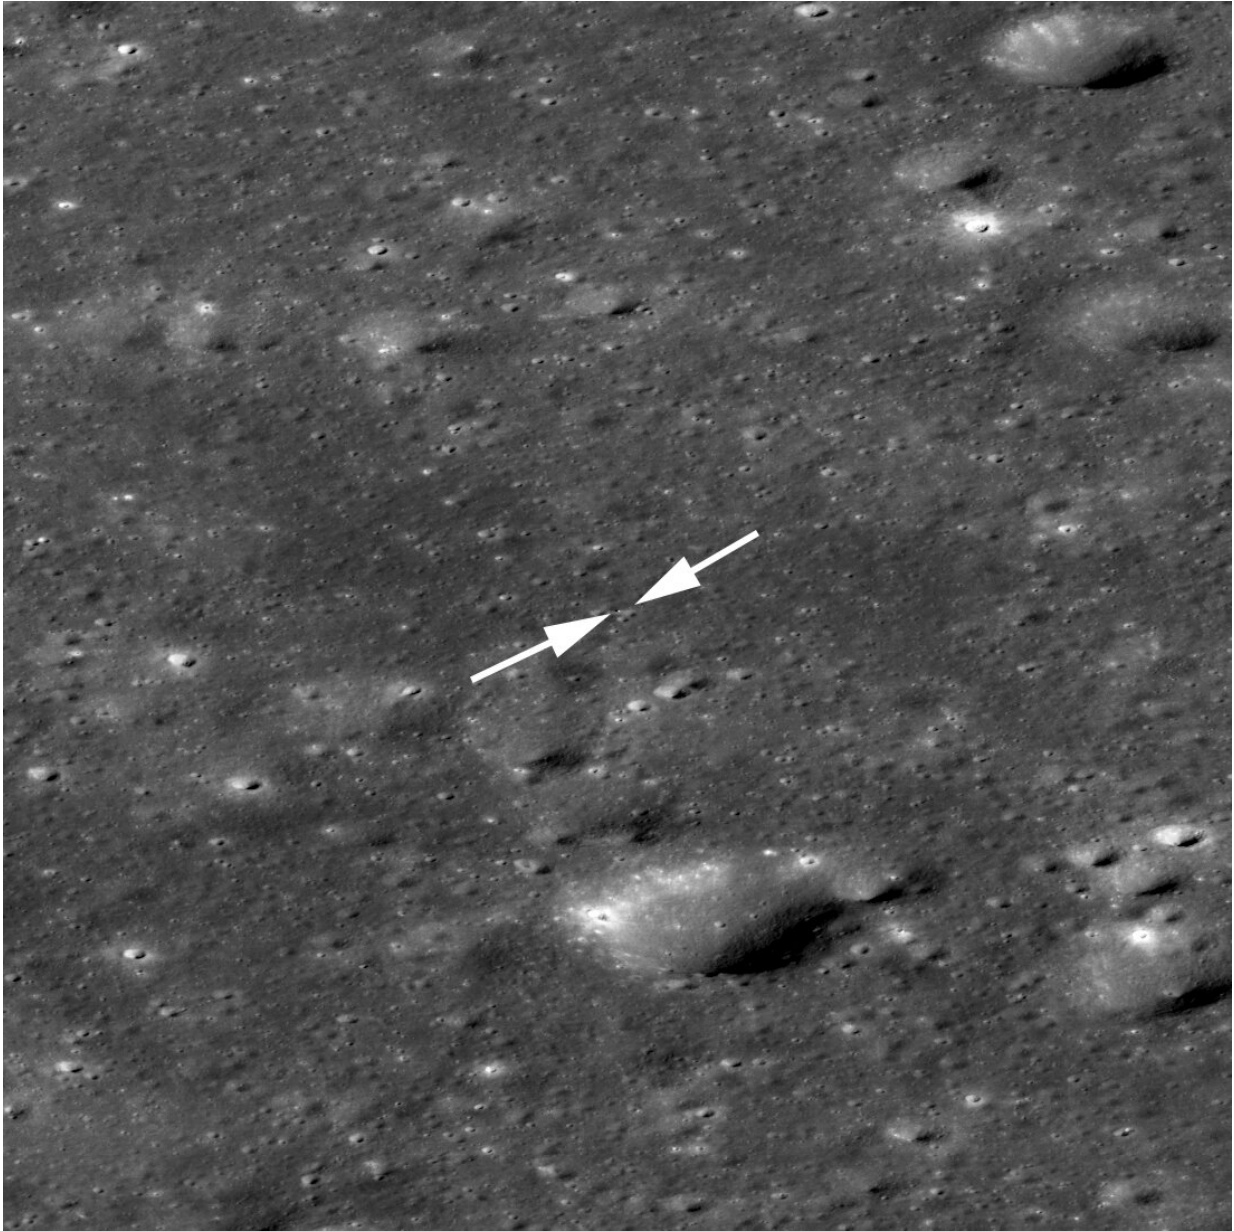
Chang'e 4 lander (near tip of left arrow) and rover (near tip of right arrow) nestled among craters on the floor of Von Kármán crater. Image is 1700 meters (5580 feet) wide across the center, LROC NAC M1303570617. Credit: NASA/Goddard/Arizona State University

A striking aspect of the floor of Von Kármán crater is the number and variety of impact craters. There is a high density of craters because the surface is more than 3 billion years old! During those 3 billion years, so many small craters (1000 meters (3280 feet) diameter), which are not in equilibrium, continue to increase in density and can be used to estimate the age of the surface.

Note also all of the small craters that have formed on top of larger ones.

Smaller impacts wear down and degrade larger craters over time. You can easily see a wide variety of crater degradation states, ranging from sharp and crisp (new) to highly degraded (old). As result of all of these impacts (small and large), the surface of the Moon consists of a very fine powder known as regolith, in which the Apollo astronauts made their distinct boot prints.
