# Historic logging site shows first human-caused bedrock erosion along an entire river

April 15 2019

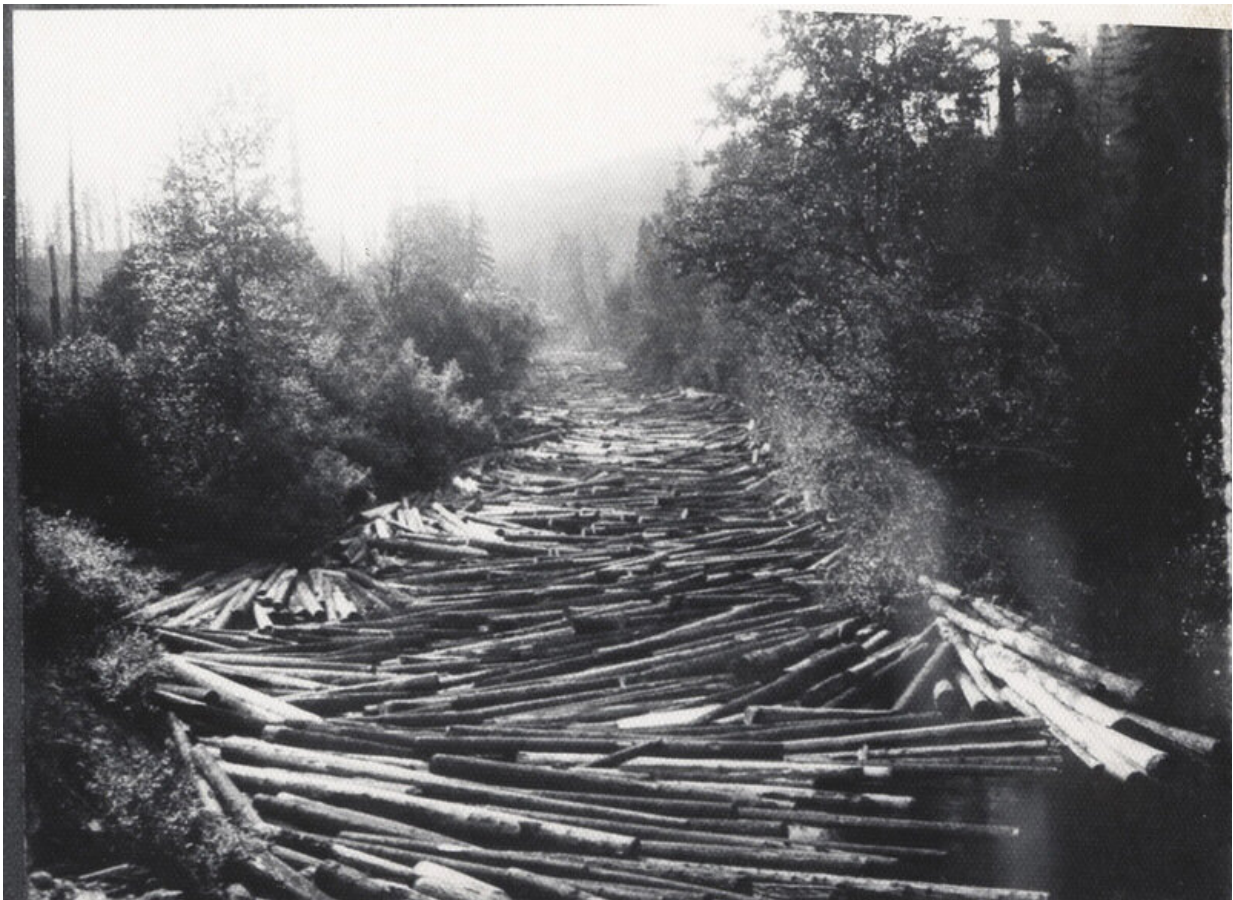
This 1920 photo of the Teanaway River shows how logs traveled down the river to the mills and railway. Credit: Frederick Krueger Photographs 376/Central Washington University Archives

Before logging roads existed, companies built temporary "splash dams" high up on the slope with all the logs and then broke up the dam with tools or explosives. Released water helped send logs shooting down to the mills.

Key to the process is that loggers would clear away debris to give the logs a clear shot down the river. This removed barriers that held back sediment and cleared out much of the gravel from the riverbed. Such events, the authors believe, caused the erosion to change dramatically.

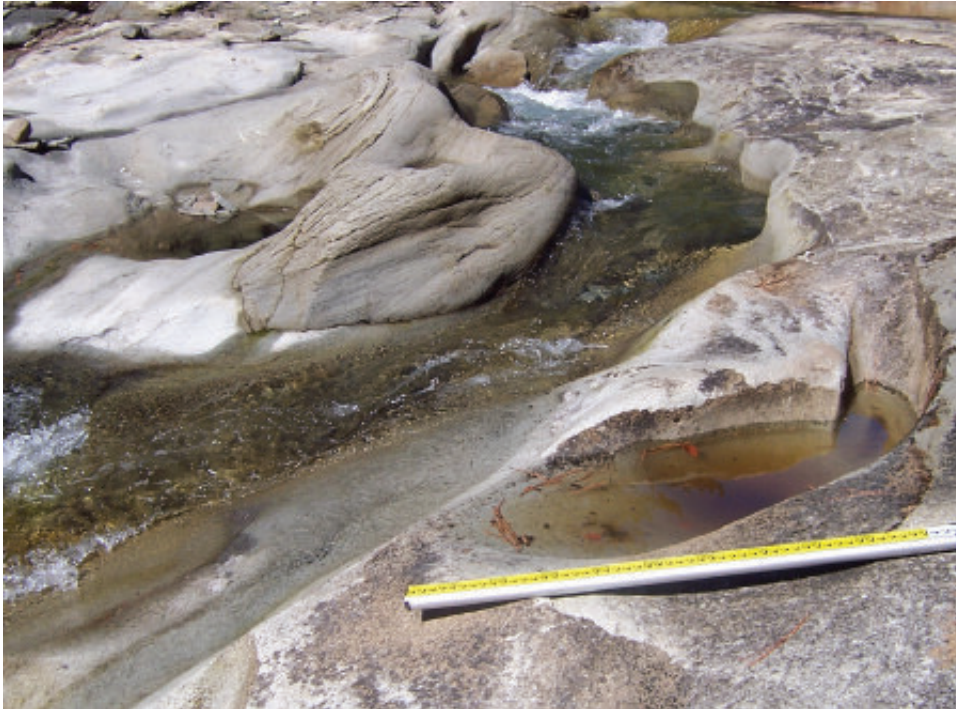
Fluting and pothole formation in the bed of the channel. The survey rod in the foreground is 1.1 meters long. Credit: Brian Collins/University of Washington

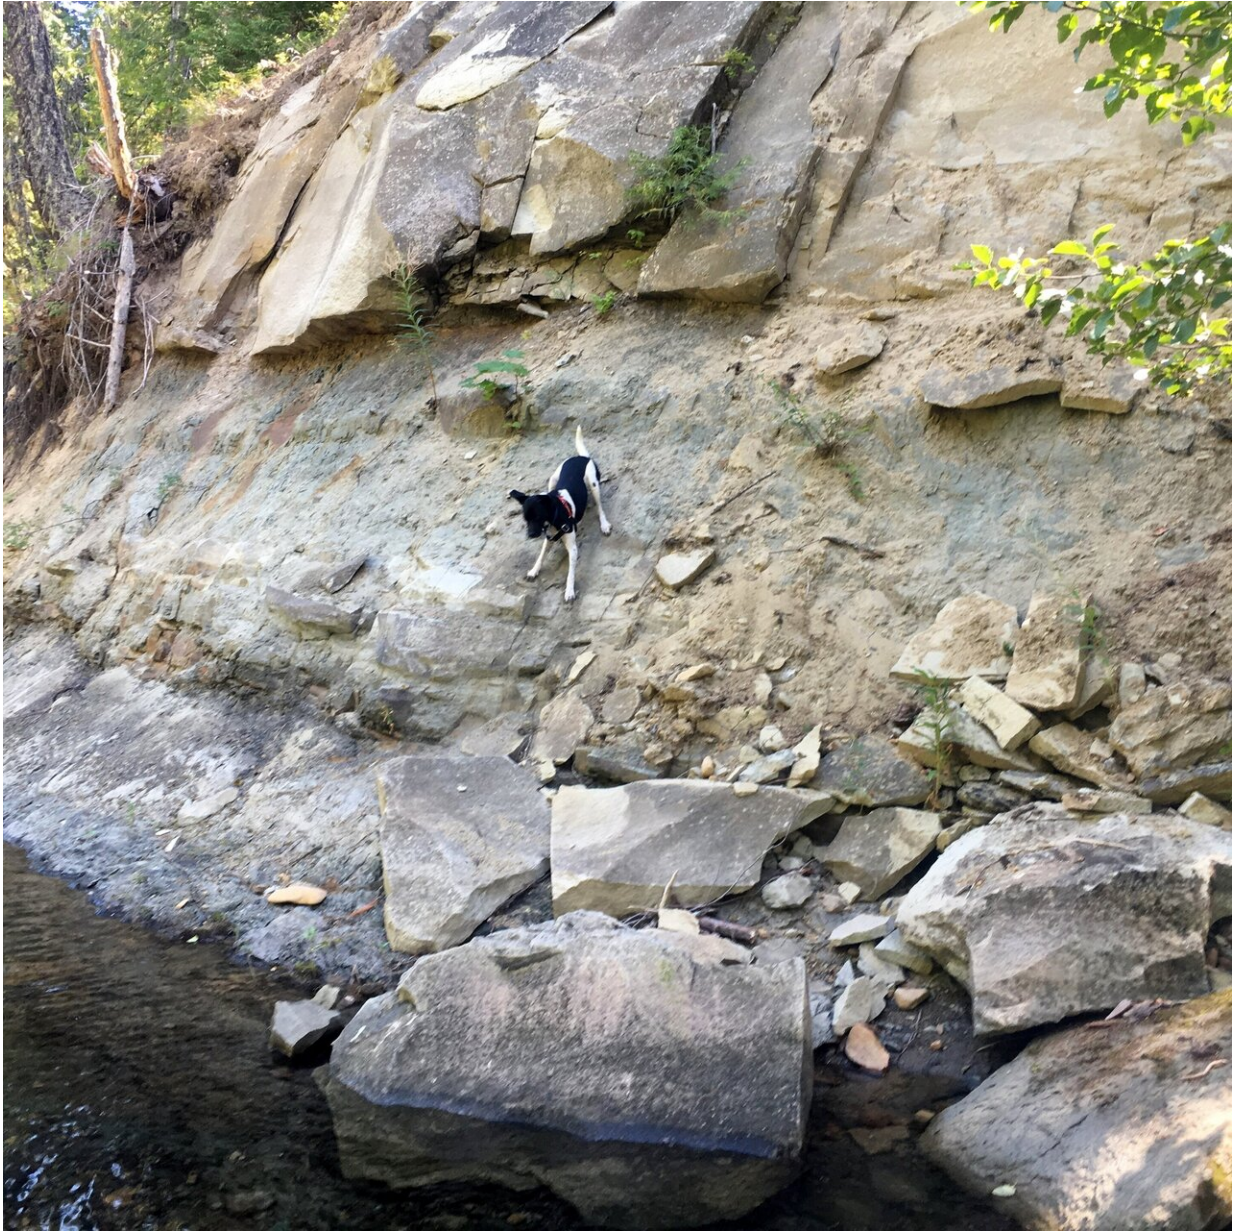
The author's 45-pound dog gives a sense of the size of the bedrock boulders being eroded from the side of the Teanaway River. The previous floodplain is just visible at the top of the frame. Credit: Sarah Schanz/Indiana University
