New study of the 2014 Oso landslide

June 26 2019

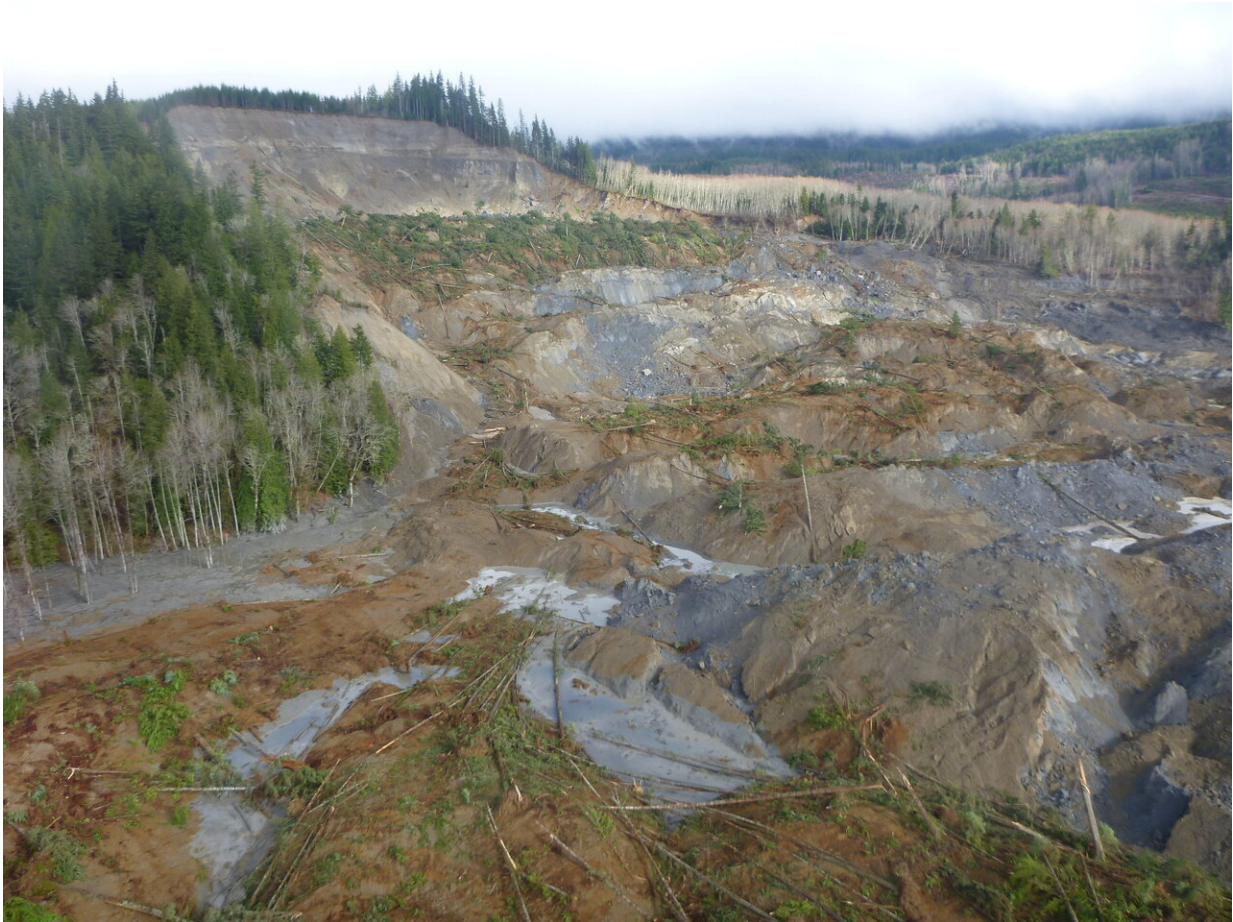
The March 22, 2014 SR530 landslide near Oso, Washington, caused 43 fatalities, destroyed a neighborhood, blocked a state highway, and temporarily dammed the North Fork Stillaguamish River. This photo was taken the day after the catastrophic slide, before the river cut through the landslide deposit. Here, several geomorphological components of the landslide are visible, with a hummock field in the foreground transitioning upslope to larger slices of deposit separated by multiple scarps, which then transition to a fallen-tree covered, back-rotated block downdropped from the headscarp in the far field. Nearly the entire

landslide deposit exhibits indications of extension. Collins and Reid attribute extensional hummock formation to widespread basal liquefaction of underlying alluvial sediments in the river valley. Photo by Stephen Slaughter (Washington Geological Survey, Washington Department of Natural Resources). Credit: Stephen Slaughter (Washington Geological Survey, Washington Department of Natural Resources)

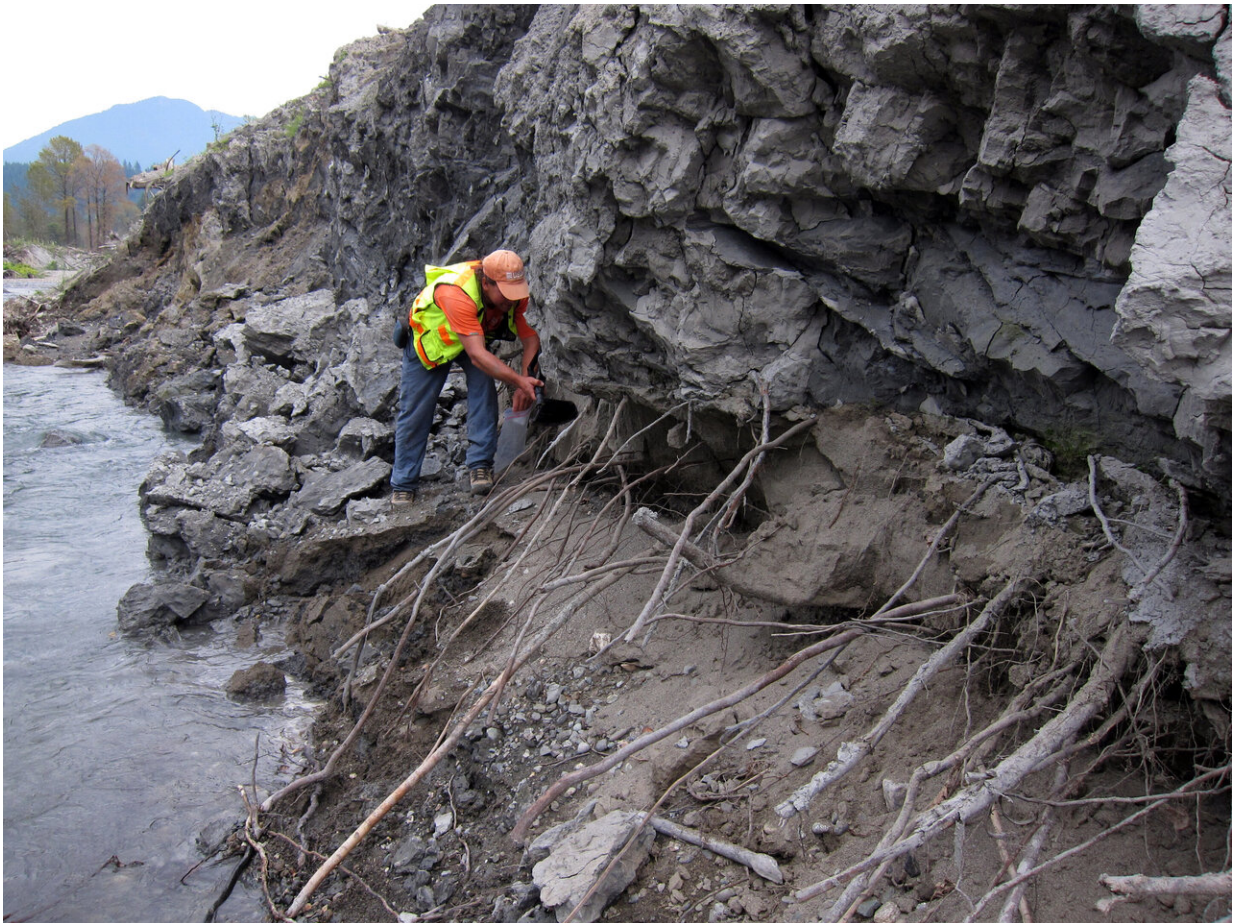
The 2014 State Route 530 (Oso) landslide in northwest Washington overran the entire North Fork Stillaguamish River valley. Here, U.S. Geological Survey civil engineer Brian Collins examines grey clay deposits overlying the brown sand that forms the underlying alluvial river valley. The clay was initially high up on the

slope hundreds of meters uphill (to the left of the image) and destroyed the Steelhead Haven neighborhood where 43 people perished. The landslide was rafted across the valley by water pressures caused by liquefaction (fluidization and loss of strength) of the alluvium, and ripped trees from the ground, leaving only root pieces sticking out of the alluvium. Photo by Mark Reid (USGS).
Credit: Mark Reid (USGS)

The large and rapid failure of the landslide caused the flood plain, composed of alluvial sands and gravels, to liquefy through a process of pore-pressure generation and consequent liquefaction. Liquefaction greatly reduced the strength along the base of the landslide and enabled it to travel over 1 km across the valley flats.

Collins and Reid found extensive evidence of high soil-water pore pressure during their [field work](#) by identifying and mapping of hundreds of "sand boils"—typically decimeter-sized cones of sand that indicated locations where liquefied alluvium tried to escape from a weakened base beneath the landslide. In their new GSA Bulletin article, Collins and Reid present their mapping and interpreted landslide sequence, as well as analyses that show how the basal liquefaction mechanism likely occurred at the site of the Oso [landslide](#). They hypothesize that this mechanism might enhance mobility of other landslides in similar settings.
