Wood documents Hurricane Dorian's impact on the Bahamas

December 2 2019, by Leslie Reed

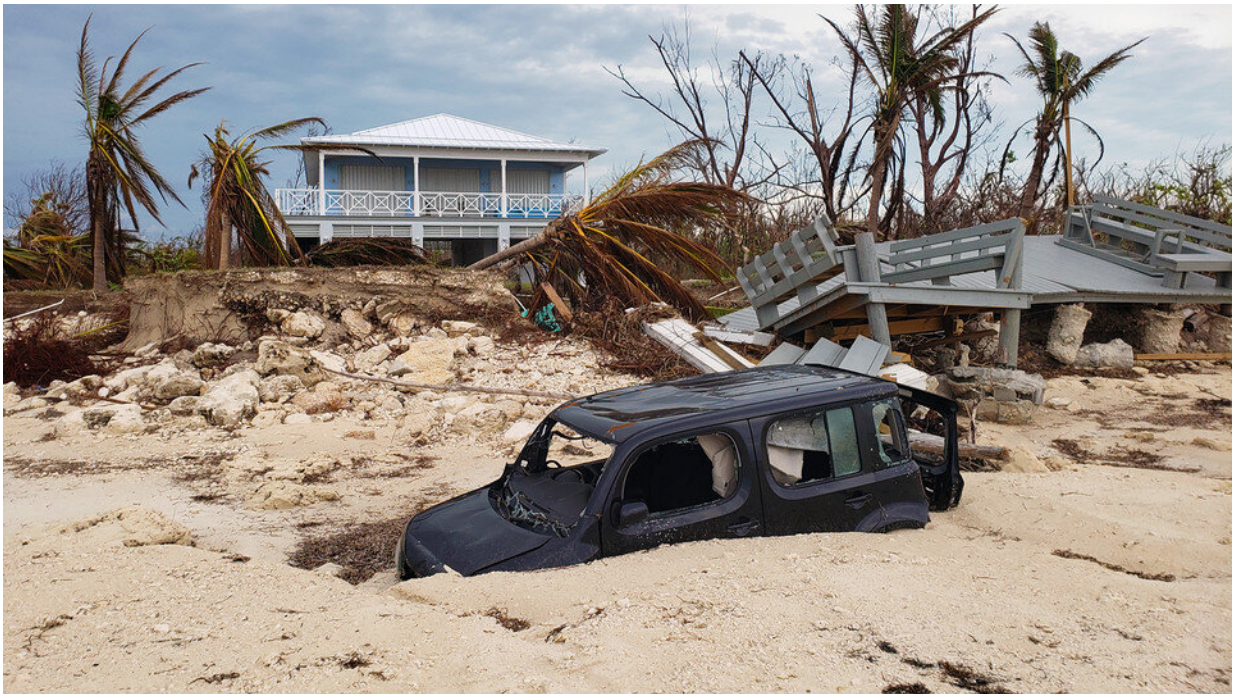
Some structures remained standing amid the devastation caused by Hurricane Dorian when it hit the Bahamas in early September. Nebraska engineering professor Richard L. Wood recently visited the islands to gather data to help understand why. Photo taken at Golden Grove, East Grand Bahama. Credit: University of Nebraska-Lincoln
