# Southern Illinois' Len Small levee likely to fail even if repaired, study says

February 4 2020, by Lauren Quinn

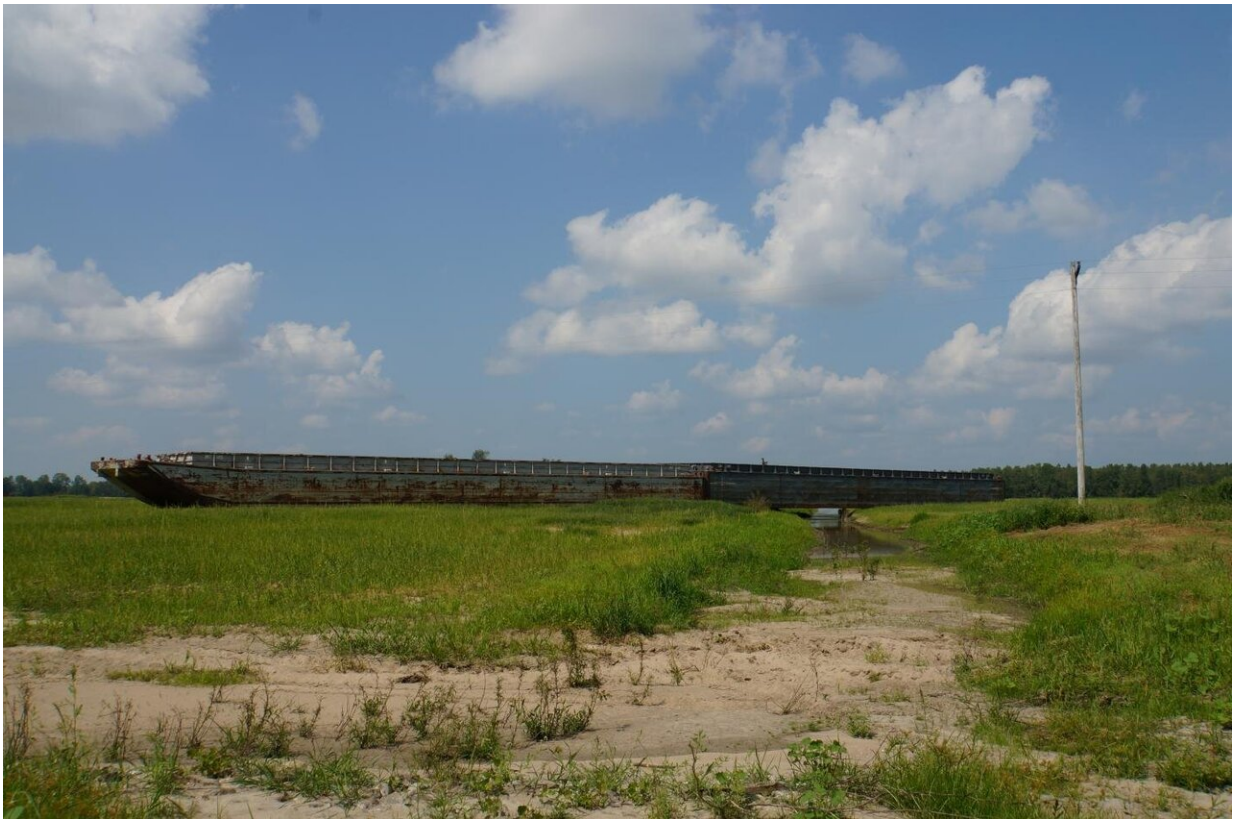
The Len Small levee, built to hold back the Mississippi River as it rounds the southern tip of Illinois, has failed repeatedly, but it has been left unrepaired since 2016. A new University of Illinois study predicts it will continue to fail even if repairs are made. Credit: Ken Olson, University of Illinois

"Because the levee is built on unconsolidated ancient Ohio River valley alluvial sediments, which are easily eroded by the Mississippi River, any patch or repair will only be a short-term solution. The levee is very likely to fail again during a future major flooding event," says Kenneth Olson, professor emeritus in the Department of Natural Resources and Environmental Sciences at U of I.

As the Mississippi River snakes around Dogtooth Bend at the southern tip of Illinois, certain curved segments of the riverbank take the brunt of the river's erosive power. One of those spots, a section of the Len Small levee near Miller City, first failed in 1993. The breach was repaired that year, but the levee breached again in 2011 and 2016. In 2011, farmers patched it themselves, but the 2016 breach was too extensive for a do-it-yourself repair. The cost to fix it was an estimated \$16 million, including a required \$3-million local match. Without funds to make the necessary repairs, floodwaters now cross the Dogtooth Bend peninsula between river mile markers 33 and 15 every year.
