# The consequences of glacier shrinkage

November 2 2020

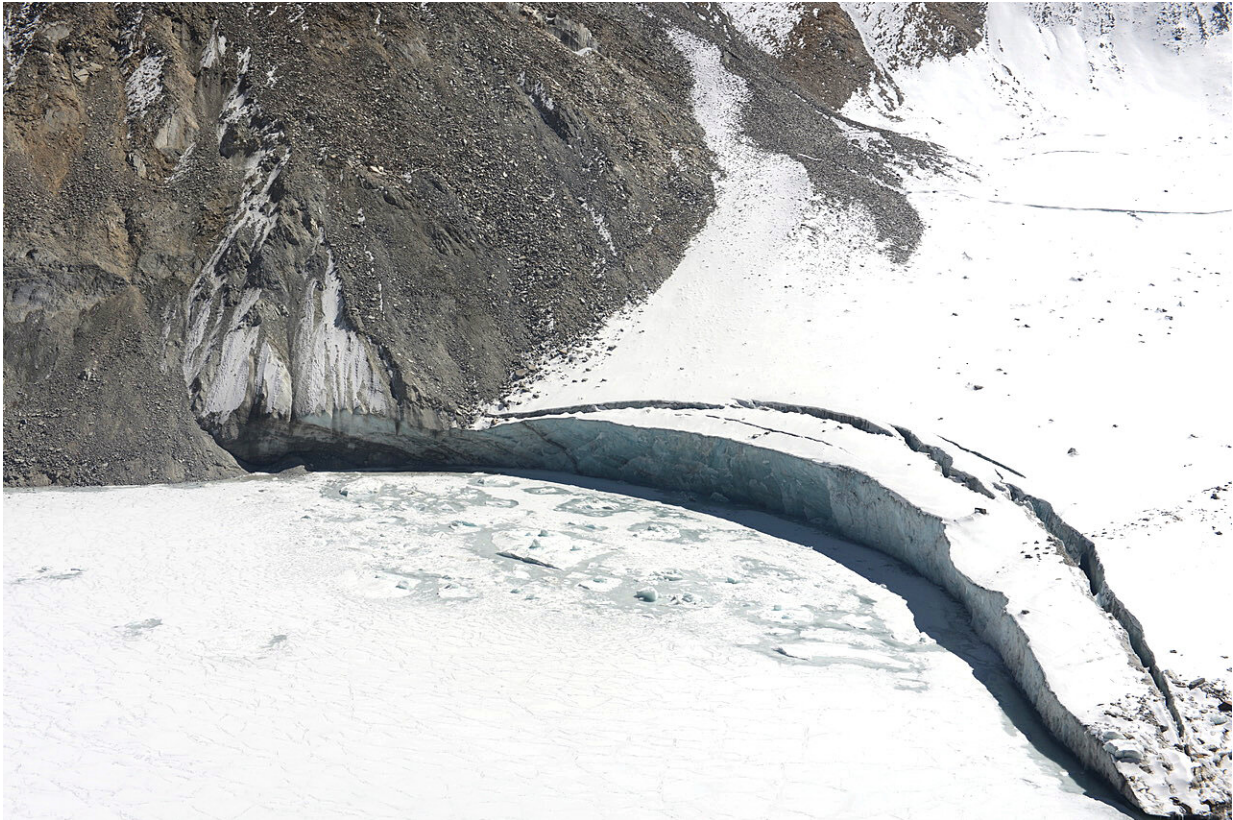
The ice-covered Gya glacier lake shortly after the GLOF event. Credit: Marcus Nüsser

The cause, as the scientists discovered, was a "previously little-known mechanism." "Increased glacial melting caused the lake level to rise quite rapidly. Instead of resulting in spillover, however, the thawing ice cores in the moraine, i.e. the glacier's debris field, drained through subsurface tunnels without disturbing the moraine's surface," states Nüsser. In addition to conducting field surveys, the scientists also interviewed the locals about their recollections of the GLOF event. On the basis of [satellite images](#), the team additionally studied the evolution of the glacial lake since the 1960s in order to reconstruct possible GLOF events.

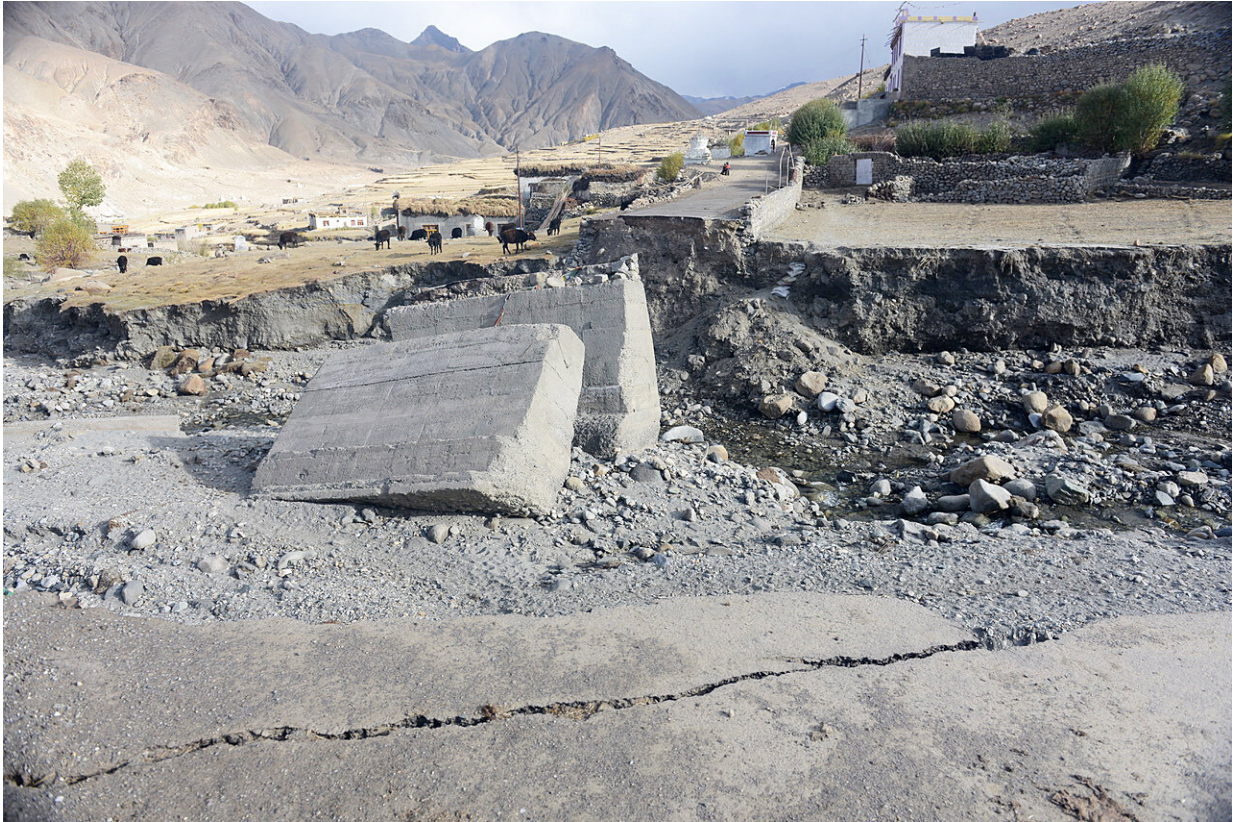
Concrete bridge destroyed by the glacier lake outburst flood. Credit: Marcus Nüsser

"The high temporal and high spatial remote sensing imagery from satellites supported by field surveys will allow us to better assess the possible risk of future outbursts in this region," adds the Heidelberg geographer. In light of recurring GLOFs, the new inventory can help us "re-evaluate the hazards, identify vulnerable locations, and develop possible adaptation measures," continues Nüsser. After the flood in Gya, for example, [concrete walls](#) were constructed along the undercut bank as a flood protection measure to safeguard the villages and fields from future floods.
