Melody of an Alpine summit falling apart

December 21 2020

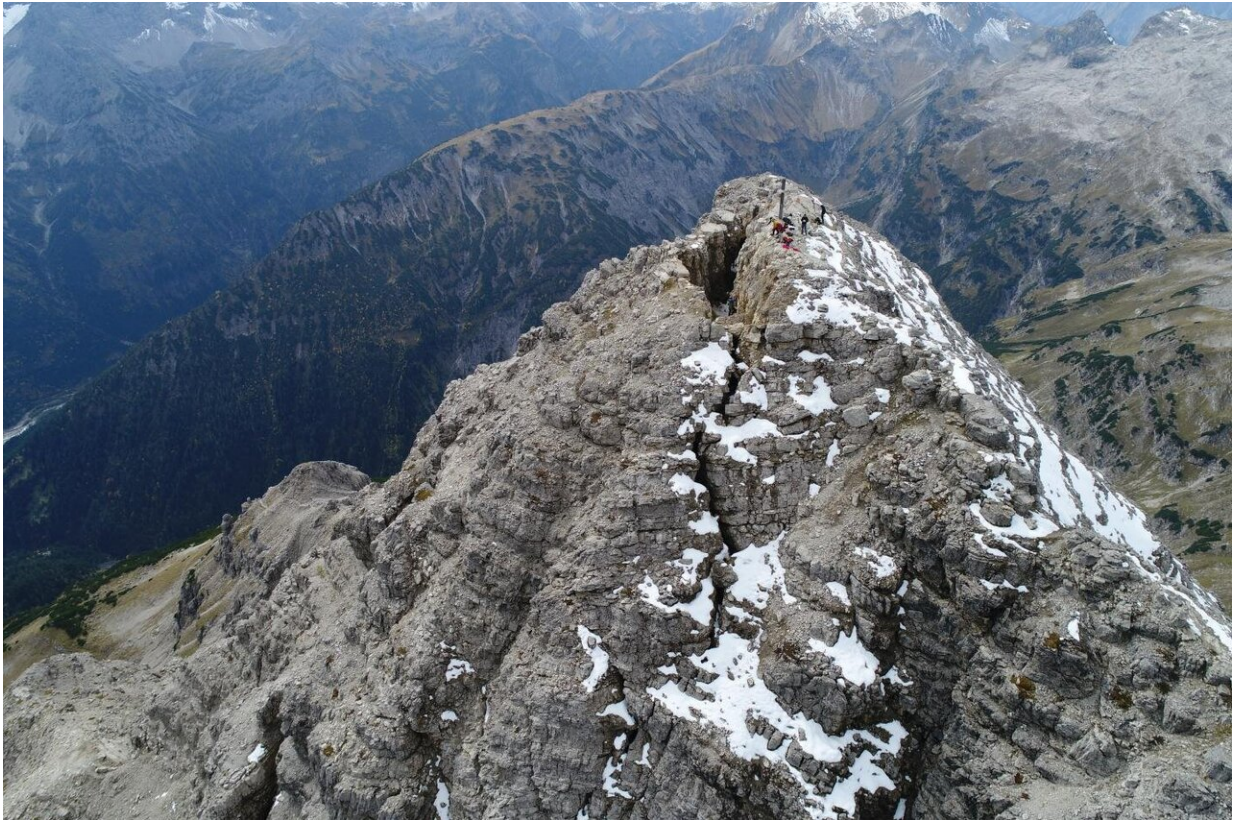
Across the summit of the 2592-meter-high Hochvogel in the Allgäu region of Germany, a dangerous crack is gaping and growing. The southern side of the mountain threatens to slide into the Austrian Hornbach Valley, releasing up to 260,000 cubic meters of limestone debris - corresponding to ~260 single-family houses. Credit: TU München

The entire summit of the 2592 meters high Hochvogel is sliced by a five

meters wide and thirty meters long fracture. It continues to open up by up to half a centimeter per month. Throughout the years, the southern side of the mountain has already subsided by several meters; and at some point it will fail, releasing up to 260,000 cubic meters of limestone debris down into the Hornbach Valley in Austria. Such a volume would roughly correspond to 260 family houses. When this will happen is hard to predict by conventional methods. Researchers of the Helmholtz Centre Potsdam—German Research Centre for Geosciences and the Technical University of Munich have approached this question by seismic sensors. The devices record the subtle vibration of the peak: similar to a violin string which is pulled more or less does the pitch of the summit change as it becomes stressed, an effect that allows unique insight to the preparation phase of an upcoming rock slide. Thus, also a timely warning should become possible—even if human dwellings are not threatened directly at this site. The study has recently been published in the journal *Earth Surface Processes and Landforms*.

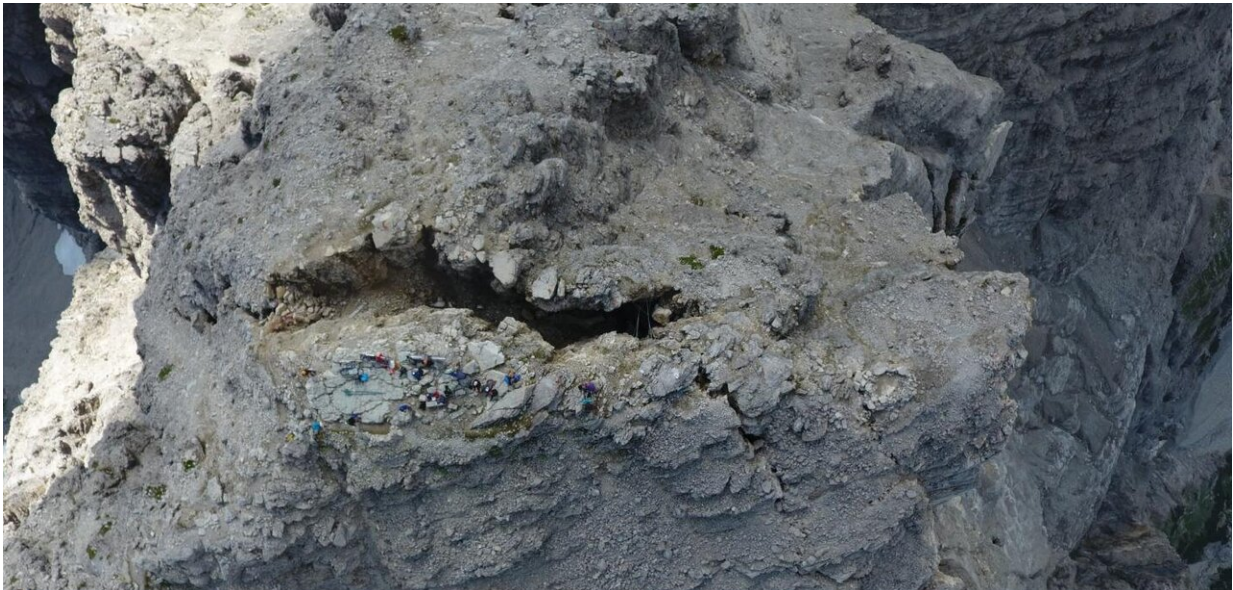
Around the 5-meter-wide and 30-meter-long crack, the researchers led by Michael Dietze of the GFZ have installed a network of six seismometers, which they use to eavesdrop on the Alpine peak as it breaks. Credit: TU Munich

To understand when and why the instable rock mass at the Hochvogel becomes mobile, in 2018 researchers around Michael Dietze of the GFZ had deployed a network of six seismometers at the summit, each at a distance of thirty to forty meters from each other. For several months, the sensors have recorded the frequency with which the mountain swings back and forth. The vibrations are caused by wind and numerous small excitations of the Earth's surface, and the summit's frequency is determined by factors such as temperature, rock stress and material weakening.

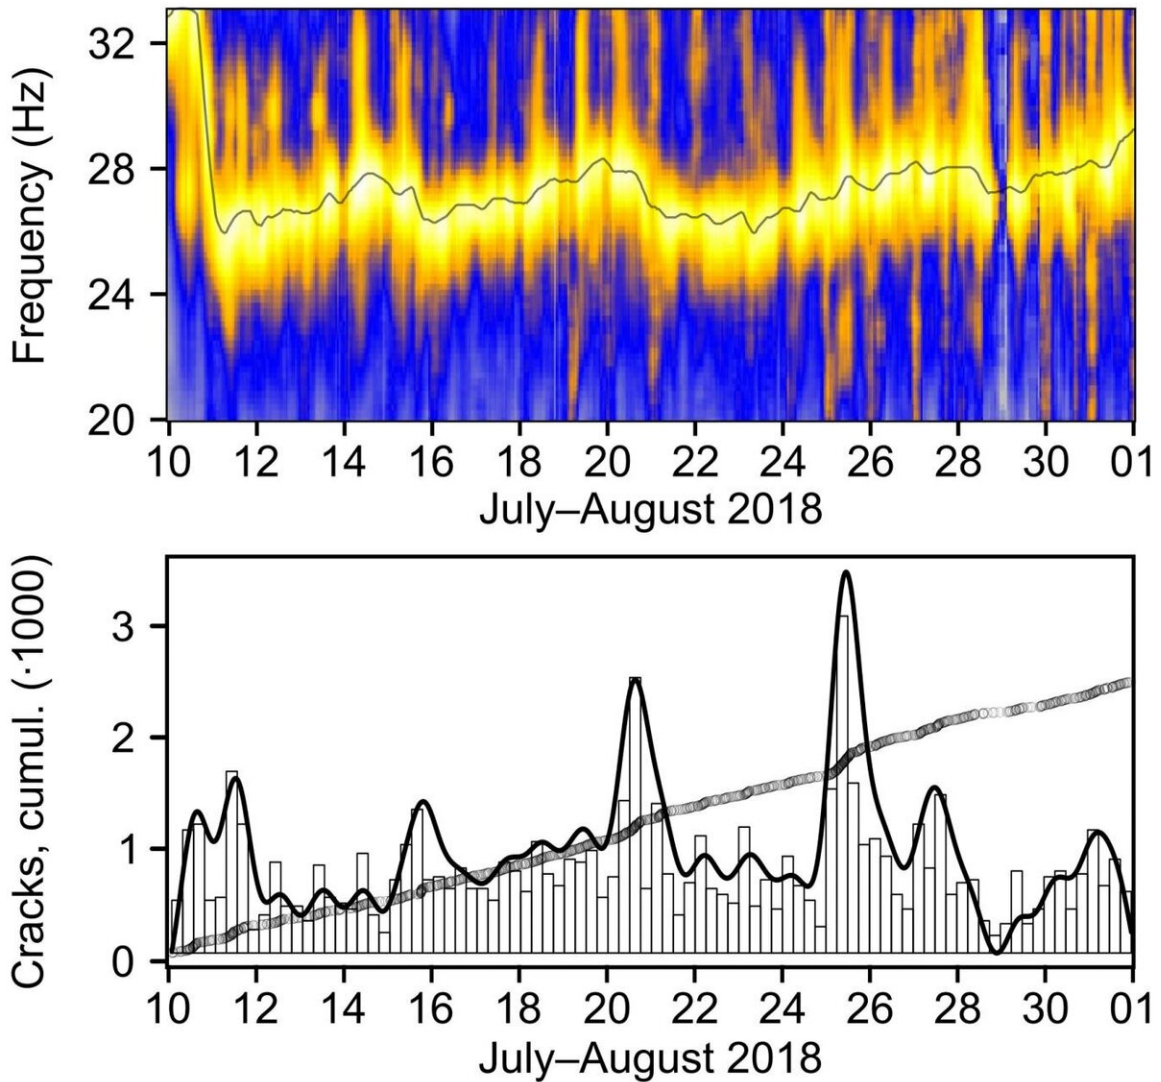
The researchers observe a characteristic sawtooth pattern in the frequency of the mountain (top): it rises with the stress in the rock and drops again after days. In the process, seismic signals are registered (bottom), which occur when rock cracks open. If the cycles become shorter, a mass break-up is approaching. This is also a danger indicator. Credit: Dietze/GFZ

During the summer of 2018, the researchers were able to measure a recurring sawtooth-like frequency pattern: Over a period of five to seven days, it rose repeatedly from 26 to 29 Hertz, only to drop back to its original value within less than two days. The increase in frequency is caused by stress increase within the rock mass. As the frequency drops, the sensors also recorded an increased rate of crack signals, as they are known to happen when rock is being torn apart. This cyclic increase and decrease of stress by jerky movement is also called stick slip motion. It is a typical precursor of large mass movements. The decisive factor here is that the closer this event comes, the shorter the observed cycles become, making them an important hazard indicator.
