Quake-ravaged part of Croatia sees gaping sinkholes emerge

March 5 2021, by Darko Bandic

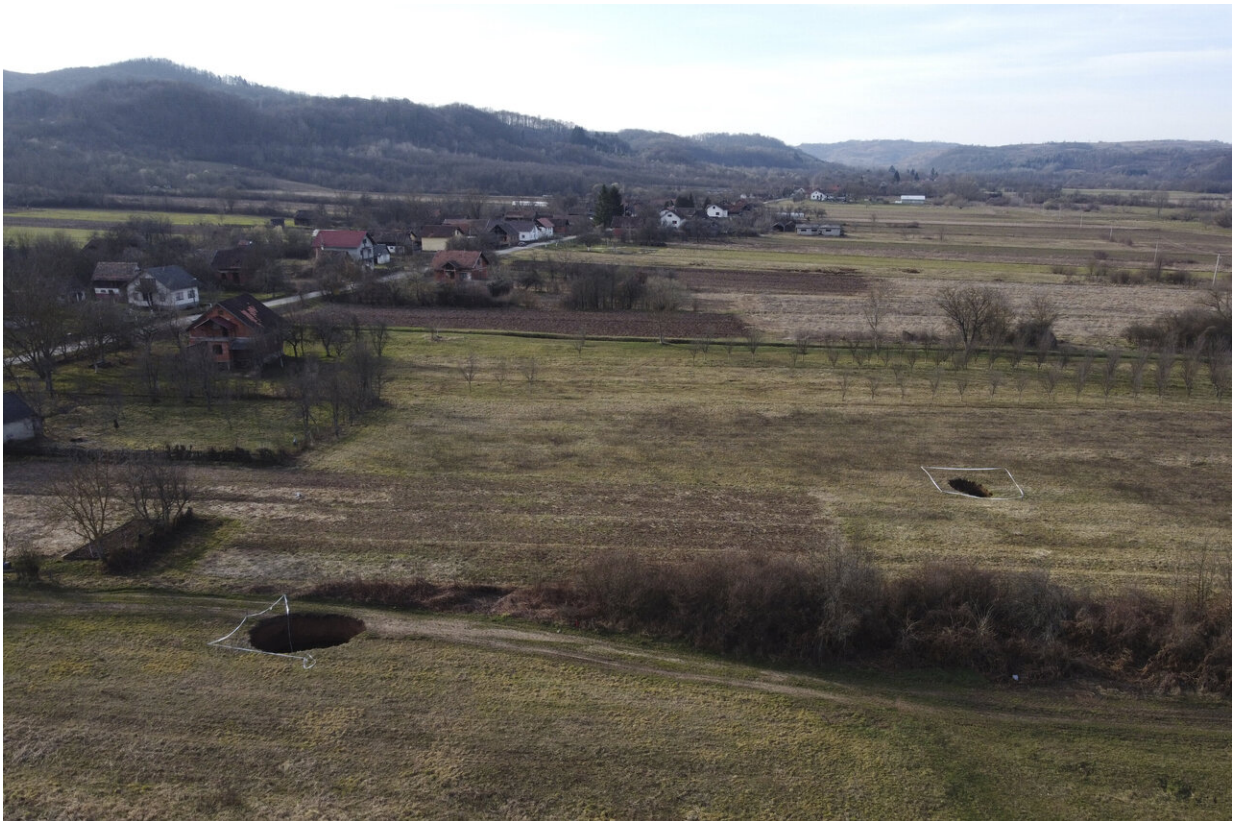
This aerial photo shows sinkholes in the village of Mececani, central Croatia, Thursday, March 4, 2021. A central Croatian region about 40 kilometers (25 miles) southwest of the capital Zagreb is pocked with round holes of all sizes, which appeared after December's 6.4-magnitude quake that killed seven people and caused widespread destruction. Scientists have been flocking to Mecencani and other villages in the sparsely-inhabited region for observation and study. (AP Photo/Darko Bandic)

"These are so-called dropout sinkholes, and they appeared because of the specific geological composition of this area, as the soil rests on limestone rocks heavily saturated with groundwater," said geologist Josip Terzic of the Croatian Geological Survey.

While the appearance of sinkholes is not unusual following strong seismic activity, residents have been baffled by their number—about 100 have been spotted over the past two months—and the speed at which they emerged after the main earthquake on Dec. 29, which was followed by a series of aftershocks. Geologists have said that the temblor accelerated the process of sinkhole formation that would normally have taken years, if not decades.

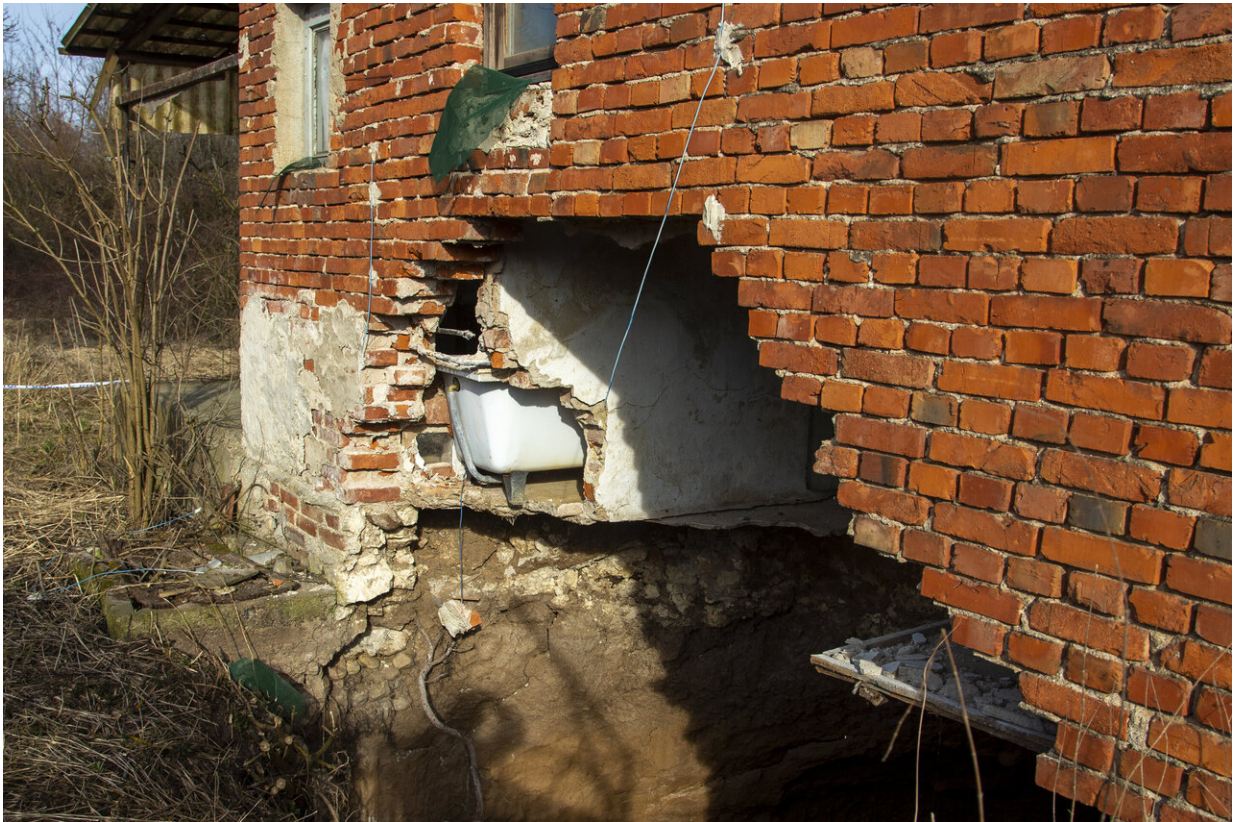
This photo shows a sinkhole under a house in the village of Mececani, central Croatia, Thursday, March 4, 2021. A central Croatian region about 40 kilometers (25 miles) southwest of the capital Zagreb is pocked with round holes of all sizes, which appeared after December's 6.4-magnitude quake that killed seven people and caused widespread destruction. Scientists have been flocking to Mecencani and other villages in the sparsely-inhabited region for observation and study. (AP Photo/Darko Bandic)

Some sinkholes have appeared by people's houses or on their farmland,

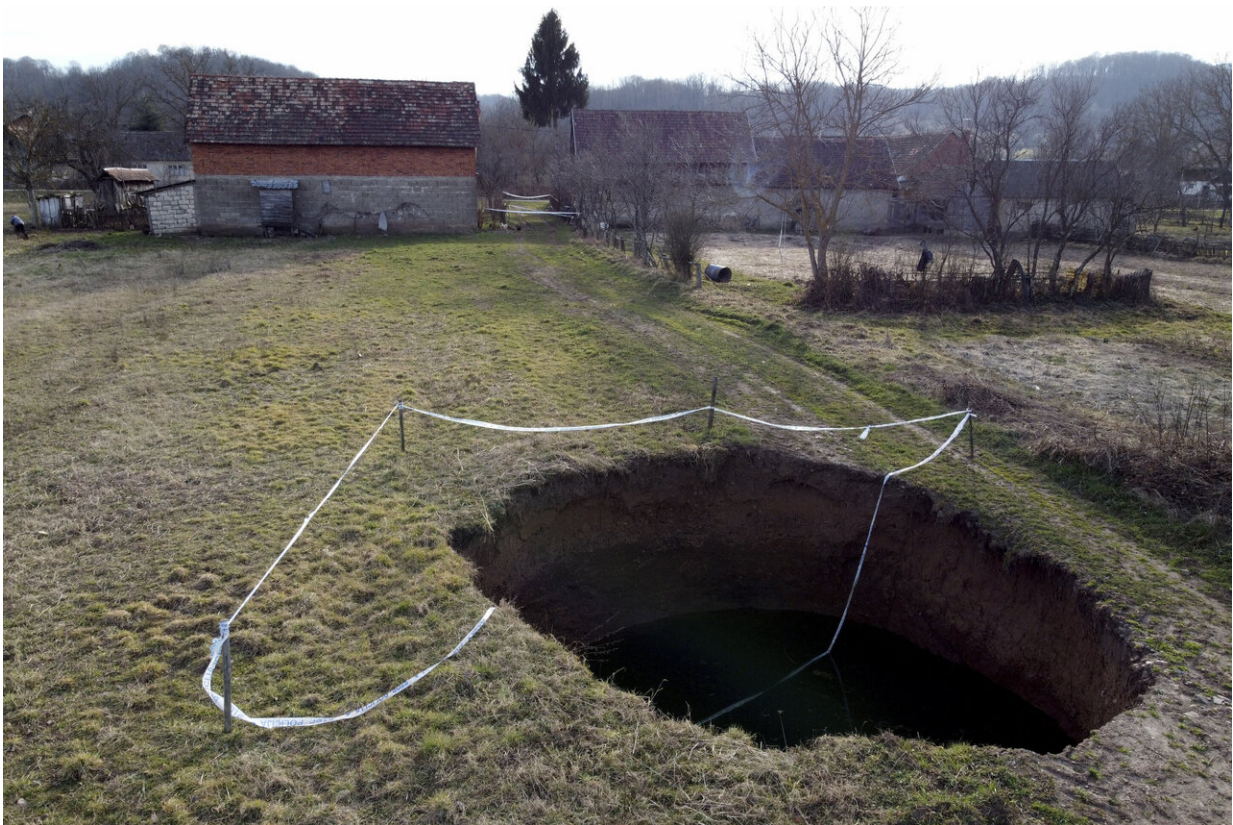
This aerial photo shows a sinkhole in the village of Mecencani, central Croatia, Thursday, March 4, 2021. A central Croatian region about 40 kilometers (25 miles) southwest of the capital Zagreb is pocked with round holes of all sizes, which appeared after December's 6.4-magnitude quake that killed seven people and caused widespread destruction. Scientists have been flocking to Mecencani and other villages in the sparsely-inhabited region for observation and study. (AP Photo/Darko Bandic)

Terzic said scientists are planning various exploration methods to determine the underwater morphology and other characteristics. He spoke to The Associated Press as he stood beside a large [sinkhole](#) that he said was up to 15 meters (yards) deep and equally wide.
