Cause, scope determined for deadly winter debris flow in Uttarakhand, India

June 10 2021

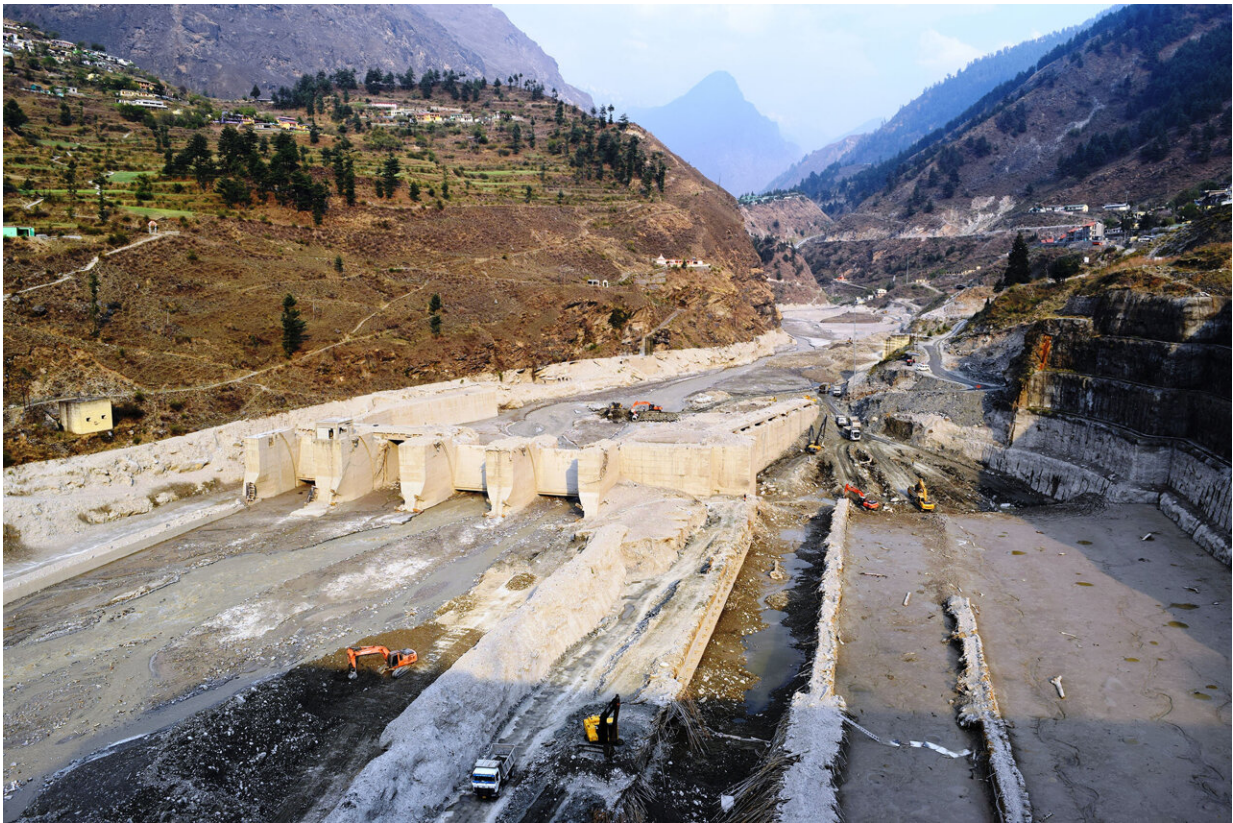
Destroyed Tapovan Vishnugad hydroelectric plant after devastating debris flow of Feb 7, 2021. Credit: Irfan Rashid, Department of Geoinformatics, University of Kashmir

The event began when a wedge of rock carrying a glacier broke off of a steep ridge in the Himalayan mountain range. The resulting debris flow destroyed two hydropower facilities and left more than 200 people dead or missing.

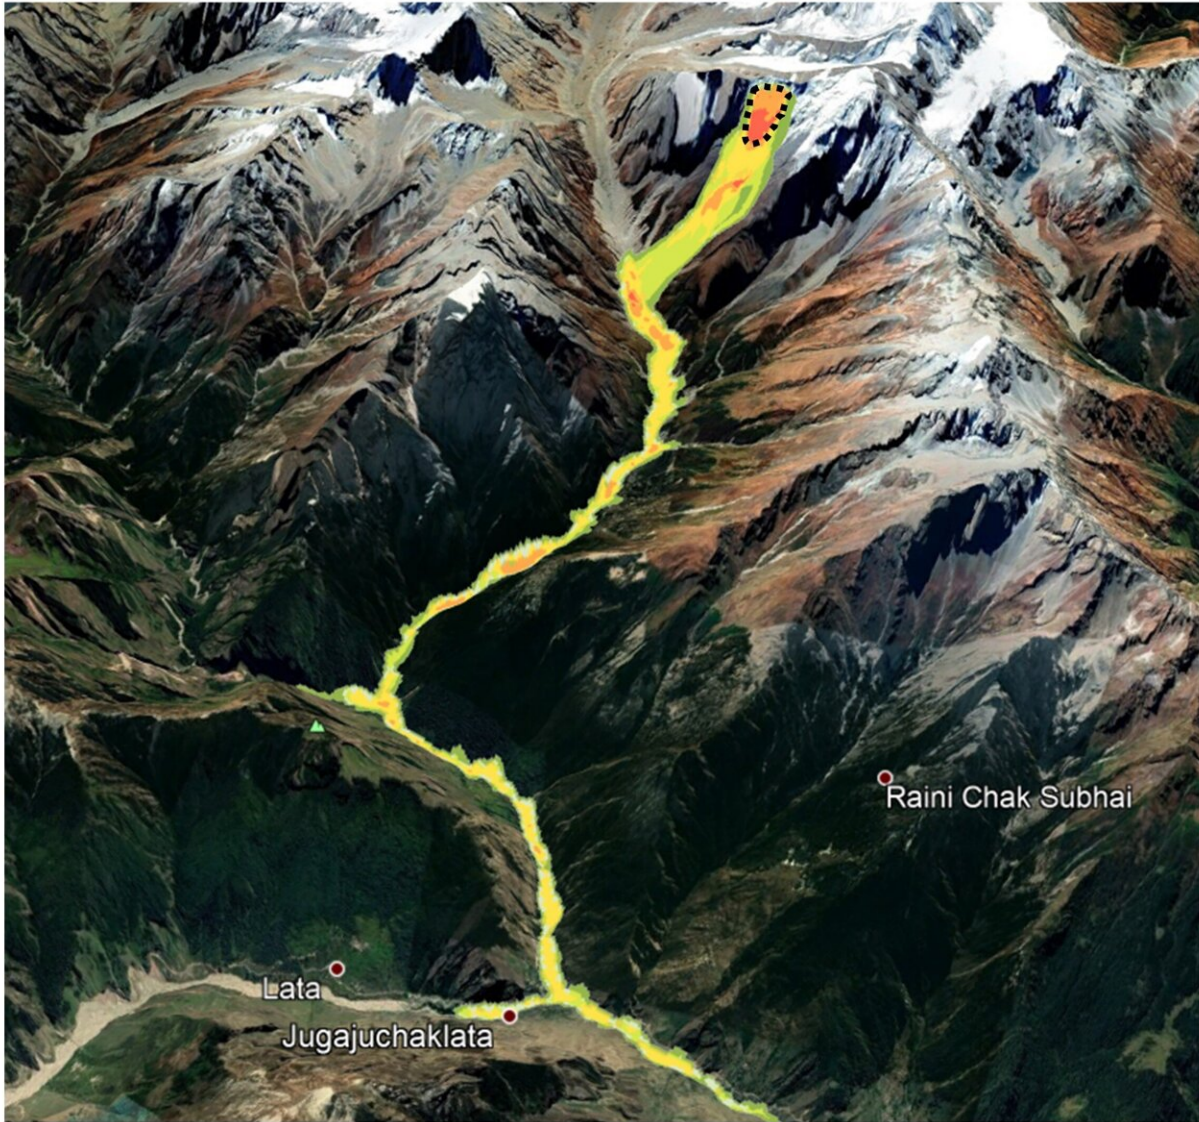
Computer modeling of the Chamoli rock and ice avalanche. Credit: Ashim Sattar; UZH

The study, which used satellite imagery, seismic records and eyewitness videos to produce computer models of the flow, was published June 10 in *Science*.

The dark patch turned out to be the scar left by the 35 million cubic yards of missing rock and glacier ice—enough material to cover Washington, D.C., with a 3-foot-deep layer.
