After the flood disaster in Western Germany: Science searches for answers

September 20 2021

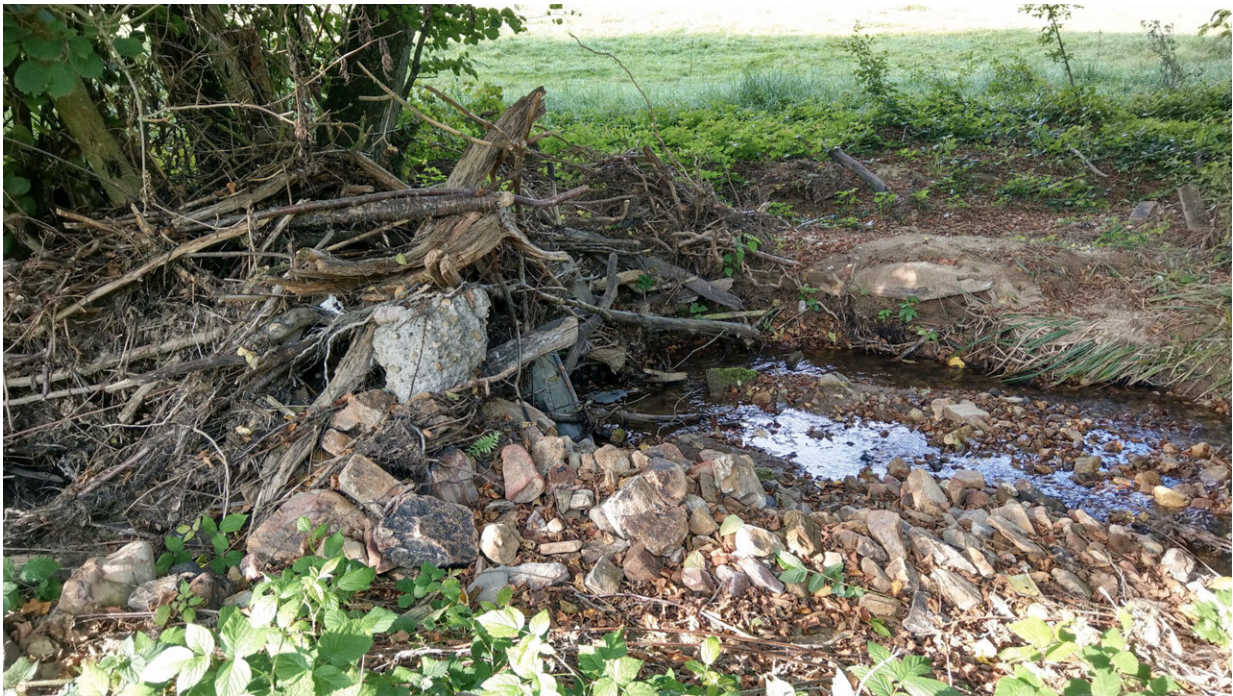
Woody debris clogging a small creek of the Ahr river, leading to temporal ponding, massive sediment deposition and overbank spillways of the flood water. Credit: M. Dietze, GFZ

In addition, the water developed enormous erosive power: On the one hand, it dug channels into the slopes and was able to flow even faster in those self-dug pathways. On the other hand, it mobilized considerable amounts of sediment and dead wood. Once in the main valleys, the tree trunks and branches drifted towards bridges. There they became entangled and led to so-called blockages. As a result, the runoff was impeded, the water dammed up and also inundated more distal areas.

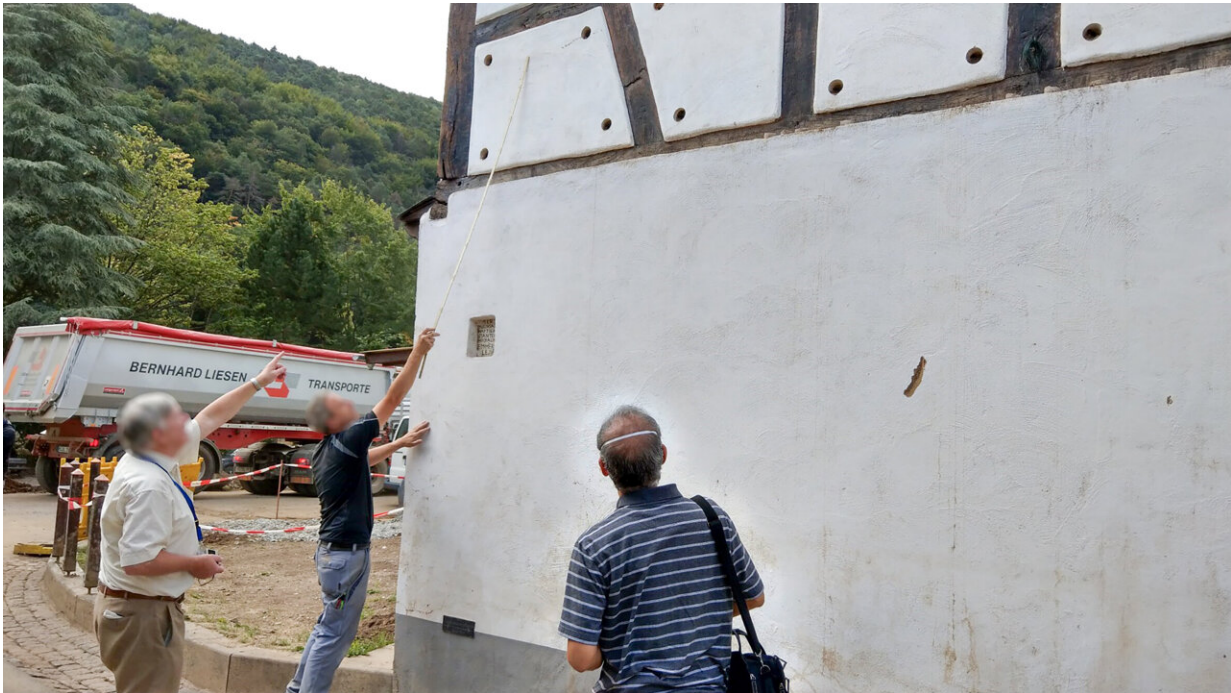
Owner showing the water level of the 14 July flood on his house in Walporzheim. Note the 2.2 m water mark of the 1804 flood and the 0.6 m mark from 2016 for comparison. Credit: Michael Dietze, GFZ
