Perseverance dumps contents of Sample Tube 261 in first step to clear rocky anomaly

January 19 2022, by Jennifer Trosper

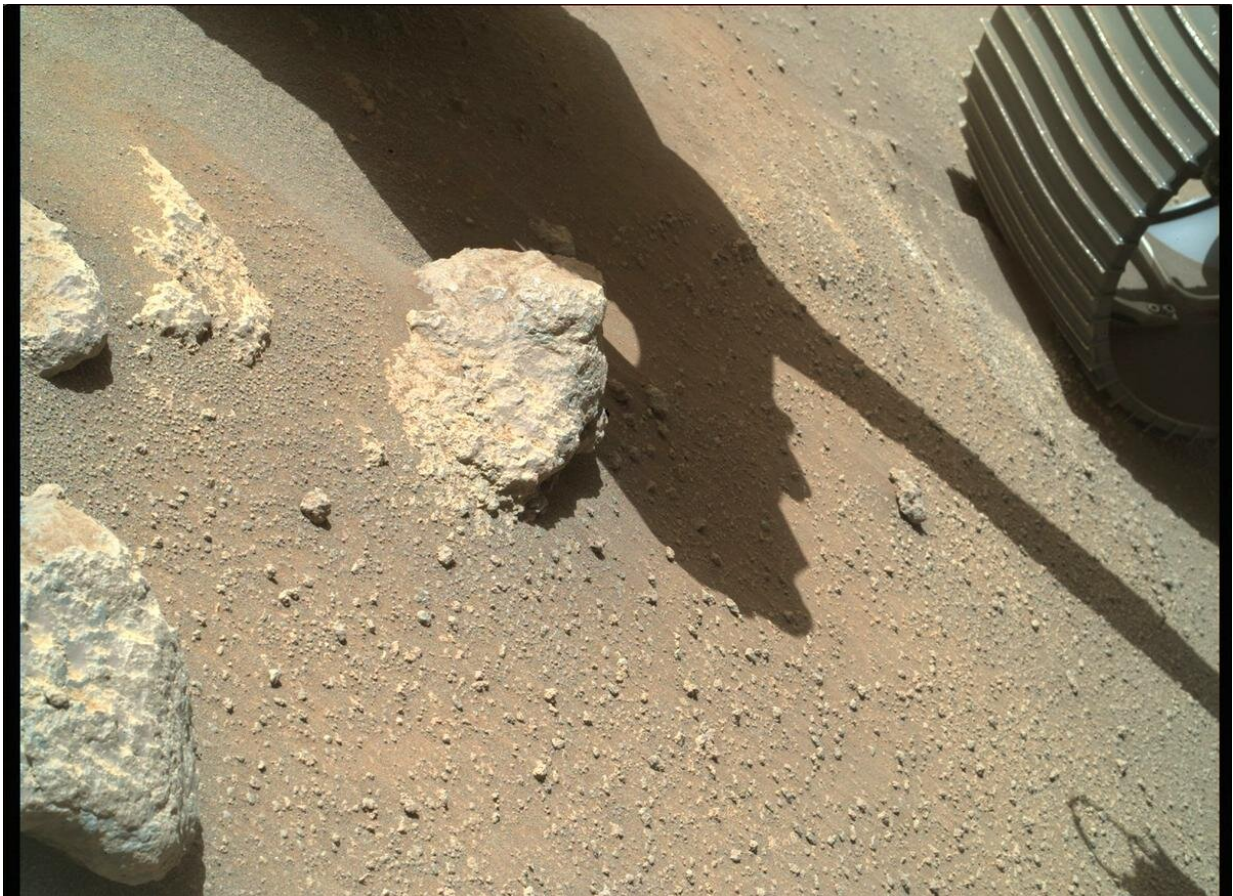
NASA's Mars Perseverance rover acquired this image using its onboard SHERLOC WATSON imager. The camera is located on the turret at the end of the rover's robotic arm. The image was acquired on Jan. 13, 2022 (Sol 320).
Credit: NASA/JPL-Caltech
