Rust-coated irrigation pipes hint at lack of nitrate in groundwater

December 7 2022

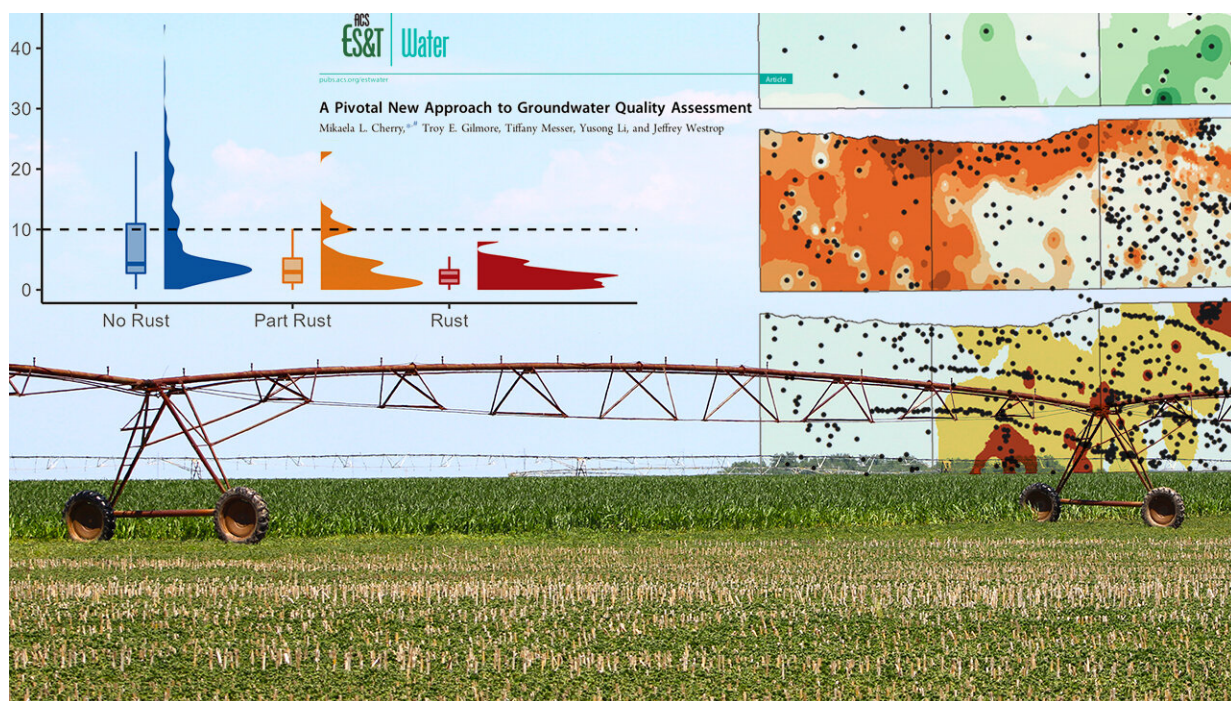
According to a study from Nebraska researchers, irrigation pivots covered with rust may signal the absence of nitrate—a contaminant linked to birth defects and cancers—in nearby groundwater. Credit: Mikaela Cherry / *ACS ES&T Water* / Scott Schrage

So the microbes prioritize the recipients of their electrons: dissolved oxygen first, followed by nitrate, manganese and then iron. By lending an electron to the iron found in groundwater, microbes convert it to a form that oxidizes, or rusts, if it gets pumped to the surface and exposed to oxygen—explaining why some center pivots become coated with the reddish-brown hue even when they're not corroding.
