Giant SpaceX rocket leaves crater, serious damage at Texas base

April 24 2023, by Patrick FALLON with Lucie AUBOURG in Washington

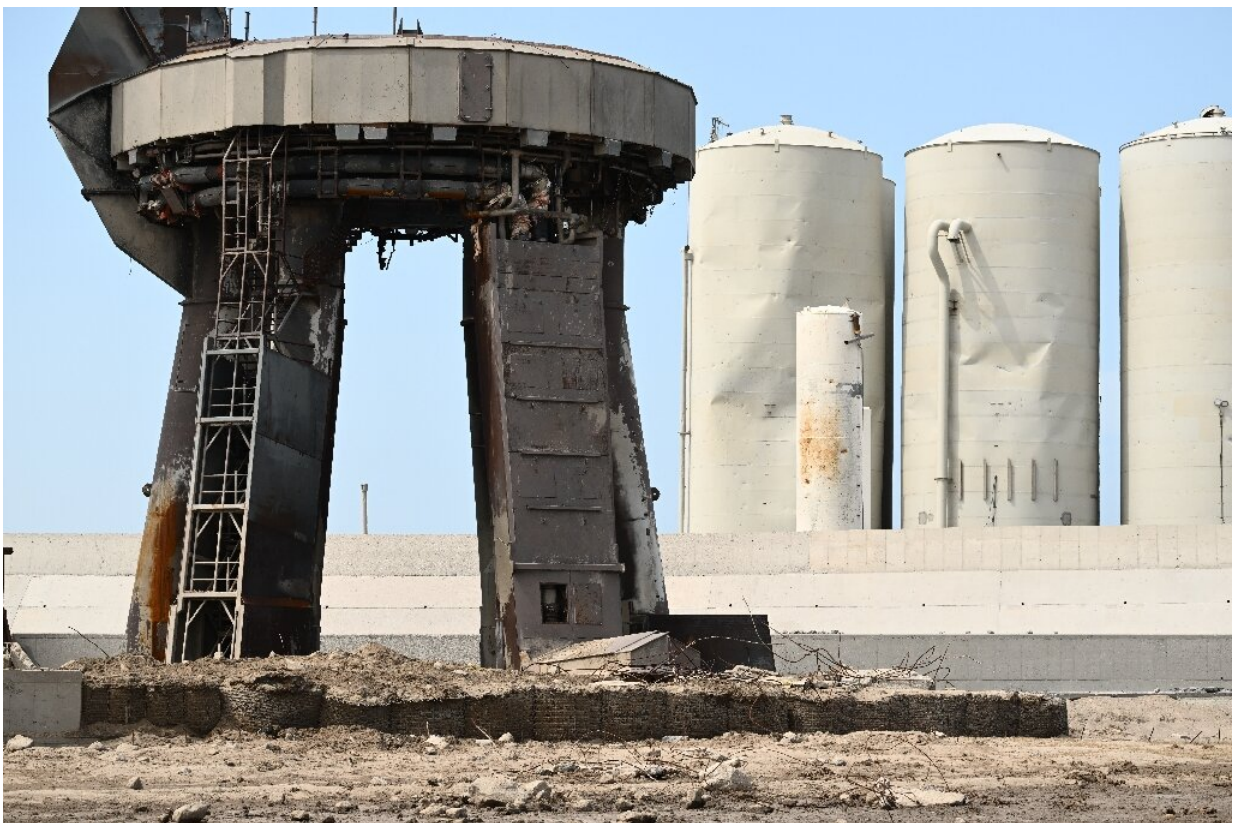
This photo from April 22, 2023 shows damage to the area around the launch pad in Texas of SpaceX's huge Starship rocket; a test launch ended with the rocket's destruction.

Photos of the launch site show the gigantic launch tower still standing while the rocket mount, which supports Starship before liftoff, damaged but still intact.

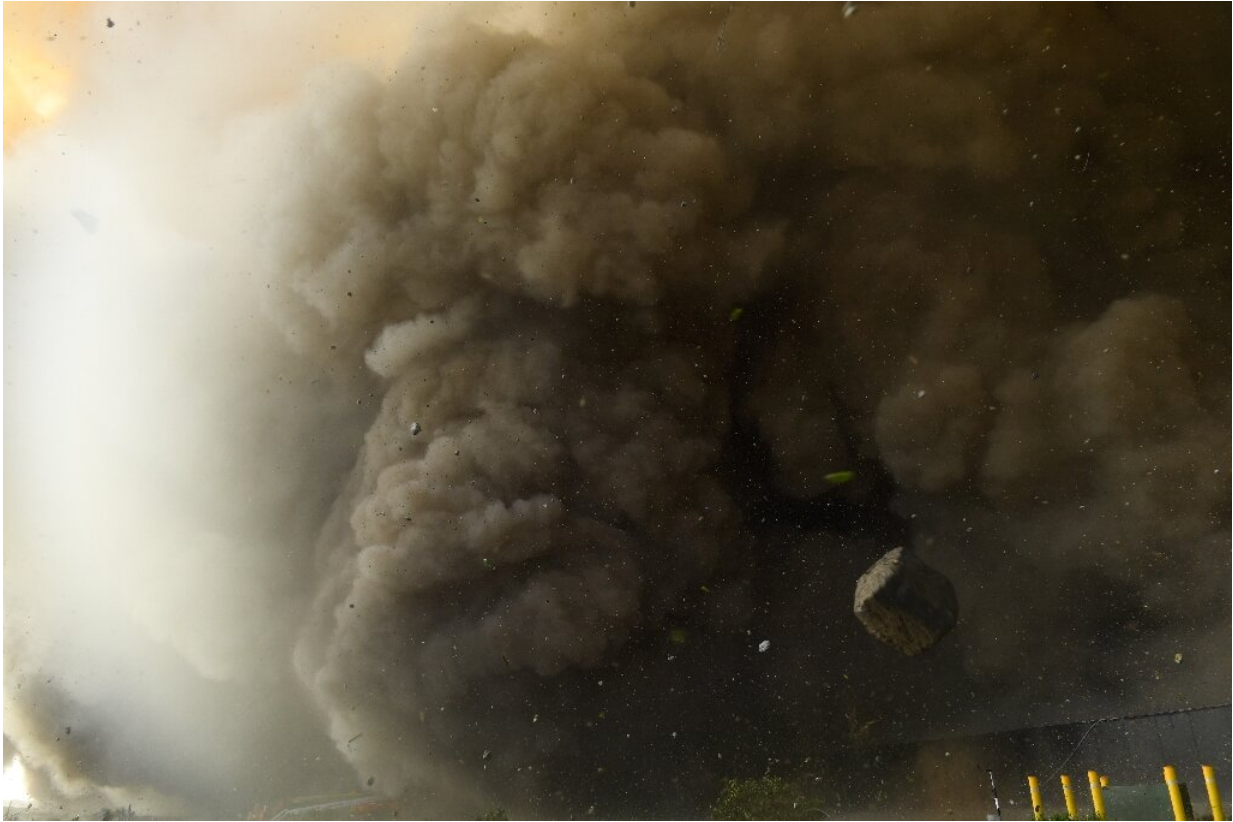
The launch of the Starship rocket on April 20, 2023 sent a huge cloud of dust and debris into the air around the Texas launch site.

Beneath it, however, lies a huge crater, images posted on social media showed.

"The force of the engines when they throttled up may have shattered the concrete, rather than simply eroding it," Musk conceded Saturday on Twitter—another company in his portfolio.

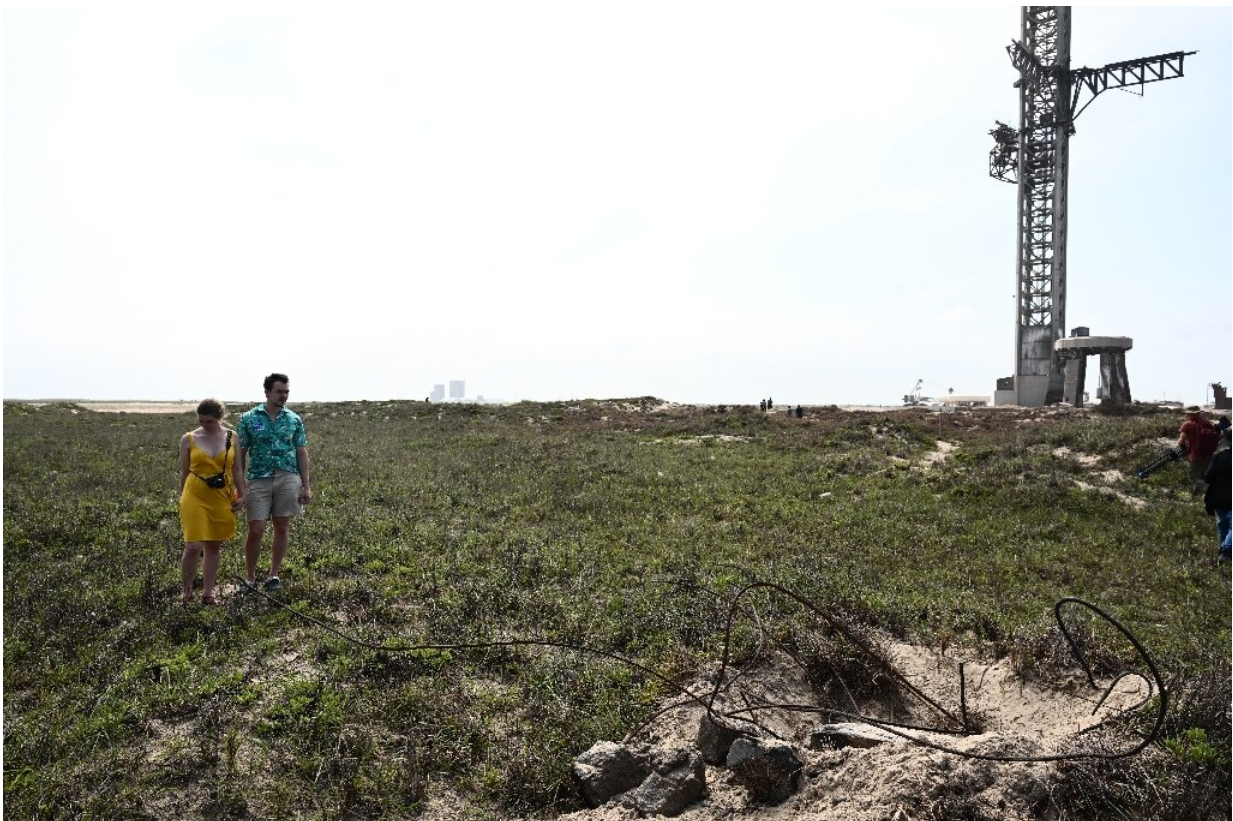
"The main damage to the launch pad is underneath, where the flames impinge on the ground," he told AFP, adding that repairing the crater "will take several months."

De Weck said that Starship's launch site, unlike others used for such large rockets, lacked a "water deluge system."

Those are used to flood the pad with water, cooling it and absorbing shock and sound waves.

This photo shows a crater blasted by the takeoff of the Starship rocket.

The Texas site also lacks what is known as a flame trench—tunnels which channel hot exhaust away from the pad.

After Thursday's test, Musk said that SpaceX had begun building "a massive water-cooled steel plate to go under the launch mount."

That could be solved by pumping water through channels in the steel, "so long as they have a high enough flow rate," said Metzger, now a professor at the University of Central Florida.

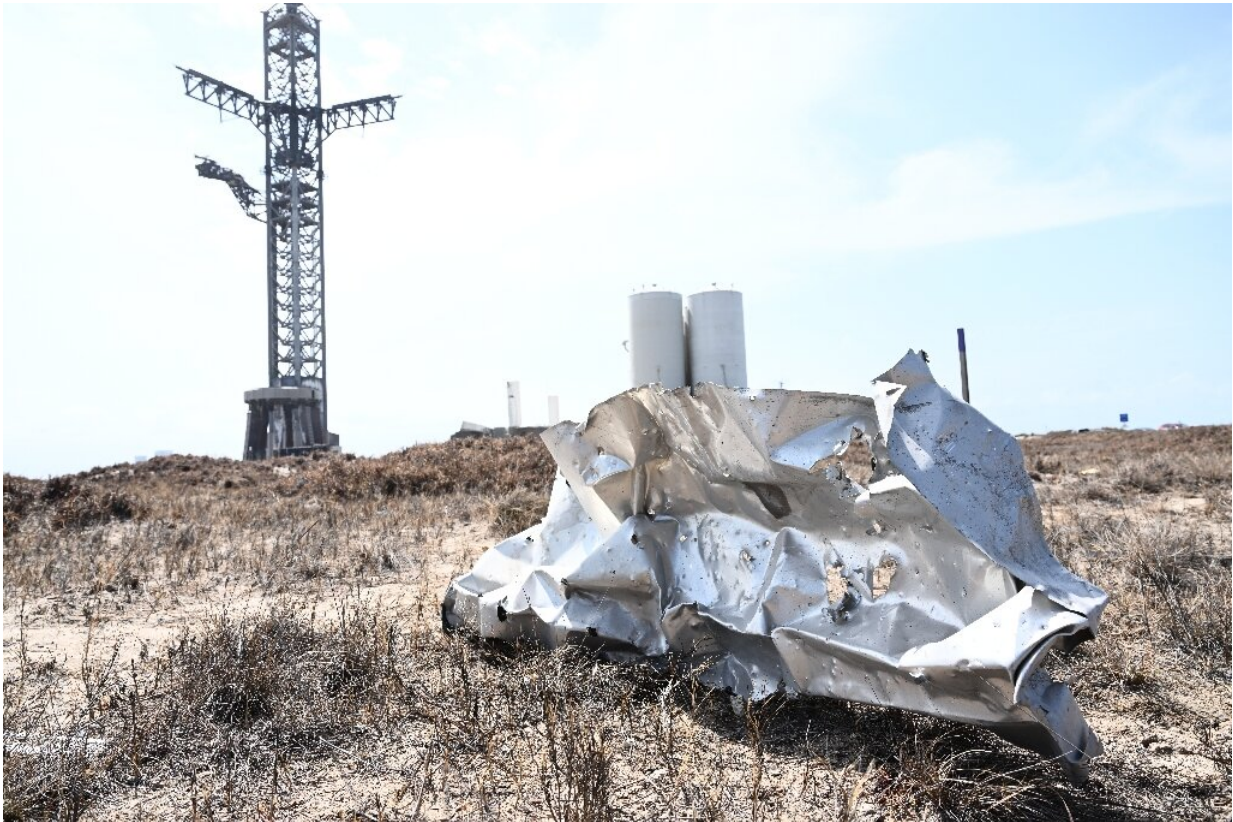
A chunk of twisted metal lies on the ground near the Starship's launch site.

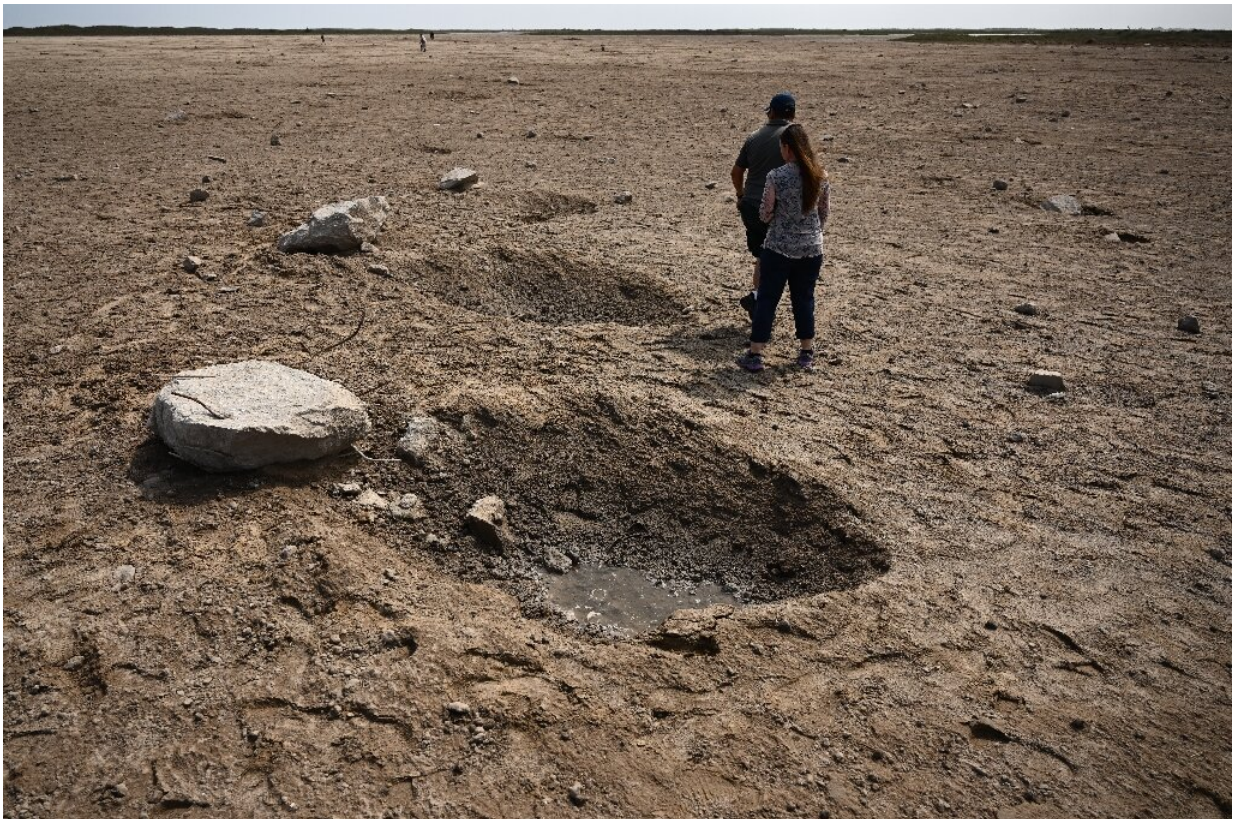
During takeoff, SpaceX video showed a hail of debris being blasted as far as the Gulf of Mexico, over 1,400 feet (420 meters) away. According to local press reports, a cloud of dust floated over a small town several miles (kilometers) away.

Members of the public walk through a debris field near the SpaceX launch pad on April 22, 2023.
