Dramatic images of the 6 Feb. 2023 Turkiye earthquake scarps reveal details of motions of tectonic plates

January 18 2024

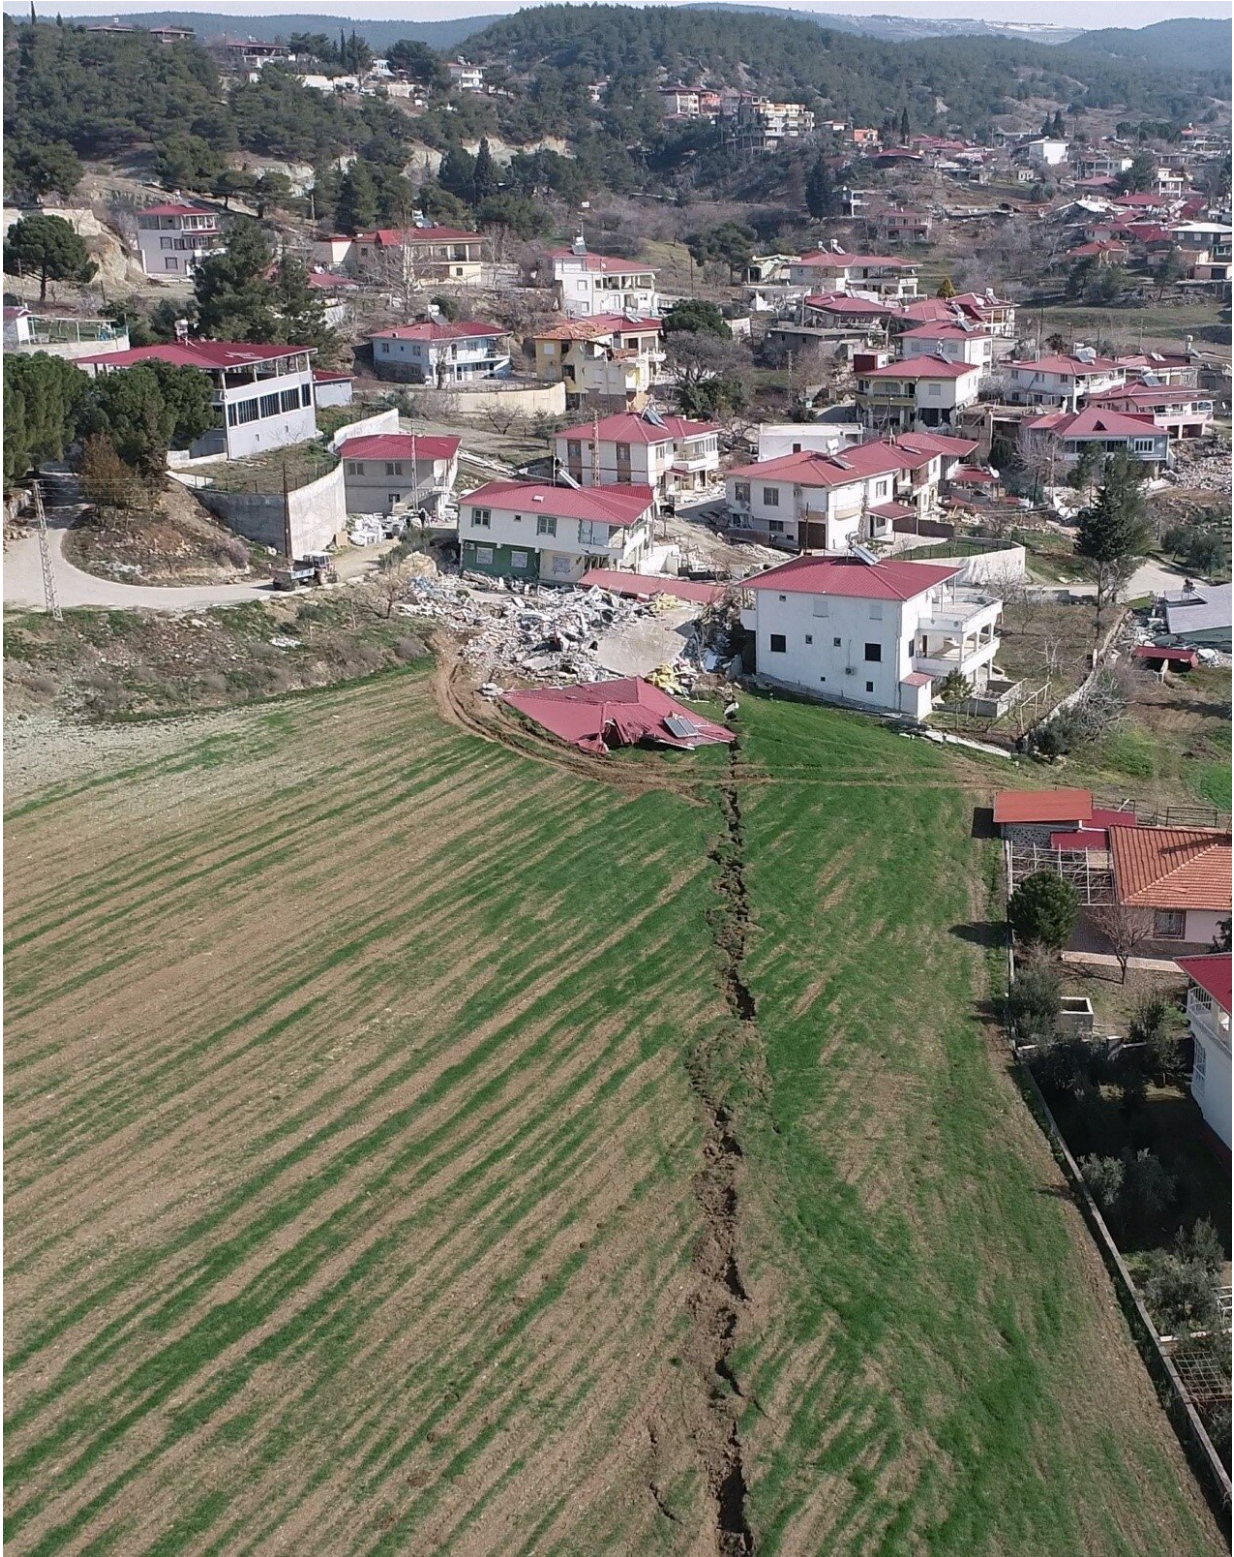
When the fault comes to town. Drone photograph of the town of Çiğli taken 16 days after the February 6th 2023 Earthquake Sequence in eastern Türkiye. The

ground ruptured by the movement of the faults collapsing many buildings but leaving others intact. Credit: Jiannan Meng

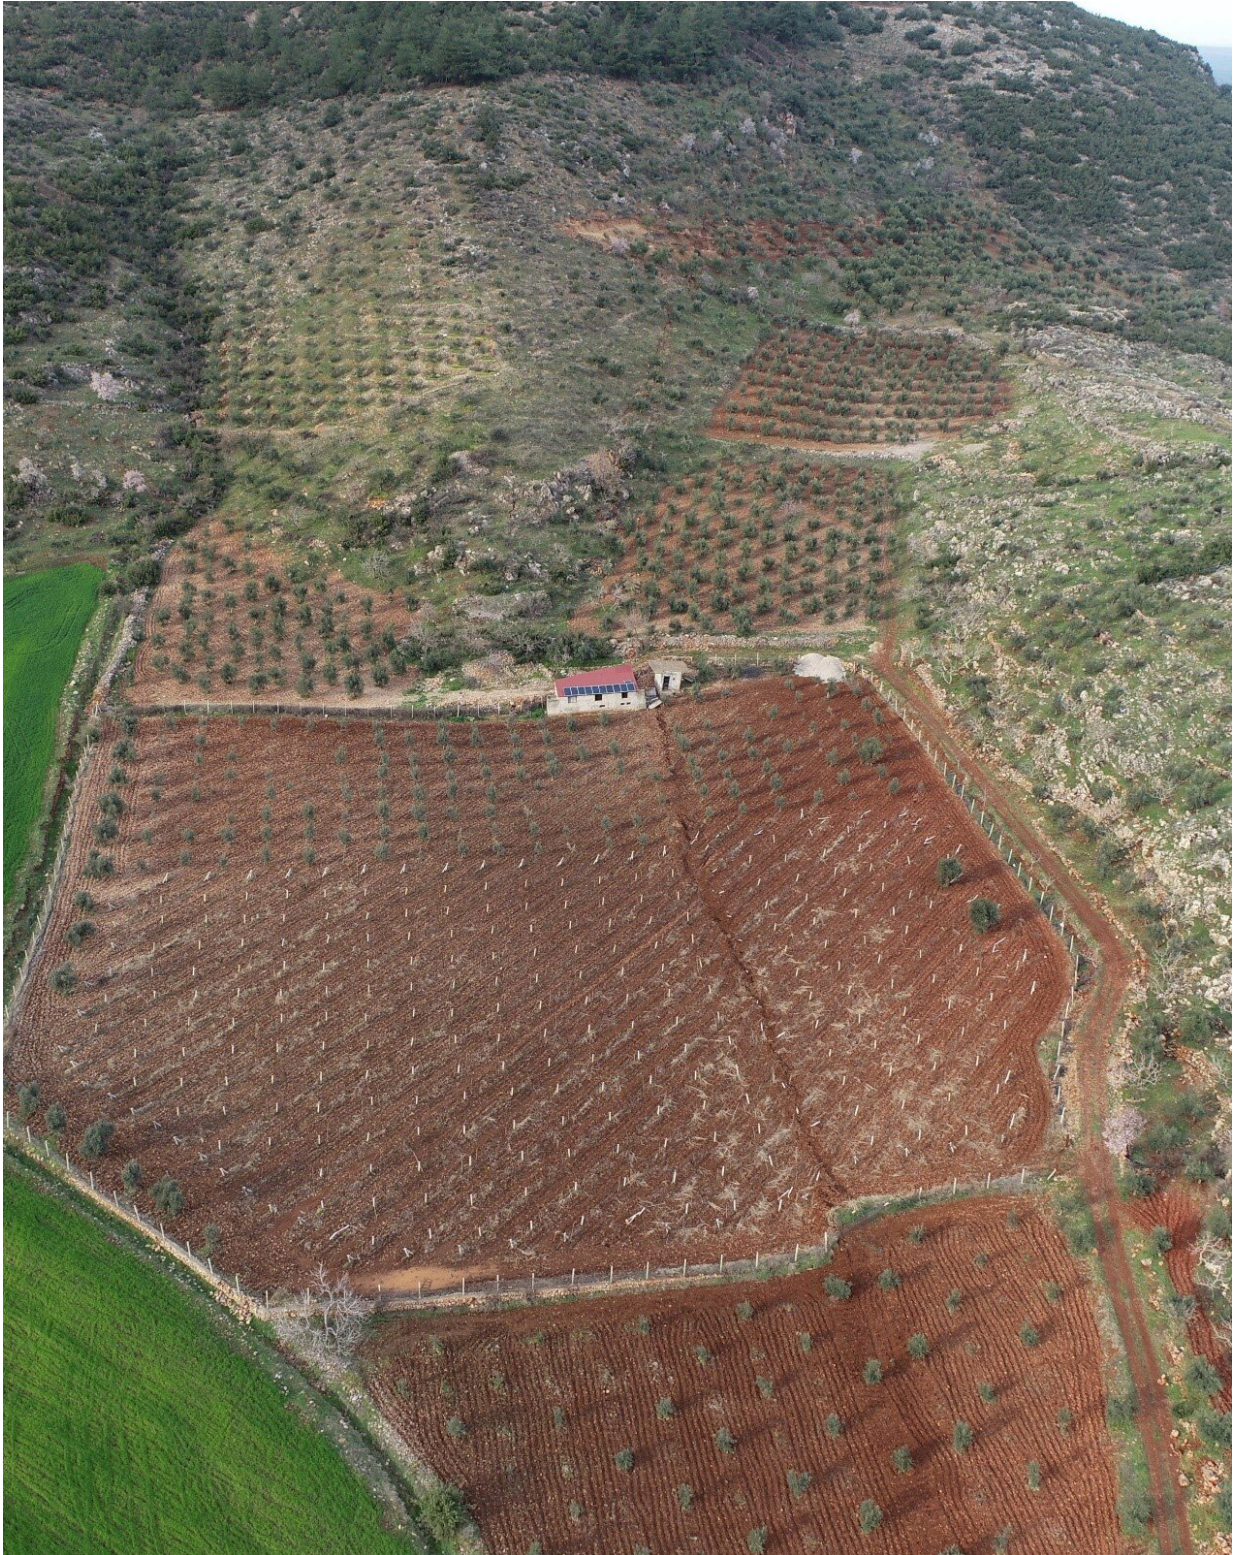
Drone image taken 30 days after the February 6th, 2023 Earthquake Sequence in eastern Türkiye. The activated transform plate boundary offset the upper 20 km

of the crust, offsetting olive groves, fences, and even buildings in its path.
Credit: Jiannan Meng

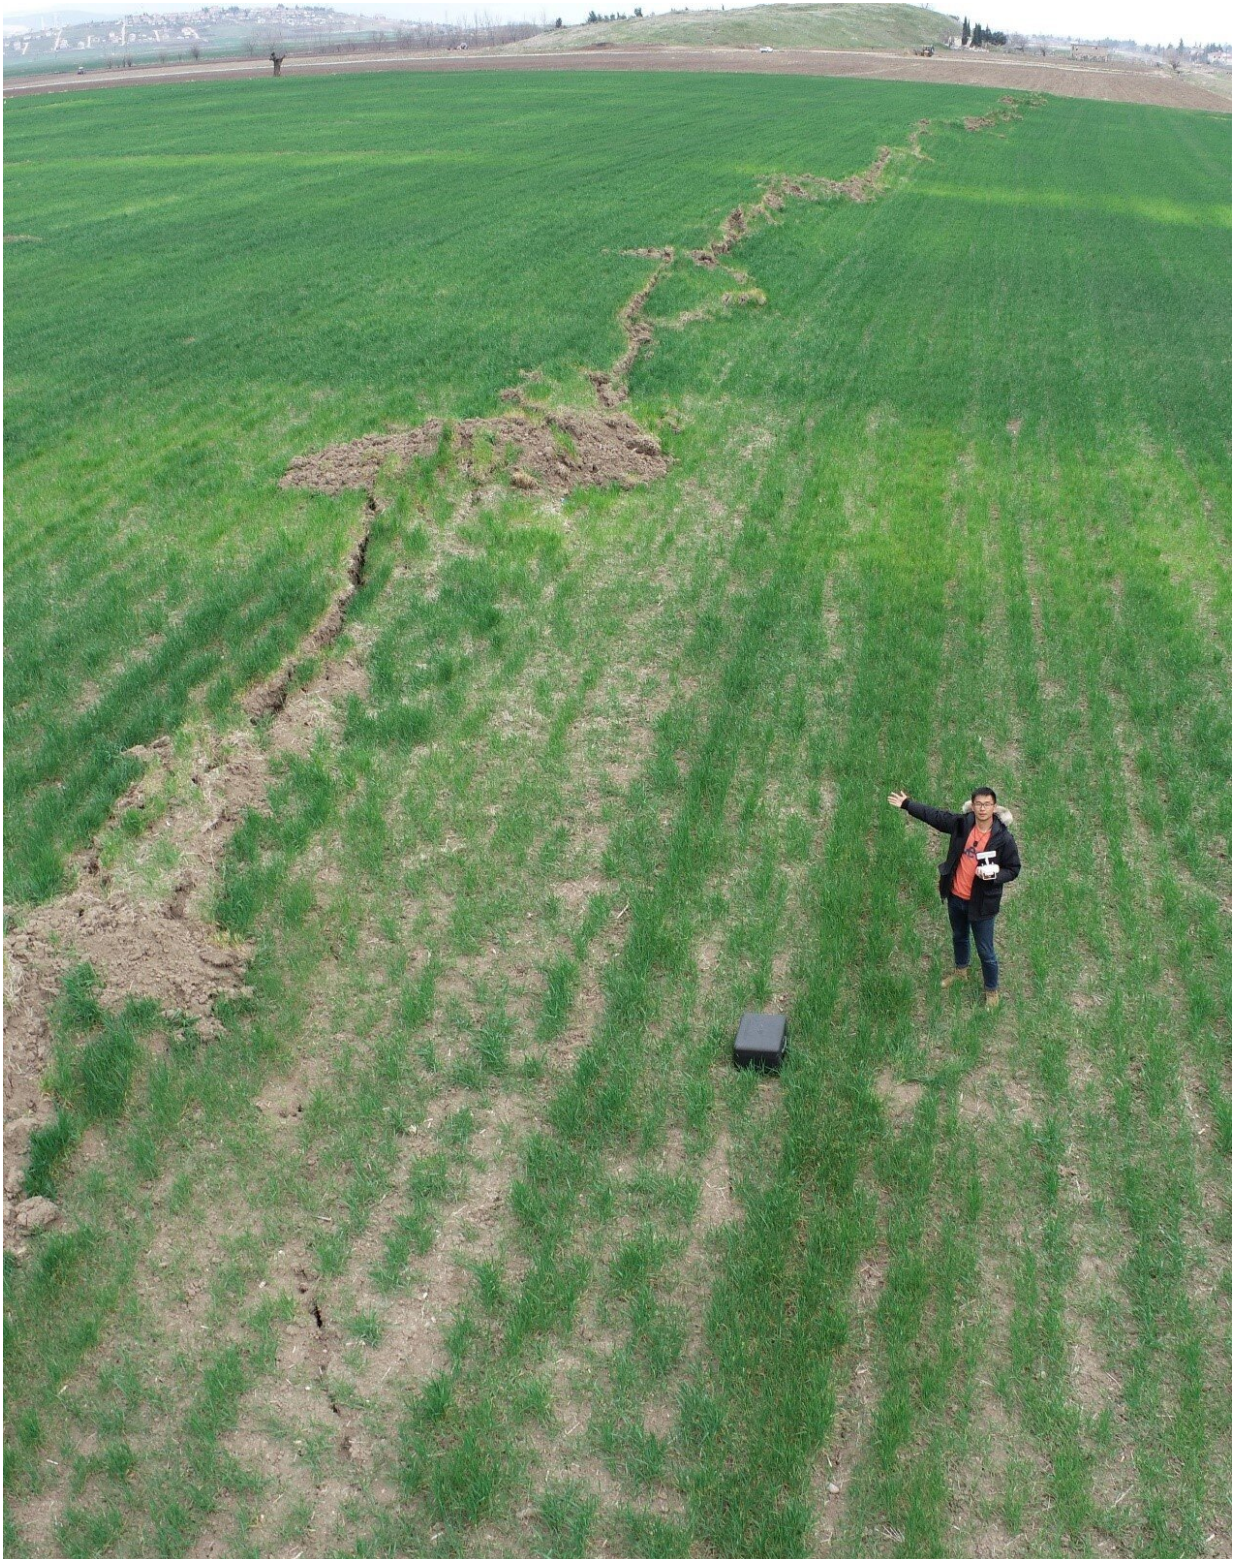
Glimpse of the ground rupture in farm land caused by February 6th , 2023 earthquake sequence in eastern Türkiye (Taken 32 days after the earthquakes, on

March 10th). The rupture continues from bottom left to the top right with the operator of the drone as a scale. Note this rupture formed in the middle of the basin without any preexisting surfaces and quickly vanished from rains human activities. Credit: Jiannan Meng

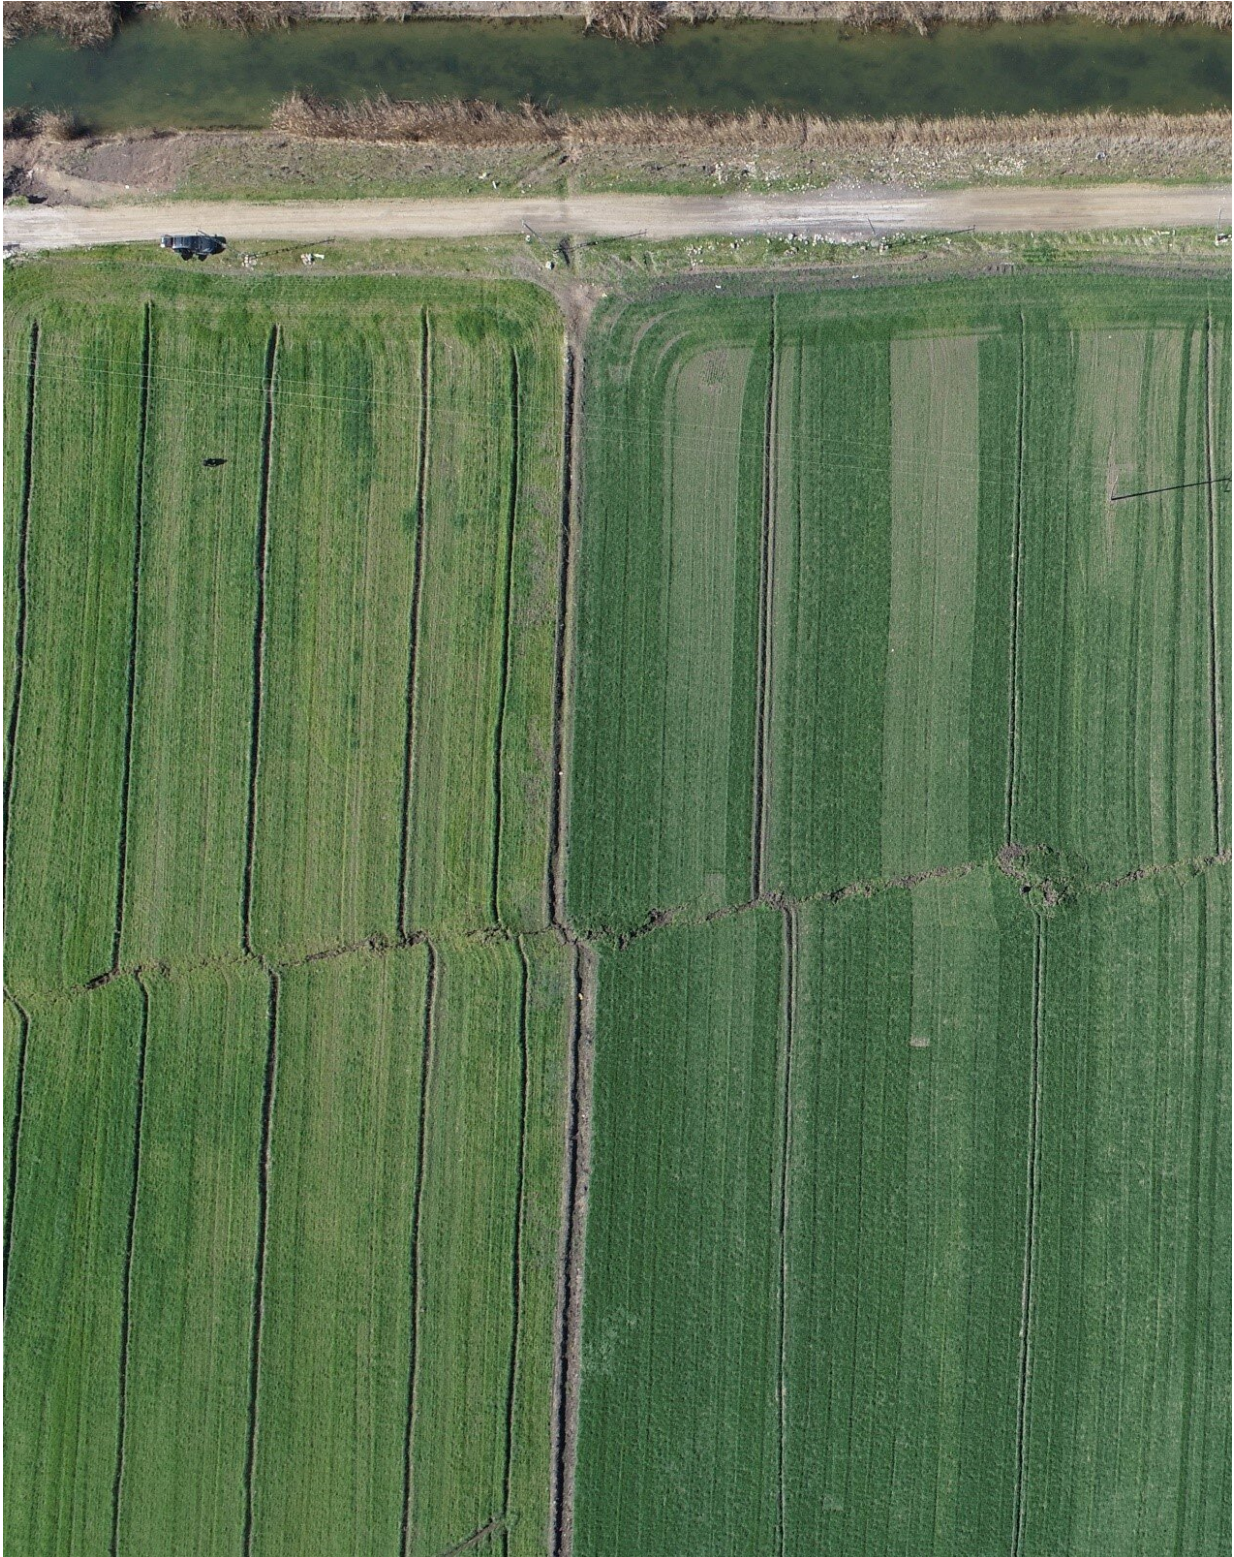
Drone image of ground offset of farm fields from the February 6 2023 earthquake sequence in eastern Türkiye, taken on February 24th 18 days after

the earthquakes. The *en echelon* ground rupture features along the sinistral (top to the left) East Anatolian fault are clearly indicated by the offset rows of crops. This ephemeral surface deformation record was soon erased by rains and human activities. Black car at top left for scale. Credit: Jiannan Meng

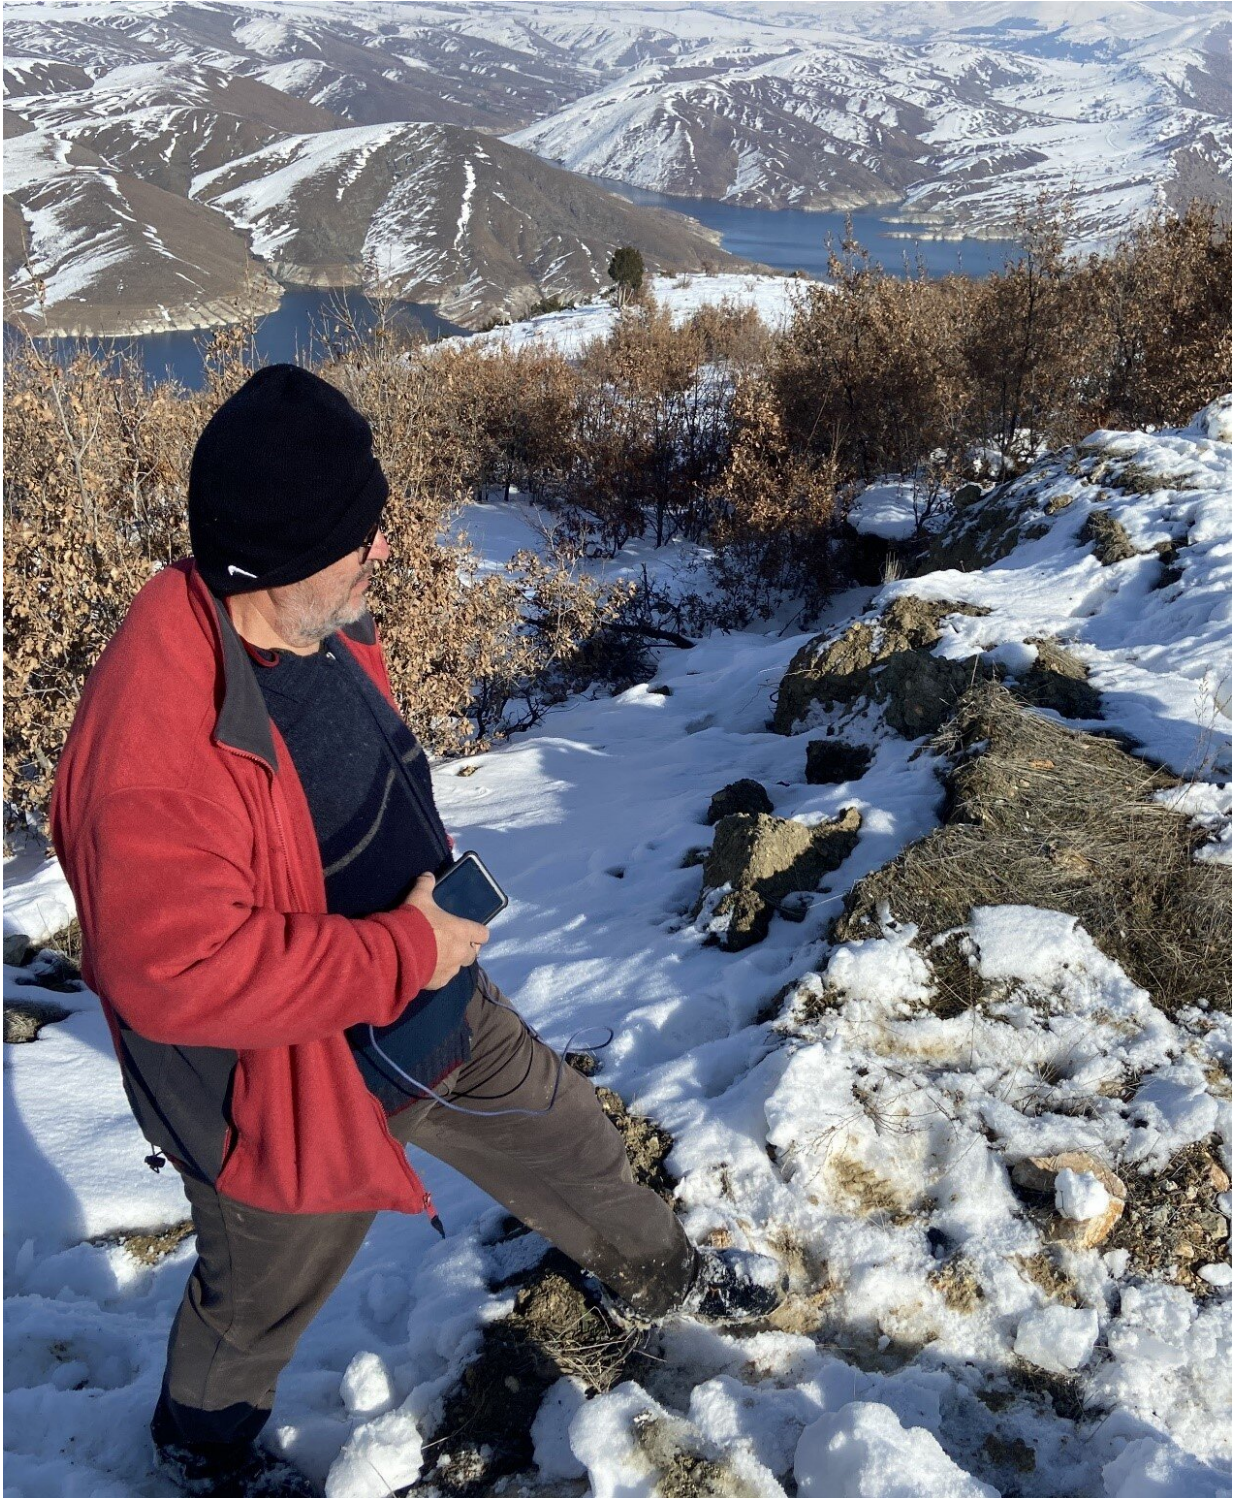
Searching for displacement features along the trace of the Çardak-Sürgü fault taken 12 days after the devastating earthquakes of February 6th, 2023, in eastern Türkiye. The fault is marked by the recent scarp straddled by the geologist in the

foreground. Credit: Jiannan Meng

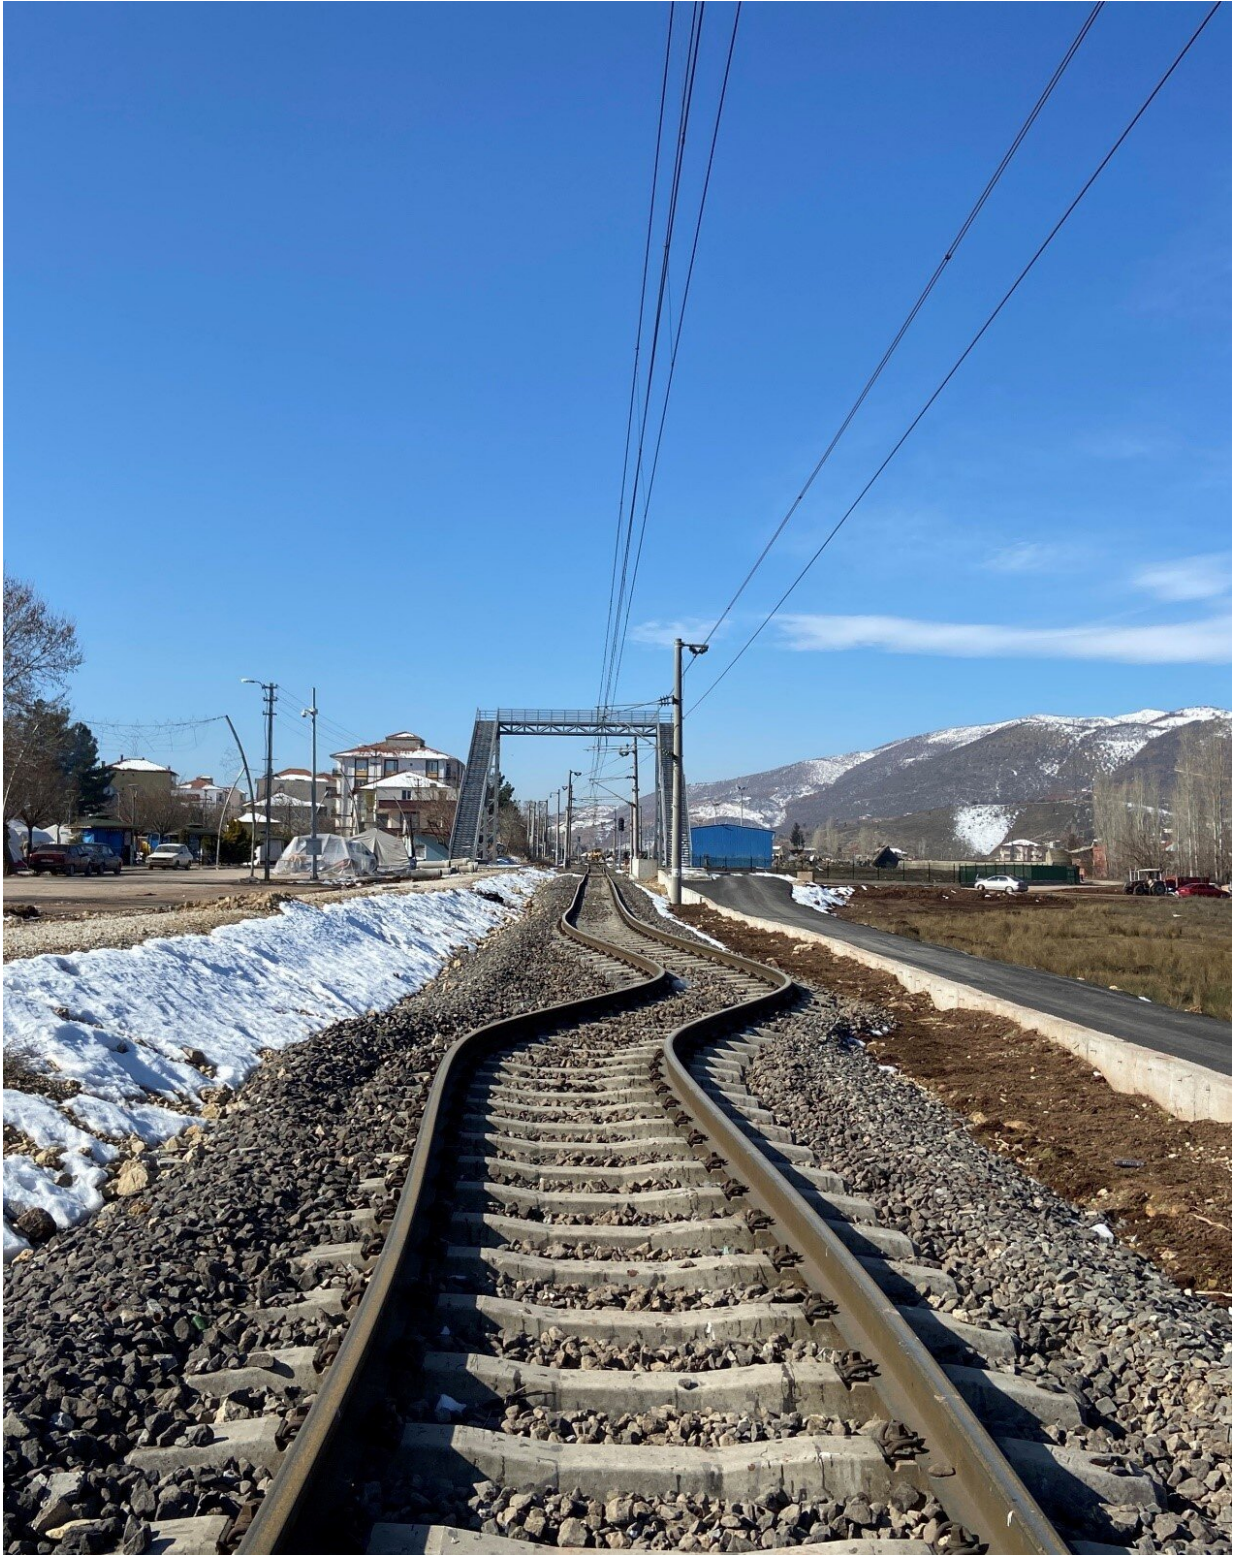
Strongly deformed railway track after the 2023 Turkey earthquake sequence, resulting from both ground shaking and liquefaction. The railway track has been

moved around 2 meters horizontally. Credit: Jiannan Meng
