Team assessing SHERLOC instrument on NASA's Perseverance rover

February 13 2024, by Karen Fox, Alana Johnson

Engineers are working to stabilize a dust cover on one of the science instrument's cameras.

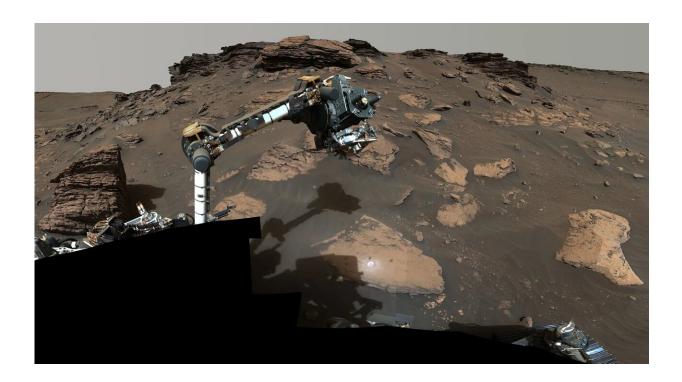
NASA's Perseverance puts its robotic arm to work around a rocky outcrop called "Skinner Ridge" in a set of images captured in June and July 2022 by the rover's Mastcam-Z camera system. SHERLOC is mounted on the end of the arm. NASA/JPL-Caltech/ASU/MSSS

Mounted on the rover's robotic arm, SHERLOC (Scanning Habitable Environments with Raman & Luminescence for Organics and Chemicals) uses cameras, a spectrometer, and a laser to search for <u>organic compounds</u> and minerals that have been altered in watery environments and may be signs of past microbial life.
