Details of hurricane Ian's aftermath captured with new remote sensing method

More information: Leanne Hauptman et al, Hurricane Ian Damage Assessment Using Aerial Imagery and LiDAR: A Case Study of Estero Island, Florida, *Journal of Marine Science and Engineering* (2024). [DOI: 10.3390/jmse12040668](https://doi.org/10.3390/jmse12040668)

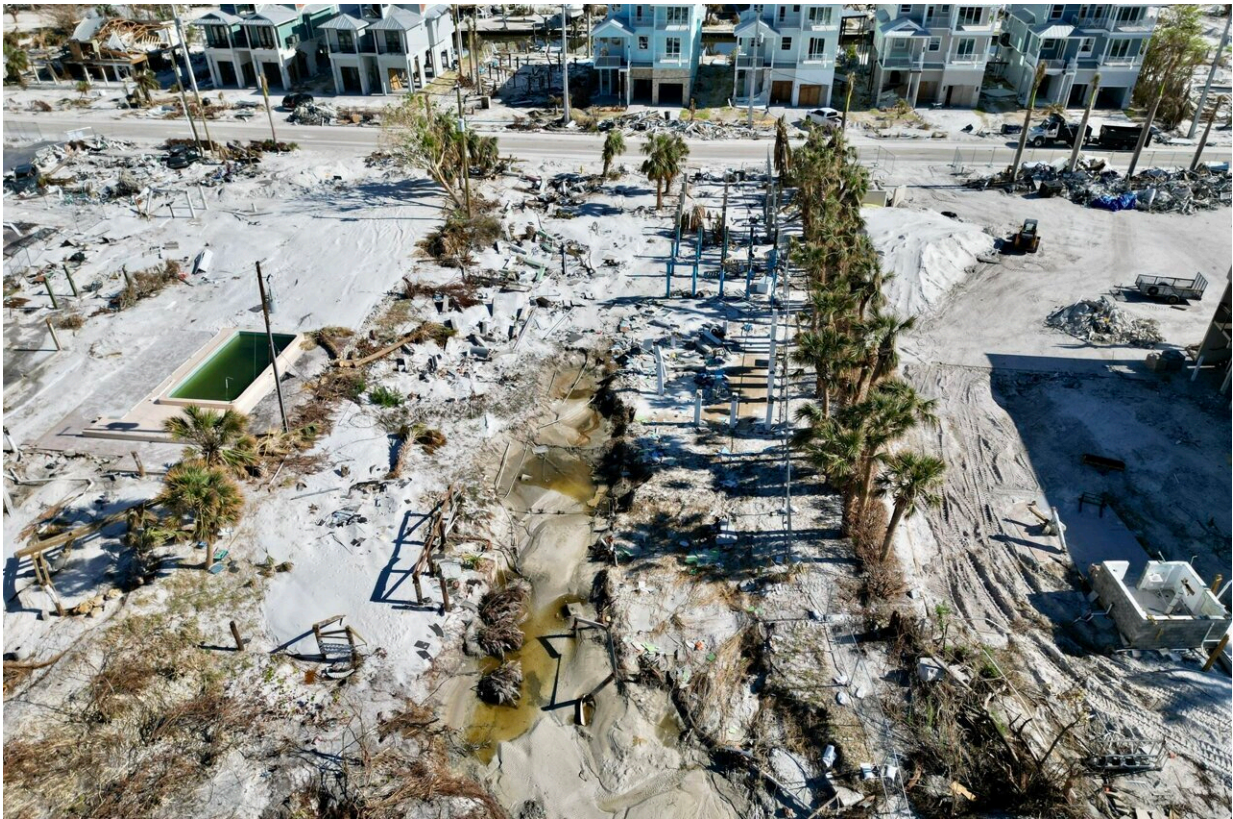
An ariel view of the structural damage on Southwest Florida's Estero Island in the aftermath of Hurricane Ian. Credit: Ryan Sloan, Florida Atlantic University

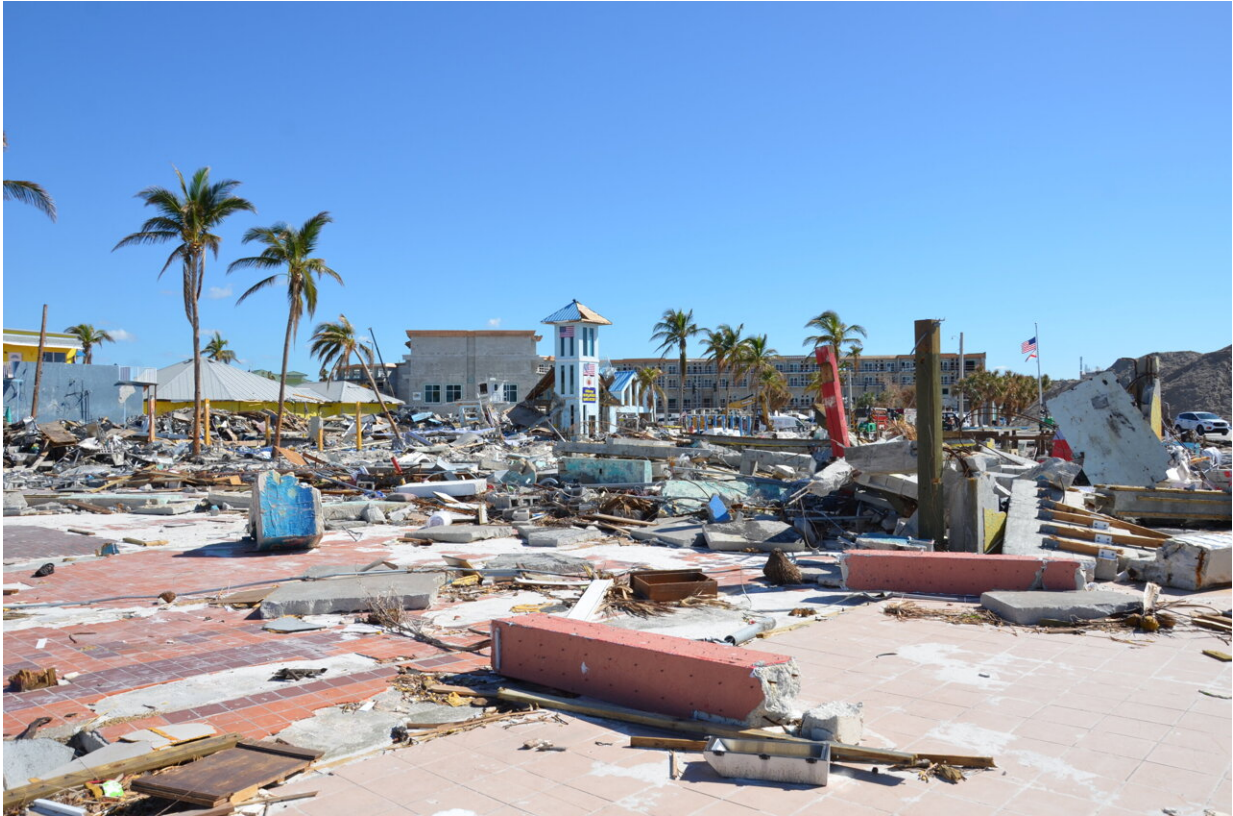
Structural damage on Southwest Florida's Estero Island in the aftermath of Hurricane Ian. Credit: Ping Wang, USF

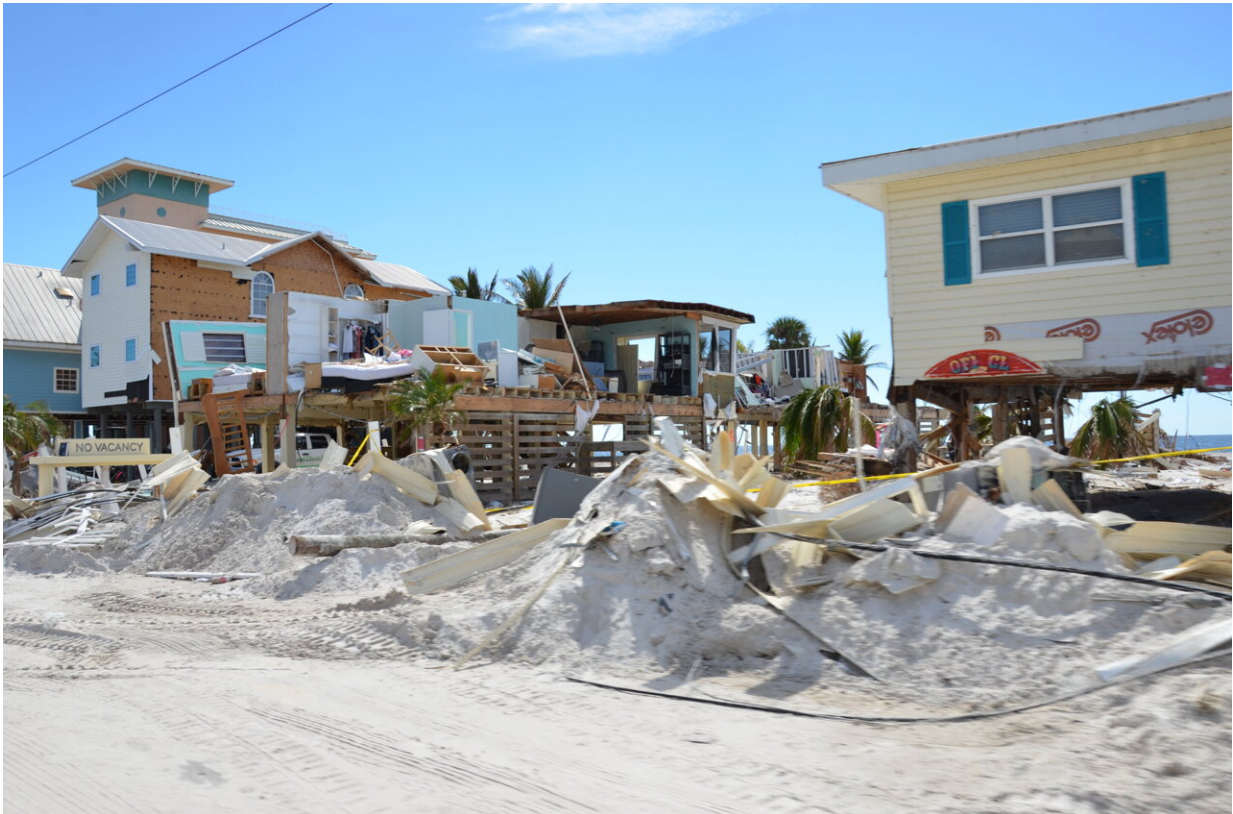
Structural damage on Southwest Florida's Estero Island in the aftermath of Hurricane Ian. Credit: Ping Wang, USF
