Research reveals pre-collapse monitoring of Kakhovka Dam, Ukraine

April 3 2024, by Laurie Fickman

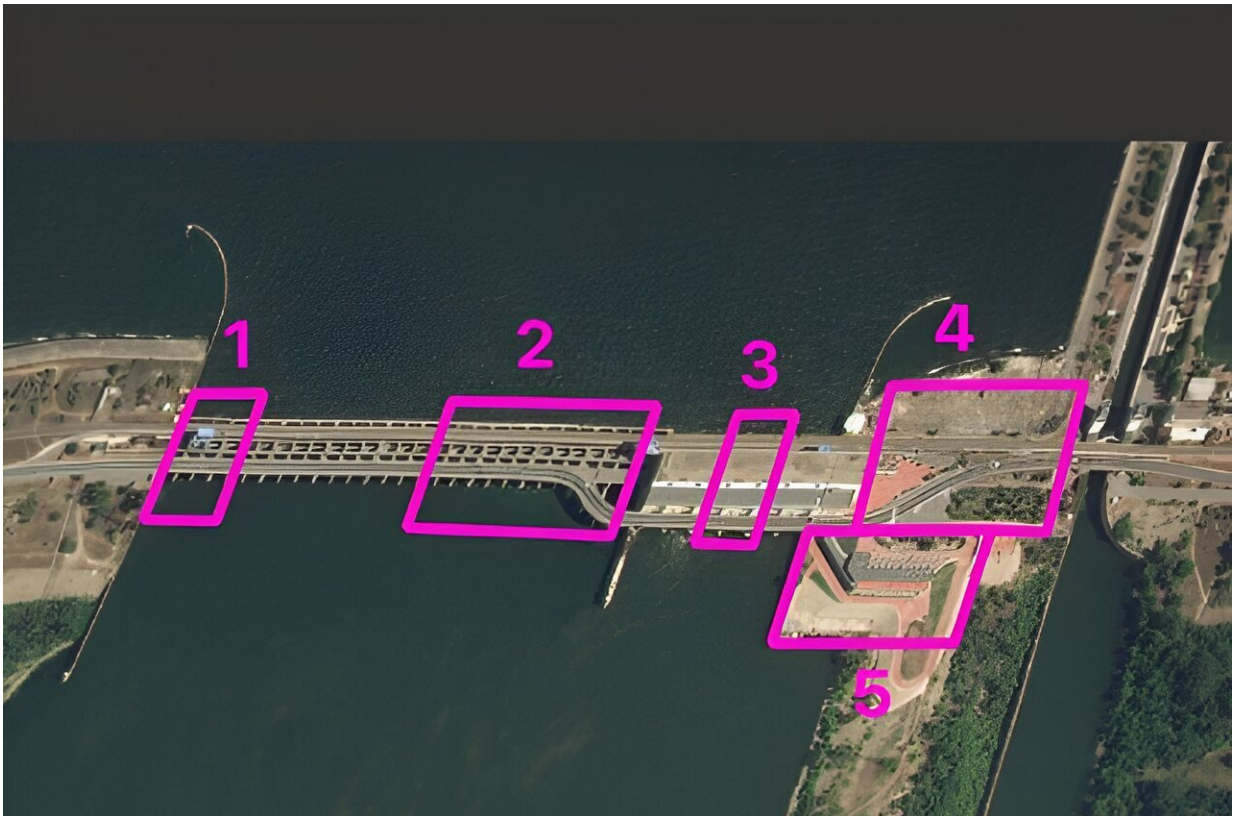
Using post-collapse images acquired by Umbra and pre- and post-collapse Sentinel-1 images, the University of Houston team identified two main breaches at the dam. Numbered portions depict the collapsed parts of the dam. Credit: University of Houston

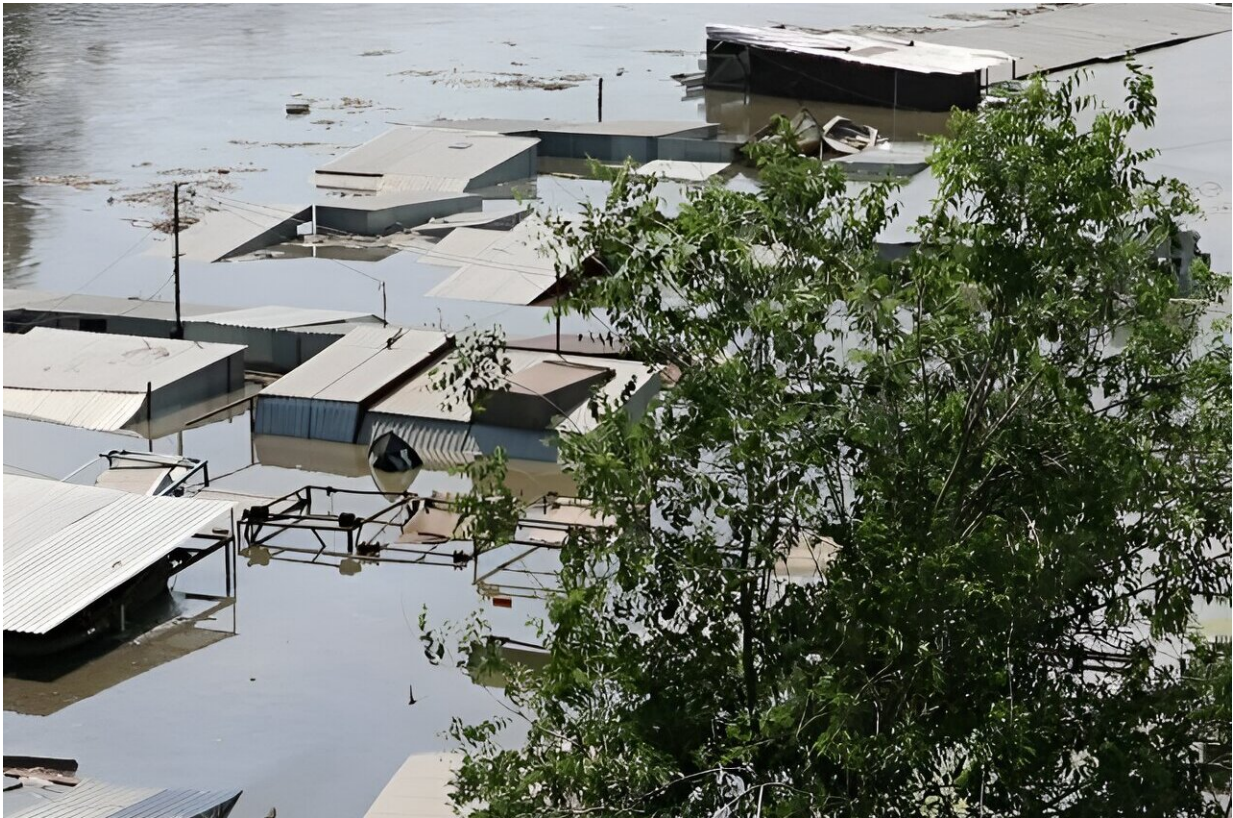
Flooding in Kherson after destruction of Kakhovka Dam 2023. Credit: Wikimedia/Creative Commons

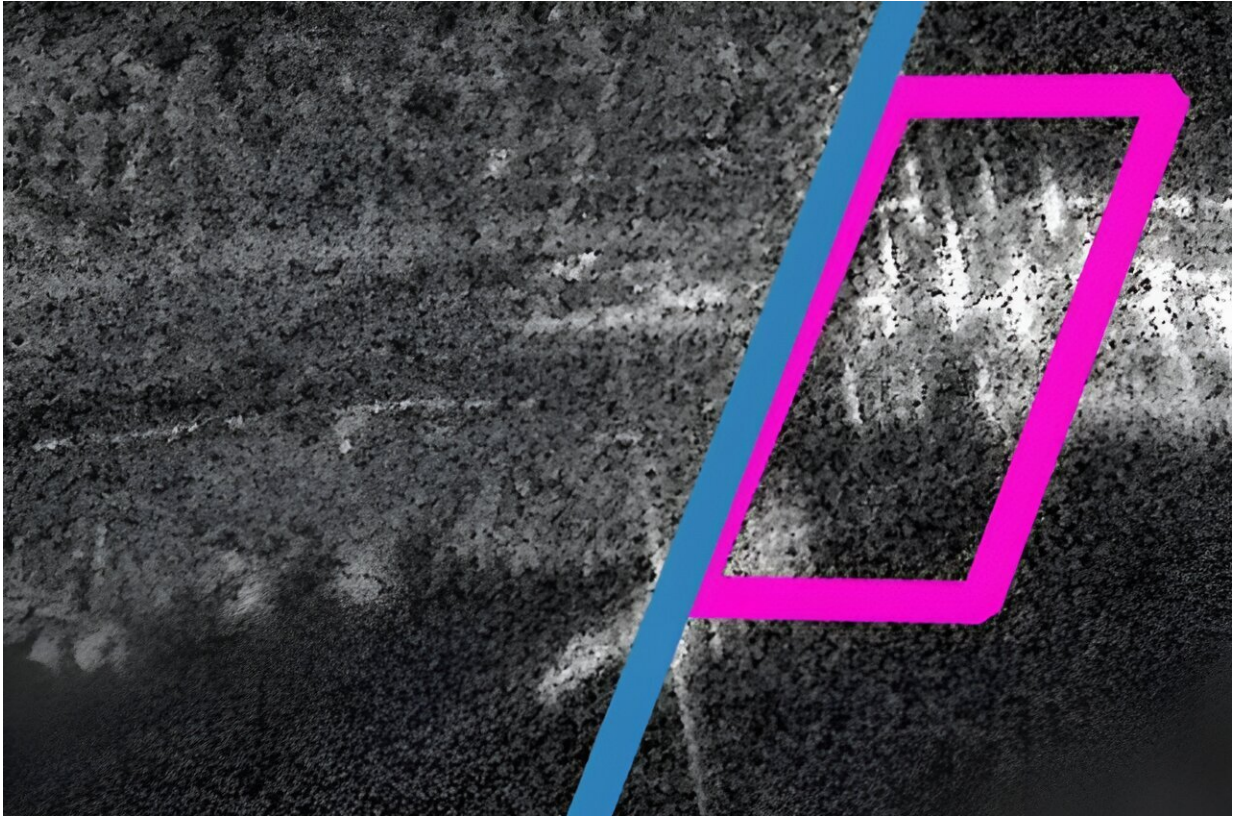
Using post-collapse images acquired by Umbra and pre- and post-collapse Sentinel-1 images, the University of Houston team identified two main breaches at the dam. Credit: University of Houston
