Repair kit for NASA's NICER mission heading to space station

July 30 2024, by Jeanette Kazmierczak

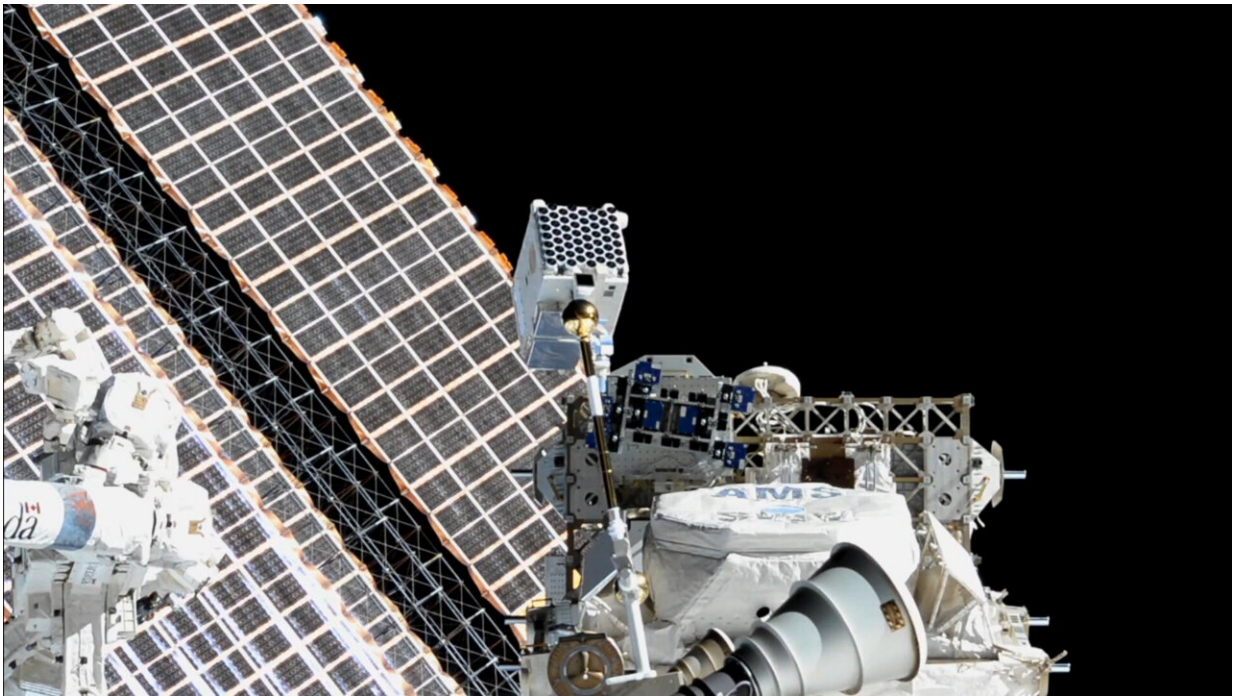
This image, obtained June 8, 2018, shows NASA's NICER (Neutron star Interior Composition Explorer) on the International Space Station, where it studies neutron stars and other X-ray sources. NICER is about the size of a washing machine. The sunshades of its X-ray concentrators are visible as an array of circular features. Credit: NASA

Photos taken aboard the station revealed several areas of damage to NICER's thermal shields. The shields are 500 times thinner than a human hair and filter out infrared, ultraviolet, and visible light while allowing X-rays to pass through. They cover each of NICER's 56 X-ray concentrators, sets of 24 nested circular mirrors designed to direct X-rays into corresponding detectors. A sunshade tops each concentrator and shield assembly, with a slight gap in between. The sunshades are segmented by six internal struts, resembling a sliced pie.

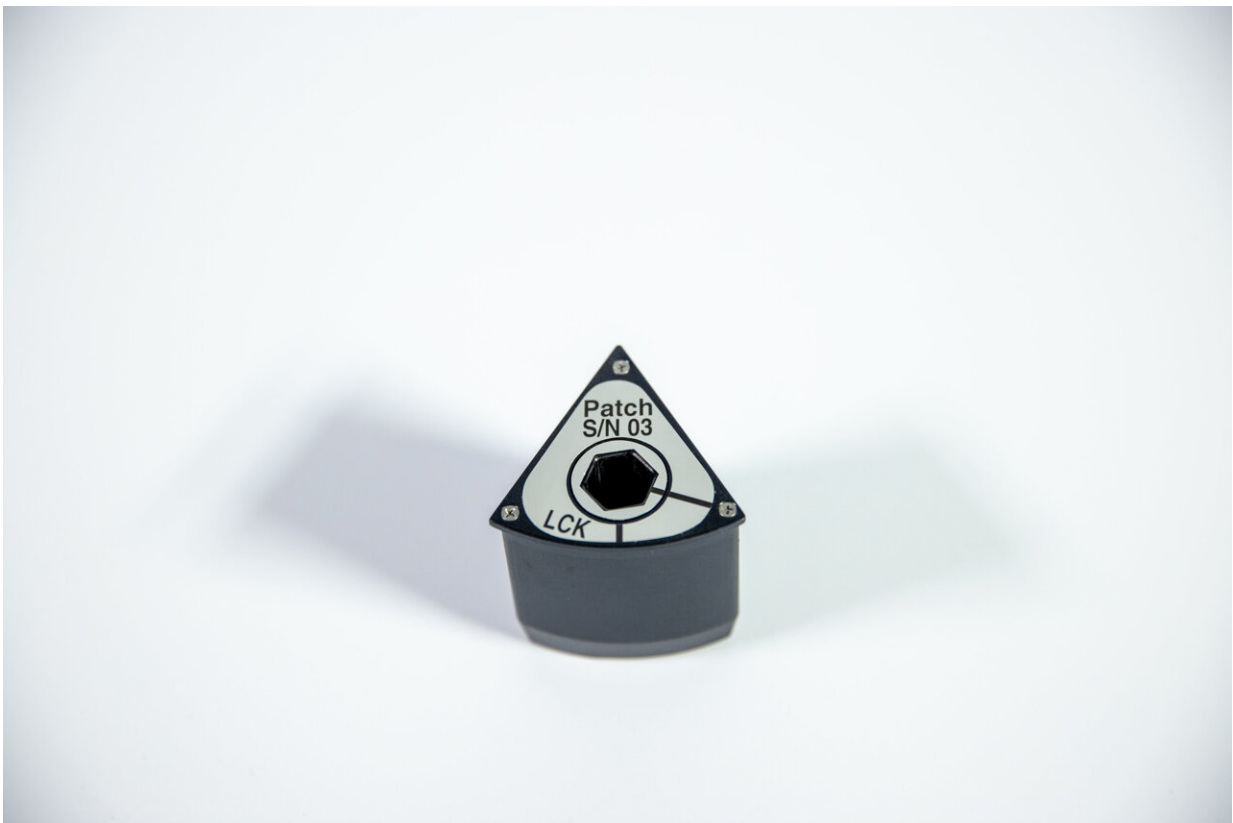
NICER's patches are made from aluminum and coated in black dye. Each is about 2 inches tall. "LCK" indicates the lock position for a tab at the bottom that will hold the patch in place. NASA is sending 12 of these patches to the International Space Station. During a spacewalk, astronauts will insert five into sunshades on the telescope to cover the most significant areas of damage. Credit: NASA/Sophia Roberts

The solution, in the end, was simple. The team designed patches, each shaped like a piece of pie, that will slide into the sunshades. A tab at the bottom of each patch will turn into the space between the bottom of the sunshade and the top of the thermal shield, keeping it in place.

Astronauts will install five patches during the spacewalk. They'll cover the most significant areas of damage and block the sunlight affecting NICER's X-ray measurements.

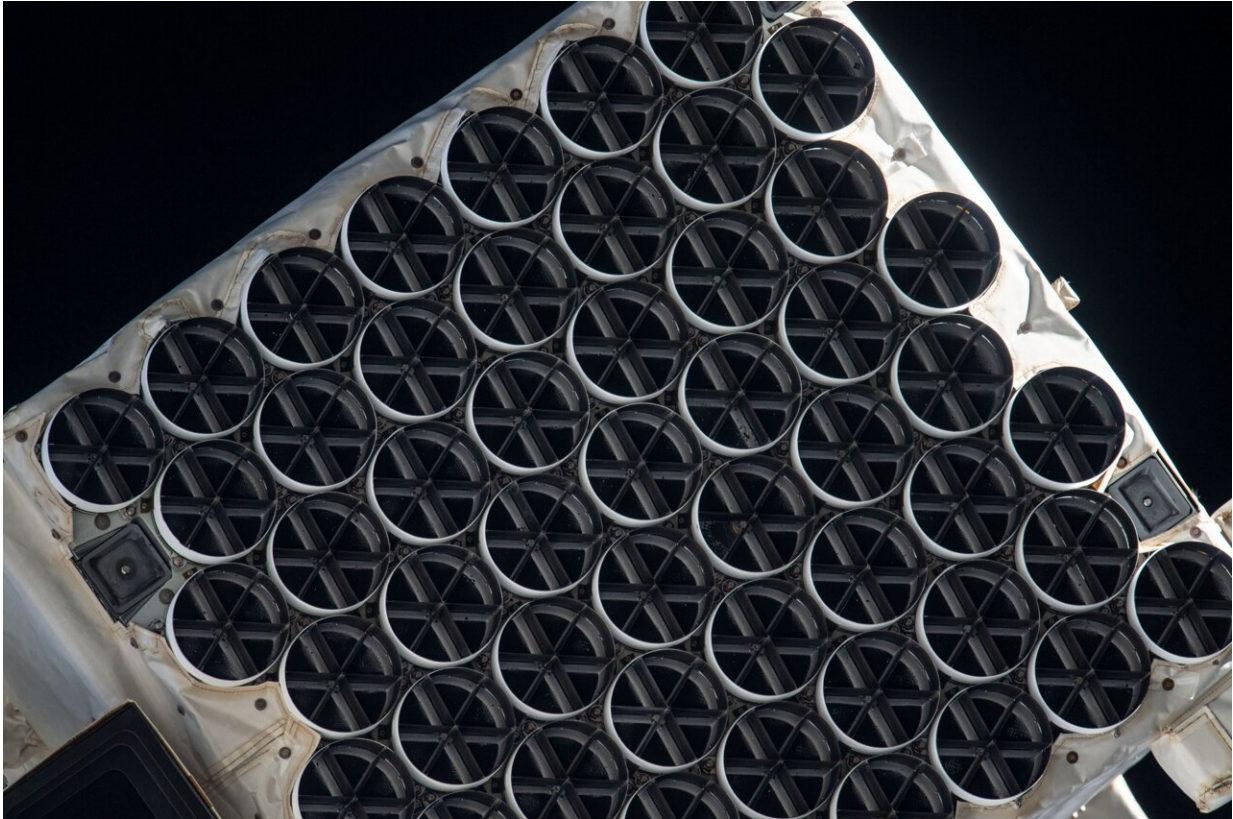
UAE (United Arab Emirates) astronaut Sultan Alneyadi captured this view of NICER from a window in the Poisk Mini-Research Module 2 on the space station in July 2023. Photos like this one helped the mission team map the damage to the thermal shields over NICER's X-ray concentrators. Credit: NASA/Sultan Alneyadi

The largest damage to the shields is around the size of a typical U.S. postage stamp. The other areas are closer in size to pinheads. During the station's daytime, the damage allows sunlight to reach the detectors, saturating sensors and interfering with NICER's measurements. The

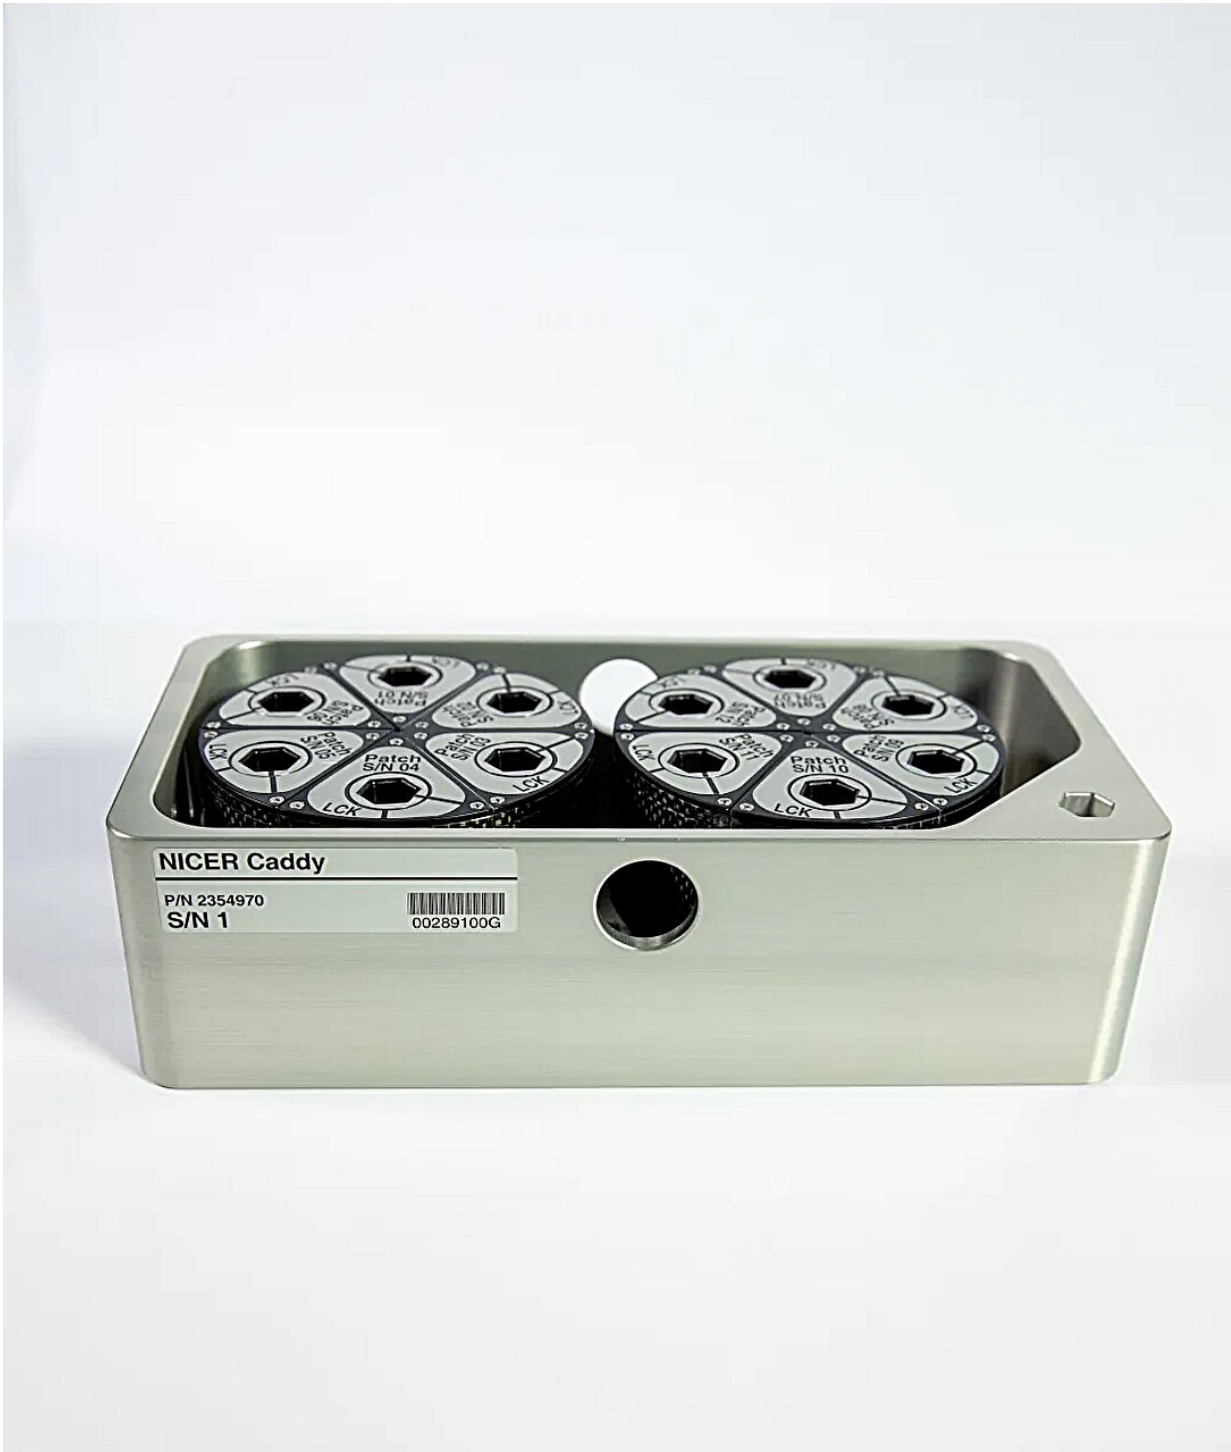
The NICER caddy is an aluminum box containing two of the mission’s spare sunshades, which are attached to the bottom. Inside the sunshades, 12 patches are locked into place. Astronauts will take the complete caddy assembly with them during a future spacewalk to address damage to NICER’s thermal shields. They’ll

insert five of the patches over the largest areas of damage, which will allow the mission to return to a normal operating status during the station's daytime.

The repair kit contains 12 patches in total, allowing for spares if needed. Astronauts will carry the patches in a caddy, a rectangular frame containing two spare sunshades with the patches held inside.
