# Ten years of data preceding a rockfall in the French Alps suggest the need for more comprehensive monitoring systems

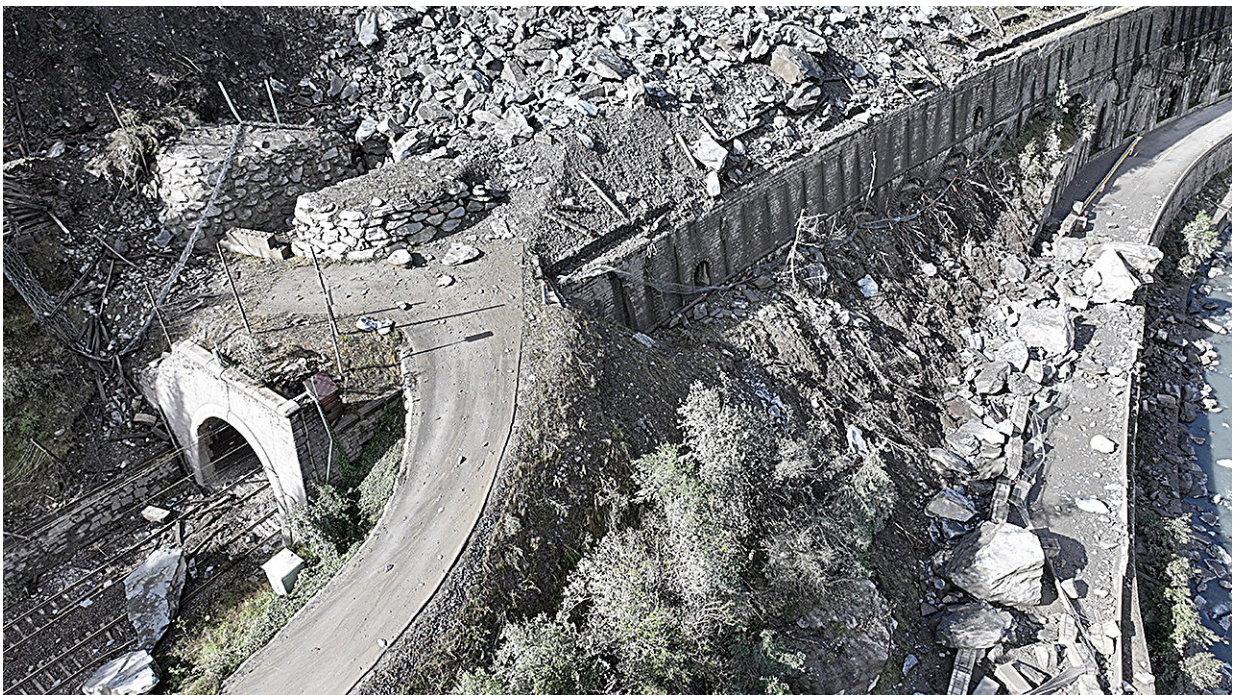
A road and major railway remain closed after a rockslide in the French Alps in August 2023 displaced 14,000 cubic meters of sandstone and shale. Credit: Pierre Bottelin

In August 2023, 14,000 cubic meters of sandstone and shale detached from a slope in the French Alps. This rockslide at La Praz closed a road

and a major railway between France and Italy at least until the end of 2024.
