# NIST WTC 7 Investigation Finds Building Fires Caused Collapse

August 21 2008

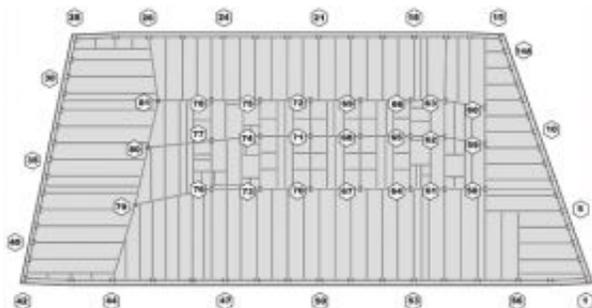
Typical WTC 7 floor showing locations of columns (numbered). The buckling of Column 79 was the initiating event that led to the collapse of WTC 7. The buckling resulted from fire-induced damage to floors around Column 79, failure of the girder between Columns 44 and 79, and cascading floor failures

Determining the probable collapse sequence for WTC 7, NIST found that the impact of debris from the collapse of WTC 1 ignited fires on at least 10 floors of WTC 7, and the fires burned out of control on six lower floors. The heat from these uncontrolled fires caused thermal expansion of the steel beams on the lower floors of the east side of WTC 7, damaging the floor framing on multiple floors. Eventually, a girder on Floor 13 lost its connection to a critical interior column that provided support for the long floor spans on the east side of the building. The displaced girder and other local fire-induced damage caused Floor 13 to collapse, beginning a cascade of floor failures down to the fifth floor. Many of these floors had already been at least partially weakened by the fires in the vicinity of the critical column. This collapse of floors left the critical column unsupported over nine stories.

“When this critical column buckled due to lack of floor supports, it was the first domino in the chain,” Sunder explained. “What followed in rapid succession was a progression of structural failures. Failure first occurred all the way to the roof line—involving all three interior columns on the most eastern side of the building. Then, progressing from east to west across WTC 7, all of the columns in the core of the building failed. Finally, the entire façade collapsed.”
