Getting to the Heart of Stents

December 9 2008

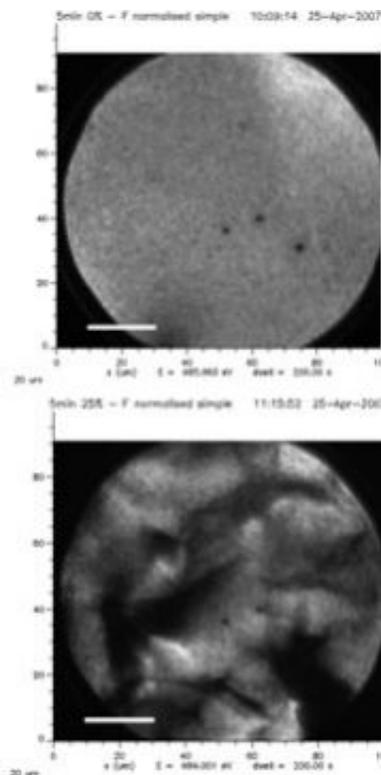
X-ray Photoemission Electron Microscope images of a 35 nanometer-thick stent coating, before (top) and after (bottom) mechanical deformation. Source: Paula Horny and Stephane Turgeon, Laval University.

"When we first looked at samples in our lab we were happy because we didn't find any cracks," says Mantovani. "But the synchrotron's X-PEEM (X-ray photoemission electron microscope) revealed pinhole defects made during the coating's manufacture. We've been able to take what we found and apply it to improving our coating technology."
