Image: Landslide and Barrier Lake near Oso, Washington

March 27 2014

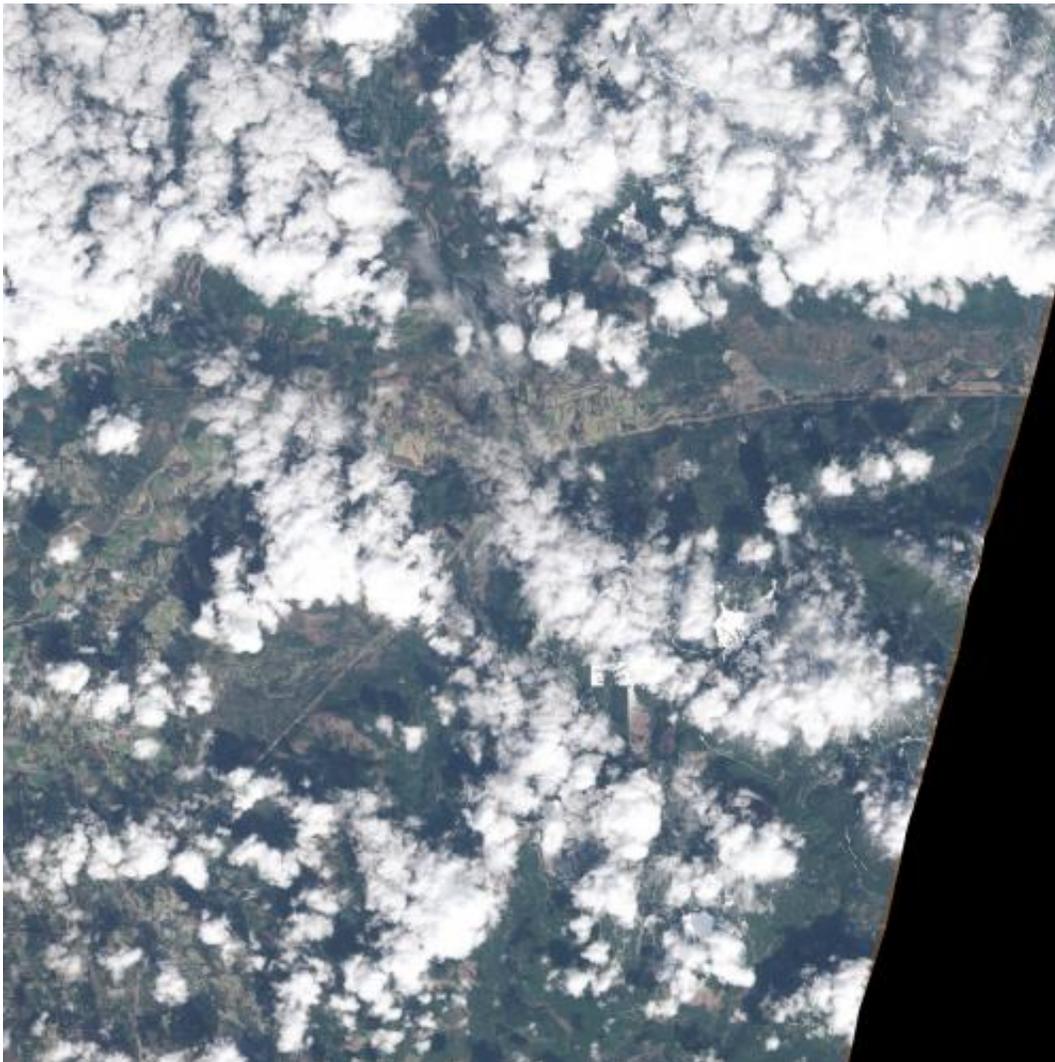
Image acquired March 23, 2014.

On March 22, 2014, a rainfall-triggered landslide near Oso, Washington, sent muddy debris spilling across the North Fork of the Stillaguamish River. The debris swamped numerous homes, resulting in the deaths of at least 24 people, according to news reports. As of March 25, dozens of people were still missing.

The [landslide](#) created an earthen dam that blocked the river, causing a barrier lake to form. The Operational Land Imager (OLI) on Landsat 8 acquired this image of landslide [debris](#) and the [barrier lake](#) on March 23, 2014. An image of the same area on January 18 is shown for comparison. Turn the comparison tool on to see how the landscape changed. To see aerial views of the landslide, read this [blog post](#).

As water backed up, local authorities expressed concerns about a potential flash flood. On March 23, water began to flow around the north side of the dam. On March 26, a National Weather Service flood warning remained in effect for areas on the Stillaguamish River east of the blockage.

According to Durham University geologist Dave Petley, the landslide was a reactivation of an earlier landslide that caused problems in 1988 and 2006. The Seattle Times has reported that retired US. Geological Survey geologist Daniel Miller warned the hillside had the "potential for a large catastrophic failure" in a report filed with U.S. Corp of Engineers in 1999.
