Three touchdowns for Rosetta's lander

14 November 2014

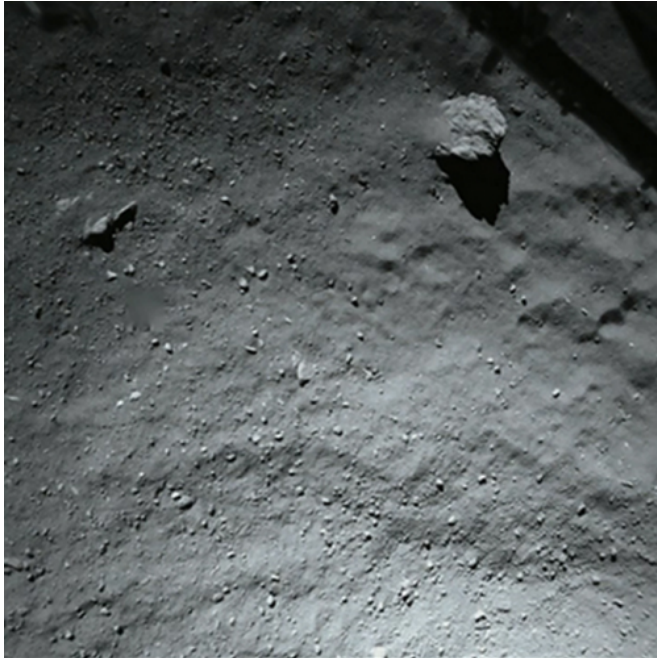
Comet from 40 metres. Credit: ESA/Rosetta/Philae/ROLIS/DLR

The descent camera revealed that the surface is covered by dust and debris ranging from millimetre to metre sizes. Meanwhile, Philae's CIVA camera returned a panoramic image that on first impressions suggests the lander is close to a rocky wall, and perhaps has one of its three feet in open space.

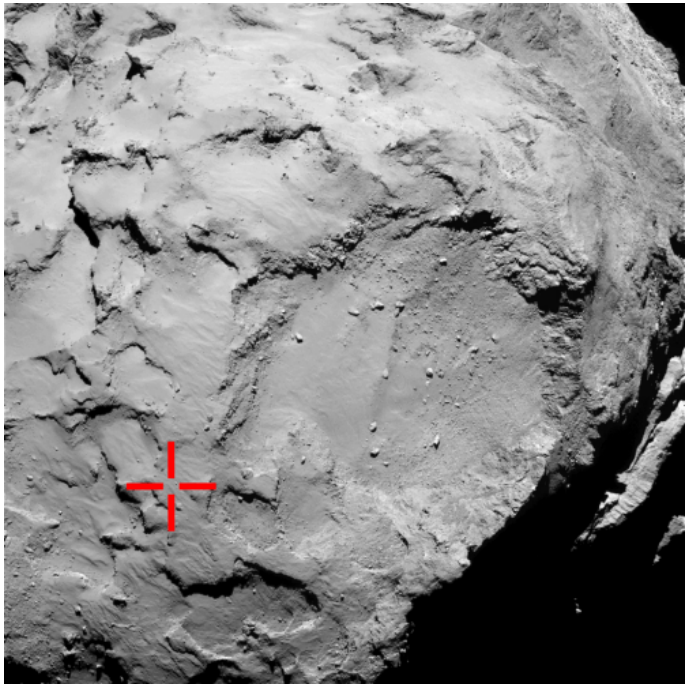
First touchdown. Credit: ESA/Rosetta/MPS for OSIRIS Team MPS/UPD/LAM/IAA/SSO/INTA/UPM/DASP/IDA

The first touchdown was inside the predicted landing ellipse, confirmed using the lander's downwards-looking ROLIS descent camera in combination with the orbiter's OSIRIS images to match features.

But then the lander lifted from the surface again – for 1 hour 50 minutes. During that time, it travelled about 1 km at a speed of 38 cm/s. It then made a smaller second hop, travelling at about 3 cm/s, and landing in its final resting place seven minutes later.

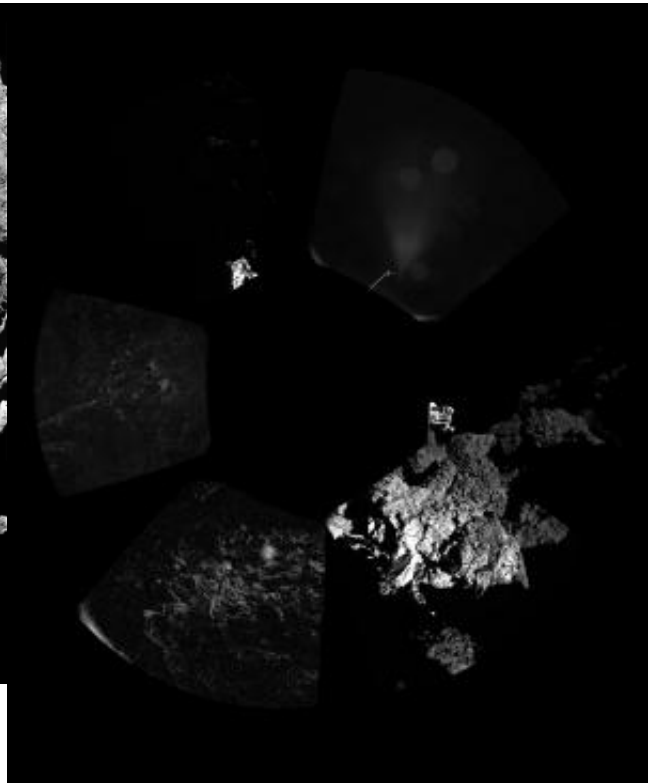
First comet panoramic. Credit: ESA/Rosetta/Philae/CIVA
