Three touchdowns for Rosetta's lander

November 14 2014

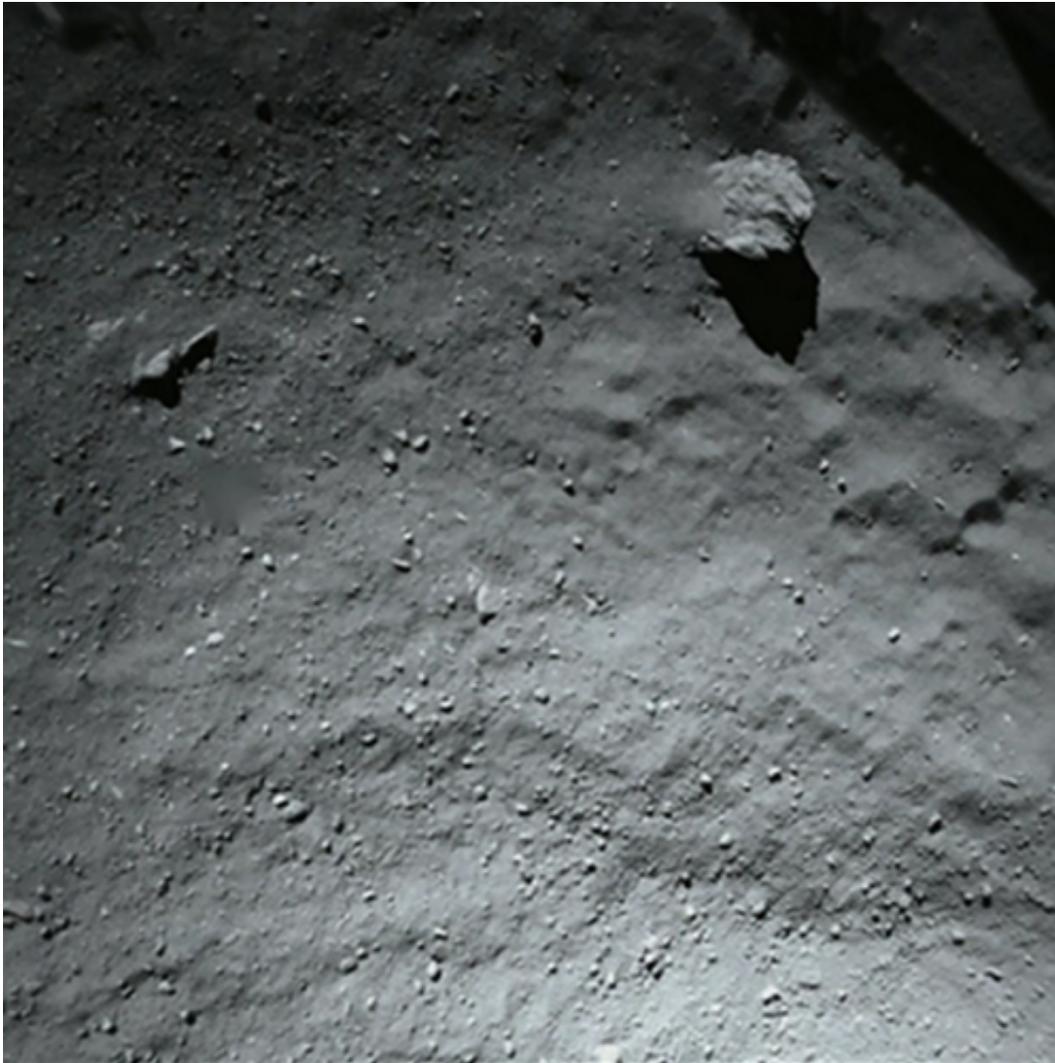
Comet from 40 metres. Credit: ESA/Rosetta/Philae/ROLIS/DLR

The first touchdown was inside the predicted landing ellipse, confirmed using the lander's downwards-looking ROLIS descent camera in combination with the orbiter's OSIRIS images to match features.

The descent camera revealed that the surface is covered by dust and debris ranging from millimetre to metre sizes. Meanwhile, Philae's CIVA camera returned a panoramic image that on first impressions suggests the lander is close to a rocky wall, and perhaps has one of its three feet in open space.

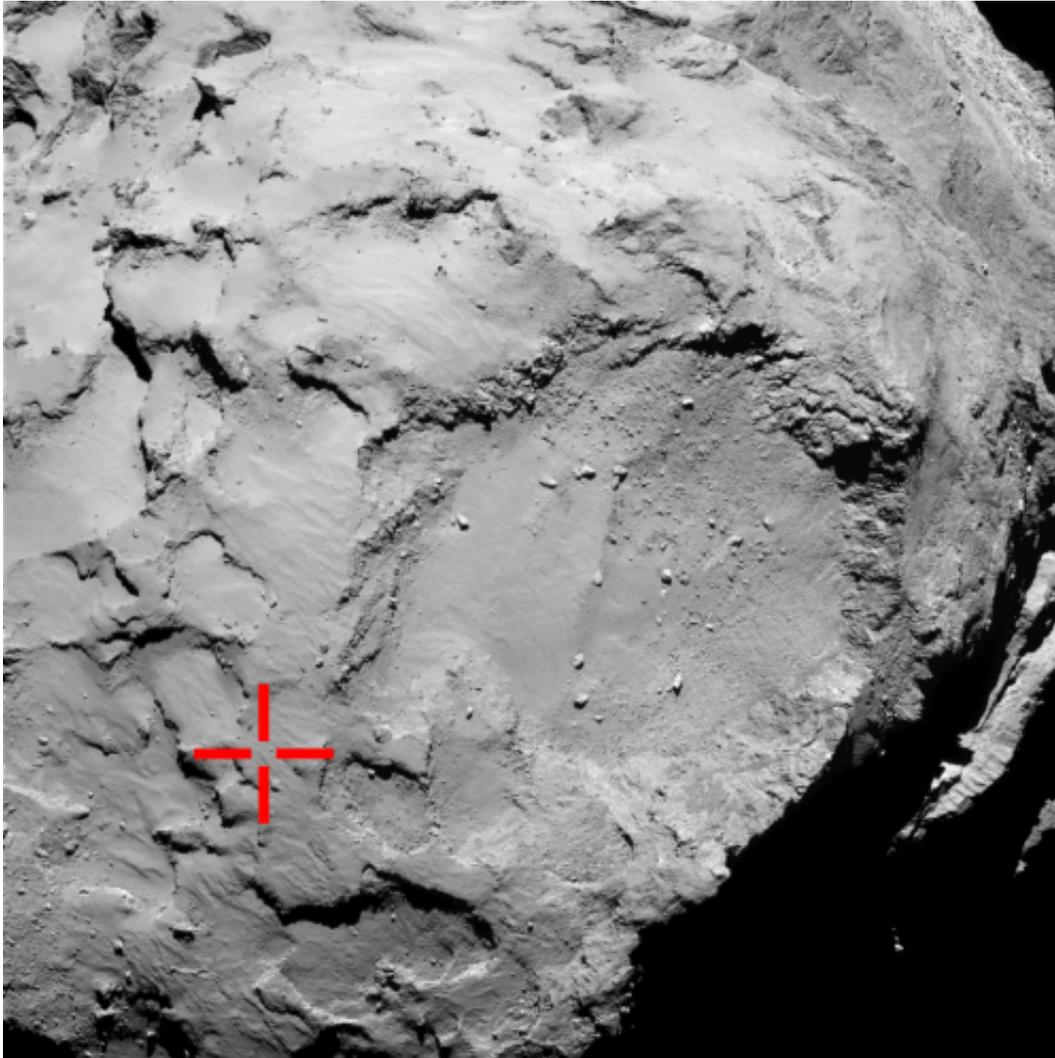
First touchdown. Credit: ESA/Rosetta/MPS for OSIRIS Team
MPS/UPD/LAM/IAA/SSO/INTA/UPM/DASP/IDA

But then the lander lifted from the surface again – for 1 hour 50 minutes. During that time, it travelled about 1 km at a speed of 38 cm/s.

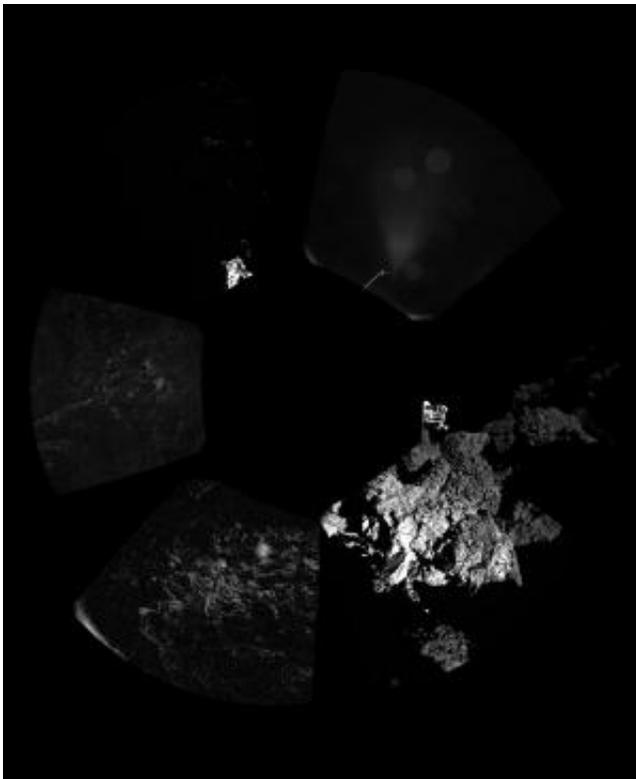
First comet panoramic. Credit: ESA/Rosetta/Philae/CIVA
