# X-ray imaging reveals secrets in battery materials

June 18 2015

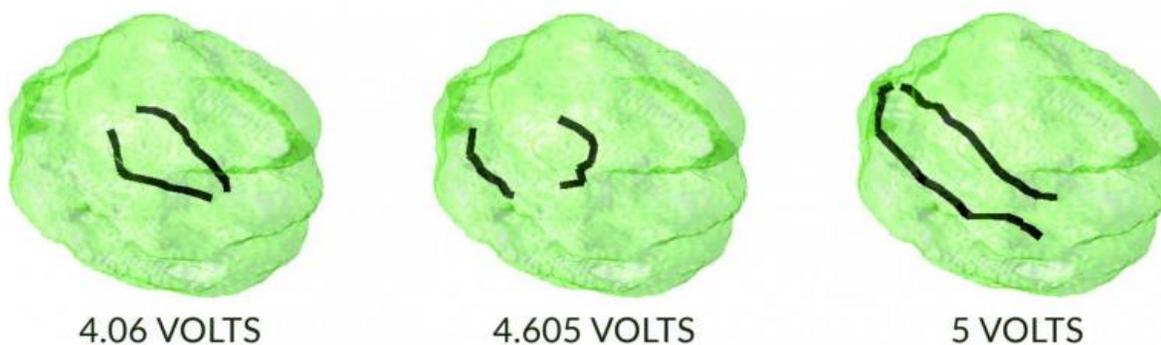
The 3D X-ray imaging technique used in the study shows how the defects move around inside the LNMO spinel as the battery is charged to higher voltages.

Using Argonne National Laboratory's Advanced Photon Source, the team imaged the cathode material while it was inside a charging lithium-ion battery. Analyses of the images revealed that the defects are stationary when the battery is at rest. But when the battery is charged to

high voltage, the defects move around within the cathode material. The researchers report that this is a significant finding because it shows that the material has a unique way of responding to the strain that is induced at high voltage.

The breakthroughs in this research came from analyzing data from an imaging technique called Bragg coherent diffractive imaging.

The method uses laser-like X-ray beams and novel computer algorithms to reconstruct high-resolution 3D images of nano-scale structures, such as the LNMO spinel described in this study.

Defects are difficult to image directly because they are extremely small — less than a nanometer in size. However, each defect causes a strain field, which is an area of deformation surrounding the defect in the atomic structure. The strain fields are much larger — tens of

nanometers in size — making them large enough to be imaged. By analyzing the strain fields in the LNMO spinel, the team mapped out the defects and studied how they play a role in the material's performance at high voltage.
