# Gaping hole in spillway for tallest US dam keeps growing (Update)

February 9 2017, by Don Thompson

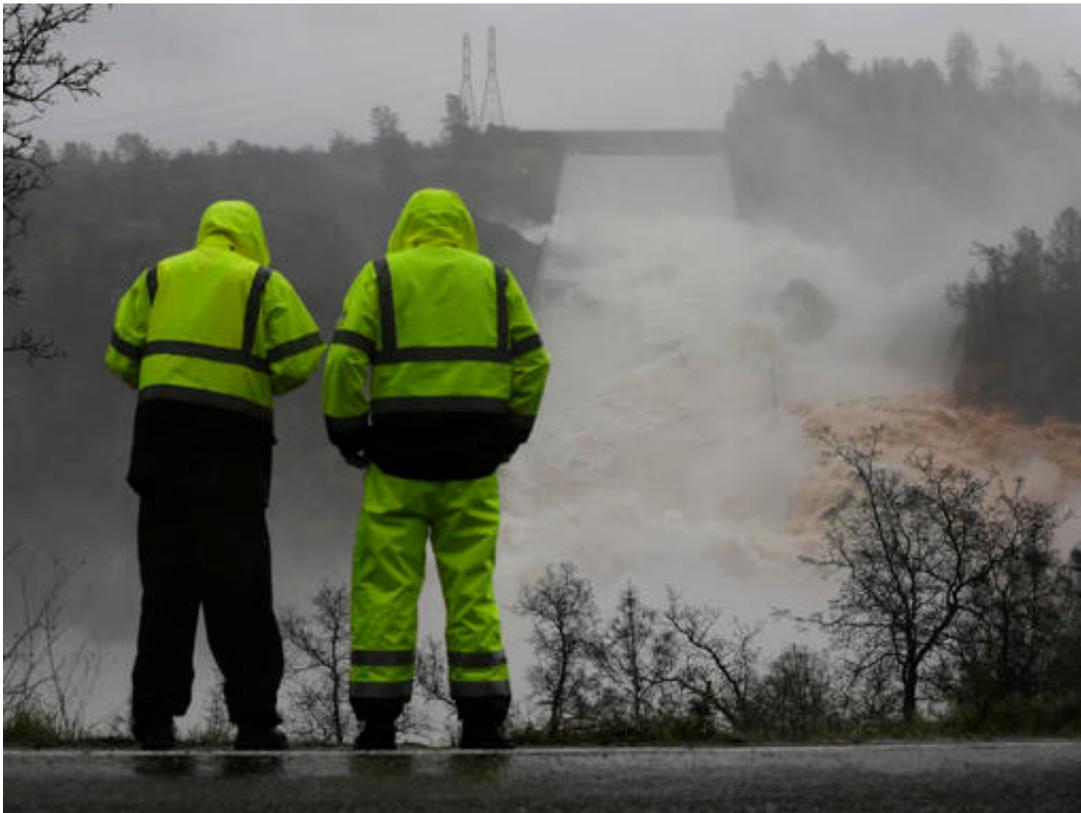
Water rushes down the Oroville Dam spillway, Thursday, Feb. 9, 2017, in Oroville, Calif. State engineers on Thursday discovered new damage to the Oroville Dam spillway in Northern California, the tallest in the United States, though they said there is no harm to the nearby dam and no danger to the public. Earlier this week, chunks of concrete went flying off the spillway, creating a 200-foot-long, 30-foot deep hole. (AP Photo/Rich Pedroncelli)

A gaping hole in the spillway for the tallest dam in the United States has grown and California authorities said they expect it will continue eroding as water washes over it but the Oroville Dam and the public are safe.

Earlier this week, chunks of concrete flew off the nearly mile-long spillway, creating a 200-foot-long, 30-foot-deep hole. Engineers don't know what caused cave-in that is expected to keep growing until it reaches bedrock.

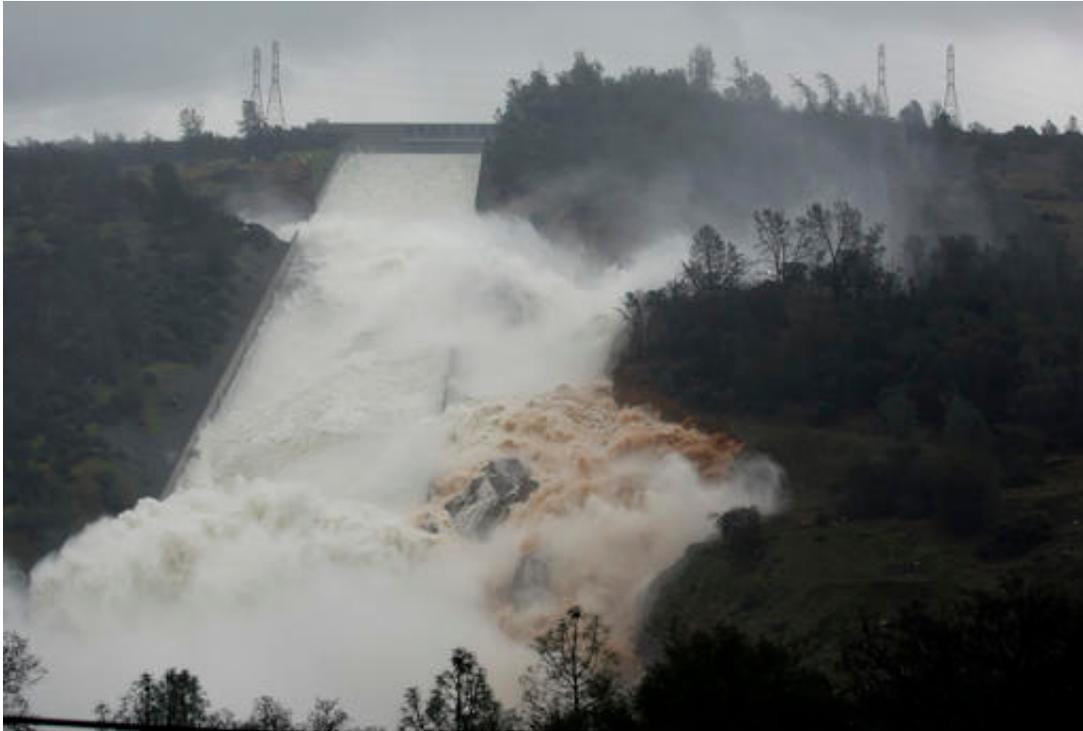
Water flows through break in the wall of the Oroville Dam spillway, Thursday, Feb. 9, 2017, in Oroville, Calif. The torrent chewed up trees and soil alongside the concrete spillway before rejoining the main channel below. Engineers don't know what caused what state Department of Water Resources spokesman Eric See called a "massive" cave-in that is expected to keep growing until it reaches bedrock. (AP Photo/Rich Pedroncelli)

The initial damage to the spillway occurred Tuesday, about 3,000 feet downstream from where water enters from the lake. The water flowing out of the hole quickly turned brown with mud as it consumed trees and soil before rejoining the main channel below in a massive confluence wave that sent up clouds of mist in the tree-lined canyon.

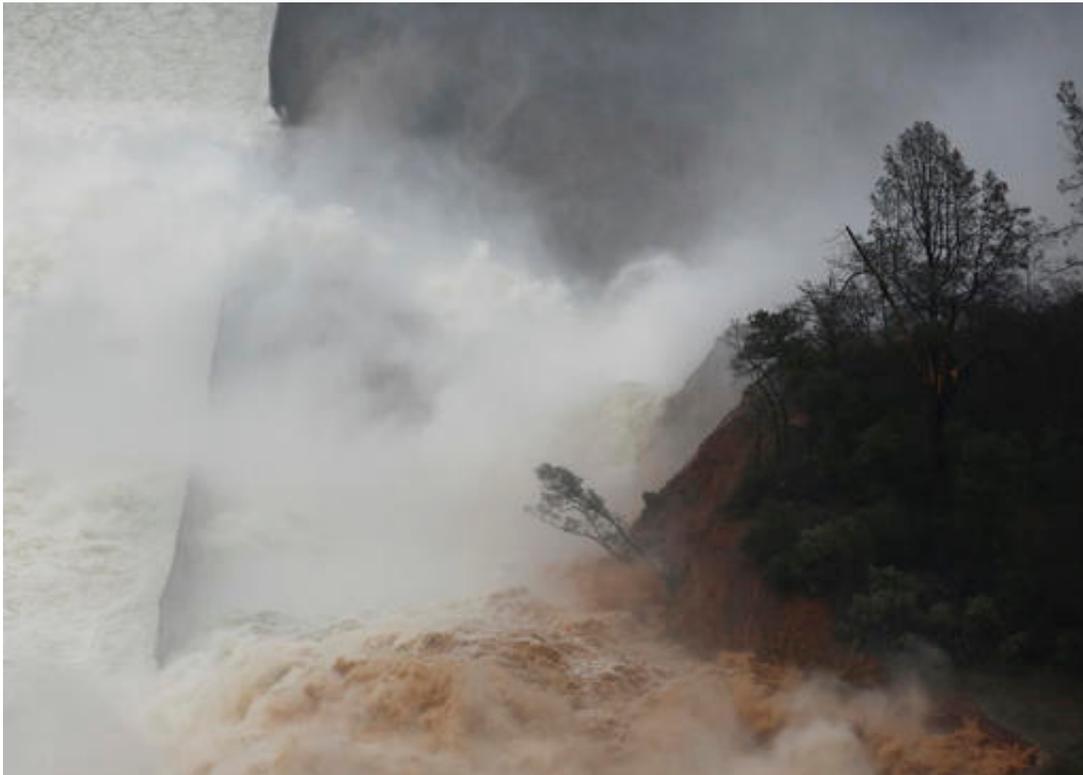
Water flows through break in the wall of the Oroville Dam spillway, Thursday, Feb. 9, 2017, in Oroville, Calif. The torrent chewed up trees and soil alongside

the concrete spillway before rejoining the main channel below. Engineers don't know what caused what state Department of Water Resources spokesman Eric See called a "massive" cave-in that is expected to keep growing until it reaches bedrock. (AP Photo/Rich Pedroncelli)

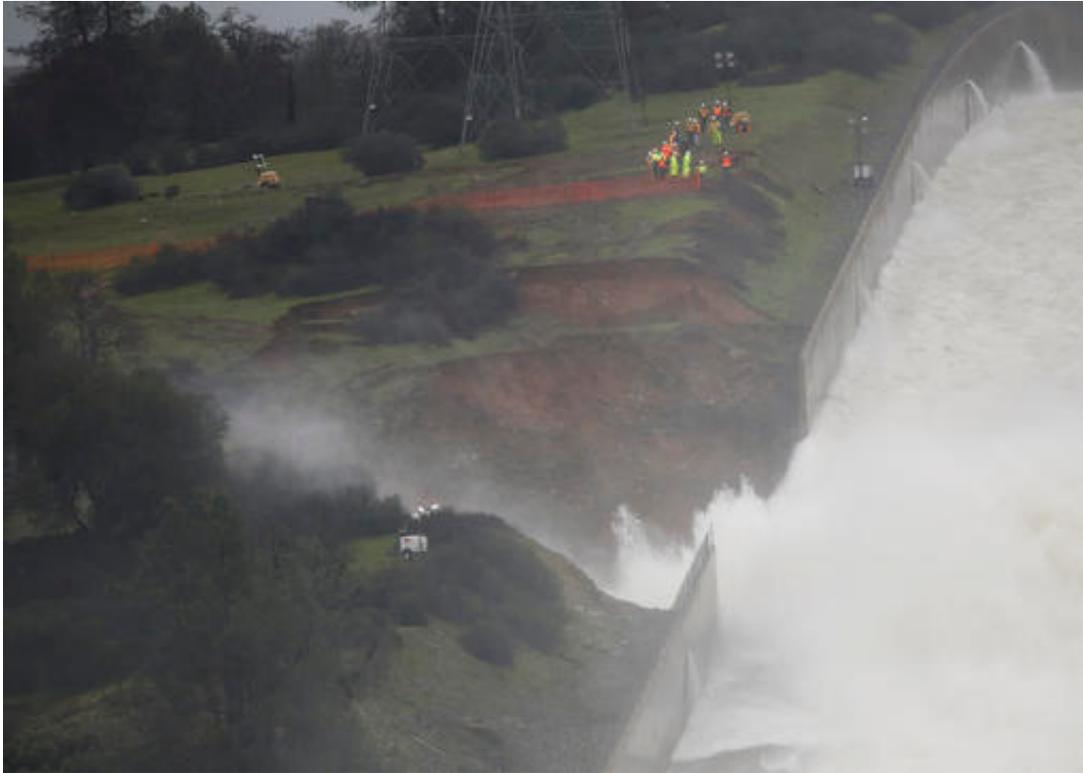
Water flows through break in the wall of the Oroville Dam spillway, Thursday, Feb. 9, 2017, in Oroville, Calif. Engineers don't know what caused what state Department of Water Resources spokesman Eric See called a "massive" cave-in that is expected to keep growing until it reaches bedrock. (AP Photo/Rich Pedroncelli)

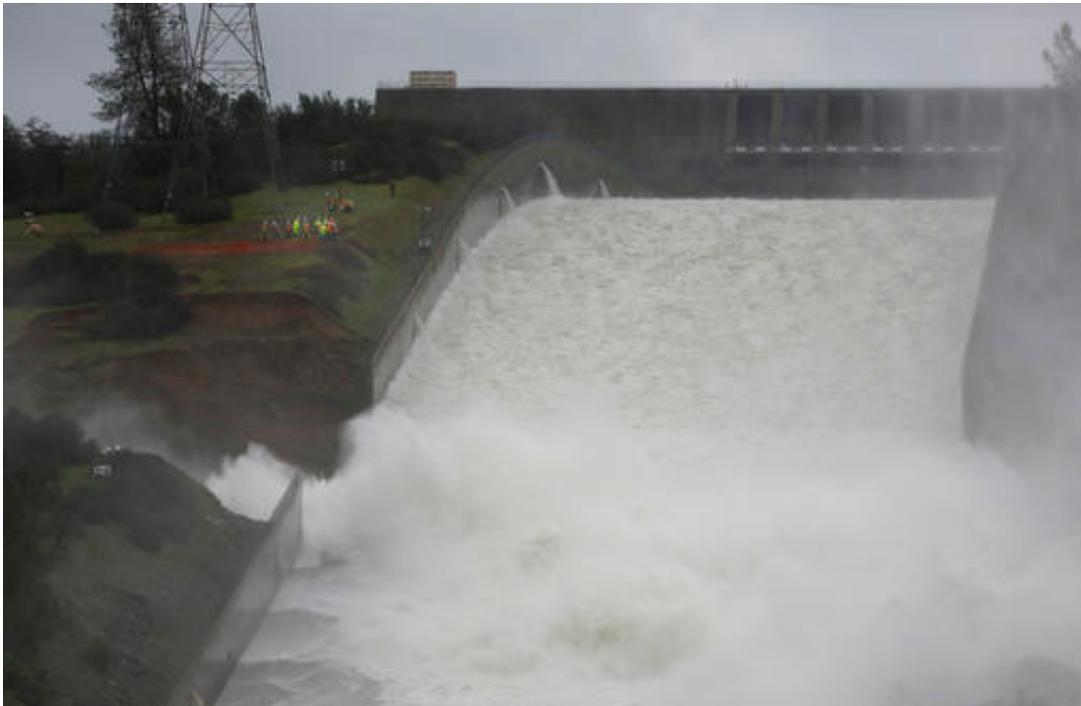
Water flows through break in the wall of the Oroville Dam spillway, Thursday, Feb. 9, 2017, in Oroville, Calif. Earlier this week, chunks of concrete went flying off the spillway, creating a 200-foot-long, 30-foot deep hole that continues to grow. (AP Photo/Rich Pedroncelli)

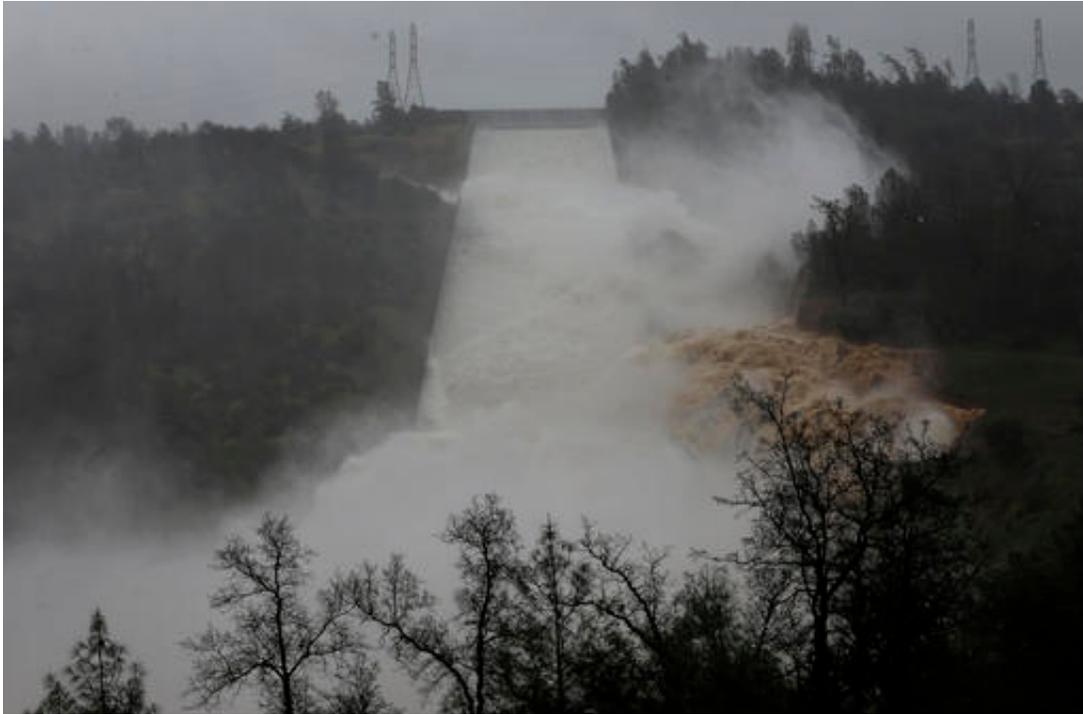
Water rushes down the Oroville Dam spillway, Thursday, Feb. 9, 2017, in Oroville, Calif. State engineers on Thursday discovered new damage to the Oroville Dam spillway, the tallest in the United States, though they said there is no harm to the nearby dam and no danger to the public. Earlier this week, chunks of concrete went flying off the spillway, creating a 200-foot-long, 30-foot deep hole. (AP Photo/Rich Pedroncelli)

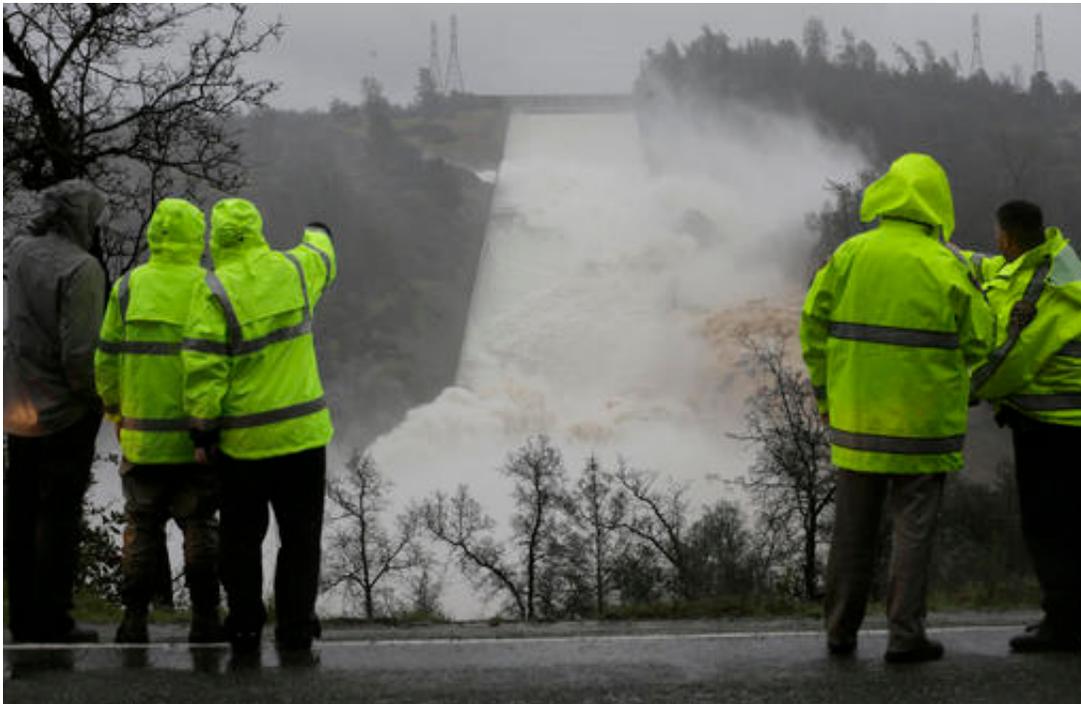
Water rushes down the Oroville Dam spillway, Thursday, Feb. 9, 2017, in Oroville, Calif. State engineers on Thursday discovered new damage to the Oroville Dam spillway, the tallest in the United States, though they said there is no harm to the nearby dam and no danger to the public. Earlier this week, chunks of concrete went flying off the spillway, creating a 200-foot-long, 30-foot deep hole. (AP Photo/Rich Pedroncelli)
