# Gaping hole in spillway for tallest US dam keeps growing (Update)

9 February 2017, by Don Thompson

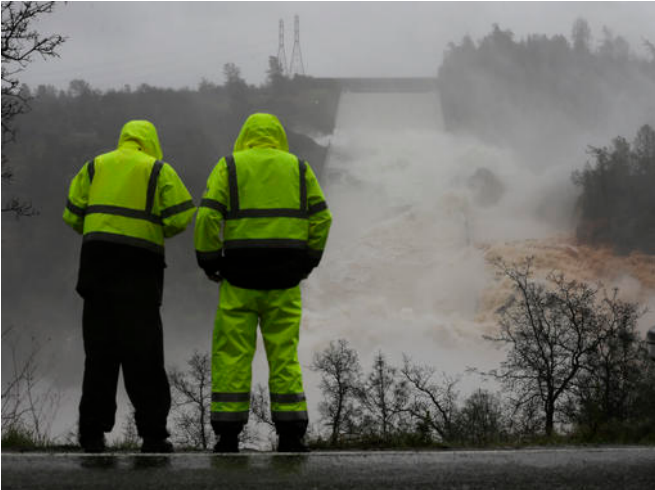
Water rushes down the Oroville Dam spillway, Thursday, Feb. 9, 2017, in Oroville, Calif. State engineers on Thursday discovered new damage to the Oroville Dam spillway in Northern California, the tallest in the United States, though they said there is no harm to the nearby dam and no danger to the public. Earlier this week, chunks of concrete went flying off the spillway, creating a 200-foot-long, 30-foot deep hole. (AP Photo/Rich Pedroncelli)

Earlier this week, chunks of concrete flew off the nearly mile-long spillway, creating a 200-foot-long, 30-foot-deep hole. Engineers don't know what caused cave-in that is expected to keep growing until it reaches bedrock.

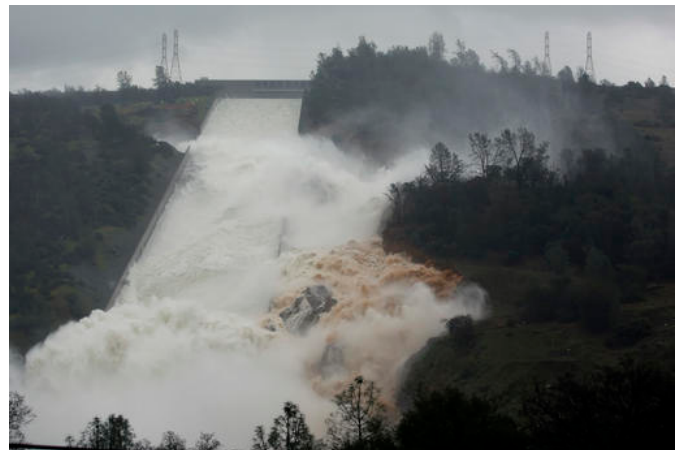
Water flows through break in the wall of the Oroville Dam spillway, Thursday, Feb. 9, 2017, in Oroville, Calif. The torrent chewed up trees and soil alongside the concrete spillway before rejoining the main channel below. Engineers don't know what caused what state Department of Water Resources spokesman Eric See called a "massive" cave-in that is expected to keep growing until it reaches bedrock. (AP Photo/Rich

Pedroncelli)

The initial damage to the spillway occurred Tuesday, about 3,000 feet downstream from where water enters from the lake. The water flowing out of the hole quickly turned brown with mud as it consumed trees and soil before rejoining the main channel below in a massive confluence wave that sent up clouds of mist in the tree-lined canyon.

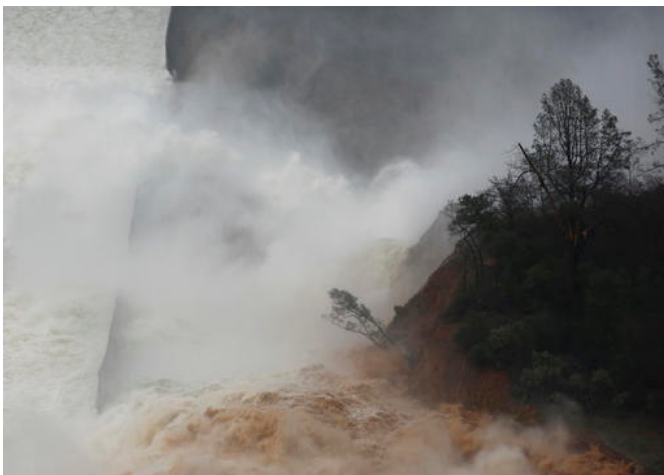
Water flows through break in the wall of the Oroville Dam spillway, Thursday, Feb. 9, 2017, in Oroville, Calif. The torrent chewed up trees and soil alongside the concrete spillway before rejoining the main channel below. Engineers don't know what caused what state Department of Water Resources spokesman Eric See called a "massive" cave-in that is expected to keep growing until it reaches bedrock. (AP Photo/Rich Pedroncelli)

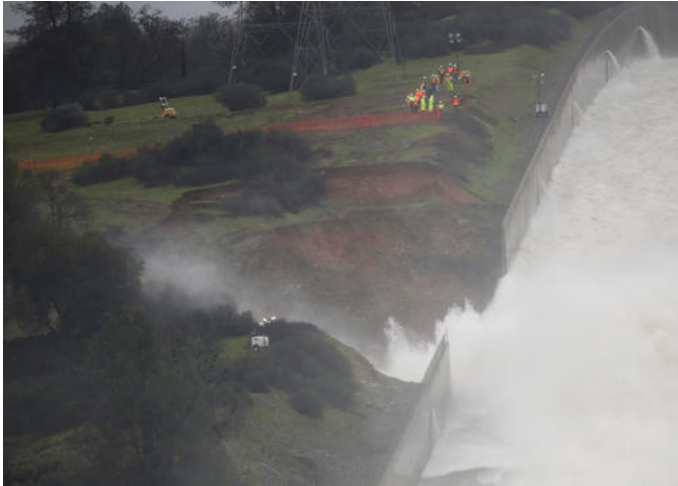
Water flows through break in the wall of the Oroville Dam spillway, Thursday, Feb. 9, 2017, in Oroville, Calif. Engineers don't know what caused what state Department of Water Resources spokesman Eric See called a "massive" cave-in that is expected to keep growing until it reaches bedrock. (AP Photo/Rich Pedroncelli)

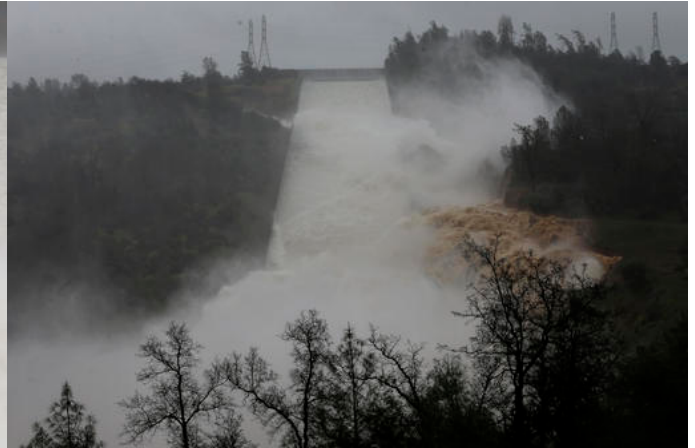
Water rushes down the Oroville Dam spillway, Thursday, Feb. 9, 2017, in Oroville, Calif. State engineers on Thursday discovered new damage to the Oroville Dam spillway, the tallest in the United States, though they said there is no harm to the nearby dam and no danger to the public. Earlier this week, chunks of concrete went flying off the spillway, creating a 200-foot-long, 30-foot deep hole. (AP Photo/Rich Pedroncelli)

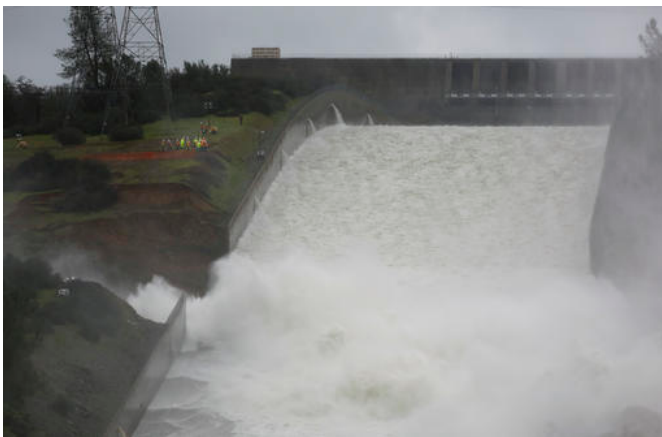
Water flows through break in the wall of the Oroville Dam spillway, Thursday, Feb. 9, 2017, in Oroville, Calif. Earlier this week, chunks of concrete went flying off the spillway, creating a 200-foot-long, 30-foot deep hole that continues to grow. (AP Photo/Rich Pedroncelli)

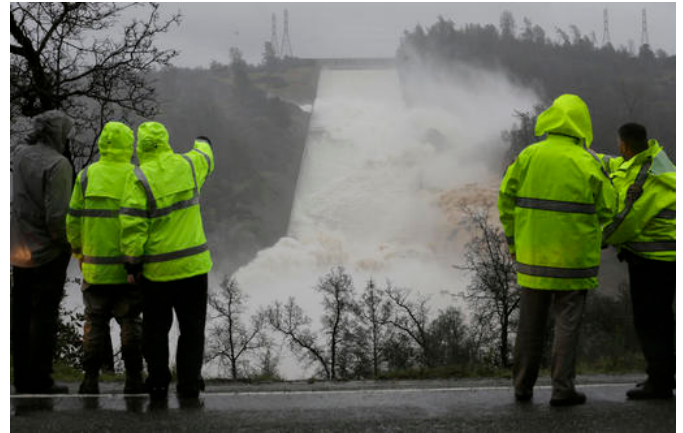
Water rushes down the Oroville Dam spillway, Thursday, Feb. 9, 2017, in Oroville, Calif. State engineers on Thursday discovered new damage to the Oroville Dam spillway, the tallest in the United States, though they said there is no harm to the nearby dam and no danger to the public. Earlier this week, chunks of concrete went flying off the spillway, creating a 200-foot-long, 30-foot deep hole. (AP Photo/Rich Pedroncelli)
