Grenfell: a year on, here's what we know went wrong

14 June 2018, by Konstantinos Daniel Tsavdaridis

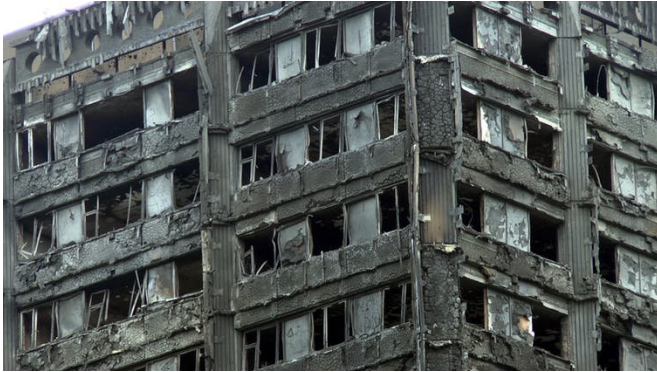
The flammable cladding was instrumental in the fire spreading so quickly. Credit: [Flickr/ChiralJohn](#), [CC BY](#)

Immediately, the focus was put on the new exterior skin (cladding), which not only contained flammable materials (polyethylene insulation covered by thin aluminium sheets that buckle in high temperatures and expose the internal material to flames) but was also installed onto the existing incombustible reinforced-concrete structure, in a way that left a gap between the facade and the building's structure. This enabled what is known as the "chimney effect". Put simply, the gap between the facade and the structural skeleton of the building meant that the fire sought oxygen and quickly travelled vertically, while burning more of the flammable skin.

But some of [the regulations](#) that need to be implemented are clear. For a start, each type of building should be designed or refurbished with the appropriate regulation. So for example, all buildings that are higher than five stories ought to be provided with alternative evacuation routes such as more (or external) staircases, be equipped with sprinklers, and only be allowed to use fire-retardant materials, such as cementitious boards, ceramics, or glass facades.
