Researchers see crack formation in 3-D-printed tungsten in real time

August 21 2020, by Jeremy Thomas

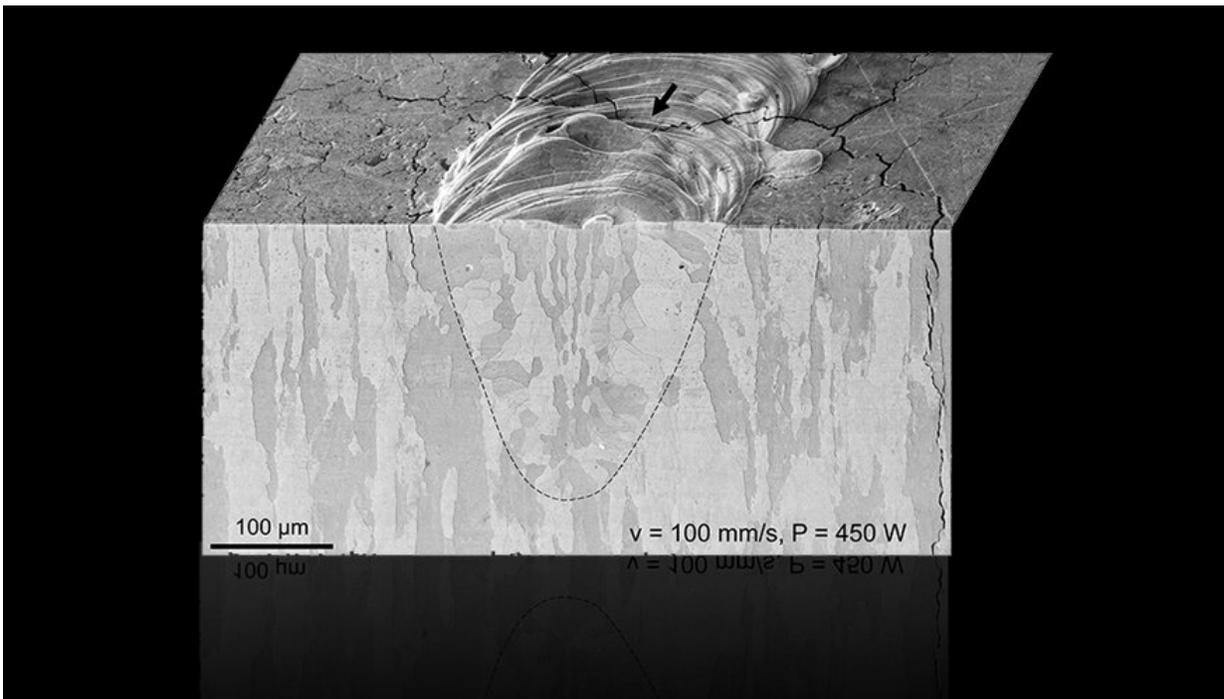
By combining simulations with high-speed videos taken during the laser powder-bed fusion process, LLNL scientists were able to visualize the ductile-to-brittle transition in 3D-printed tungsten in real-time, allowing them to observe how microcracks initiated and spread in the metal. Photos taken with a scanning electron microscope show the microcrack network branches across the laser melt track on the surface and can penetrate deep into the adjacent substrate material, preferentially along grain boundaries. Credit: Lawrence Livermore National Laboratory

Through their experimental observations and computational modeling performed using LLNL's Diablo finite element code, the researchers found that microcracking in tungsten occurs in a small window between 450 and 650 degrees Kelvin and is dependent on strain rate, which is directly influenced by process parameters. They also were able to correlate the size of the crack-affected area and crack network morphology to local residual stresses.
