# NASA spacecraft leaves its mark after grabbing asteroid Bennu samples

16 April 2021, by Marcia Dunn

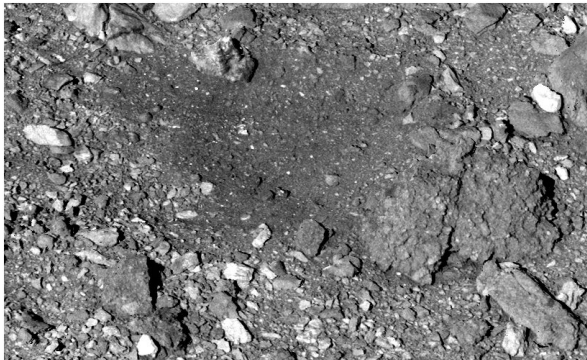
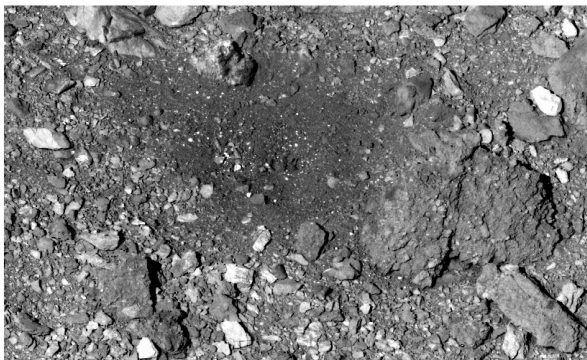
This combination of 2019 and 2021 images made available by NASA shows how the local surface of Bennu changed after the OSIRIS-REx spacecraft took a sample of the asteroid on Oct. 20, 2020. The earlier image, top, was taken on March 7, 2019, and the bottom was taken on April 7, 2021, as part of final observations to document the surface after sample acquisition. The Nightingale site is located in the relatively clear patch just above the crater's center – visible in the center of the earlier image. The large, dark boulder located at the center right measures 43 feet (13 meters) on its longest axis. (NASA/Goddard/University of Arizona via AP)

The Osiris-Rex spacecraft made one final flyby of asteroid Bennu on April 7 to take photos of the disturbance left by October's [sample collection](#).

A depression is visible where Osiris-Rex penetrated the asteroid's surface. Boulders were hurled by the pressurized nitrogen gas that was fired at the ground to churn up material for vacuuming, and by the spacecraft's getaway thruster. One 1-ton boulder was flung an estimated 40 feet (12 meters).

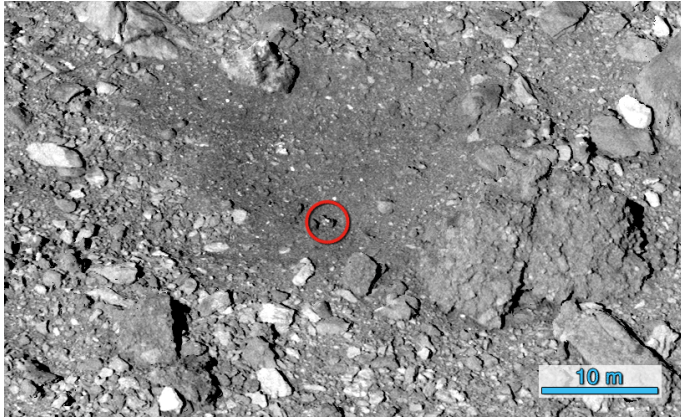
Bennu's surface was disturbed in three different ways: by the force of the spacecraft touching down; by the sampling mechanism, which collected material by blowing gas into its collection filter; and by four of the spacecraft's back-away thrusters, which moved the spacecraft away from the sample site (marked with a red "X" in the second of these two images) and agitated dust and boulders on the surface. The image above shows the TAG site and highlights (red circle) a large boulder thrown about 40 feet (about 12 meters). Credits: NASA/Goddard/University of Arizona
