After the flood disaster in Western Germany: Science searches for answers

20 September 2021

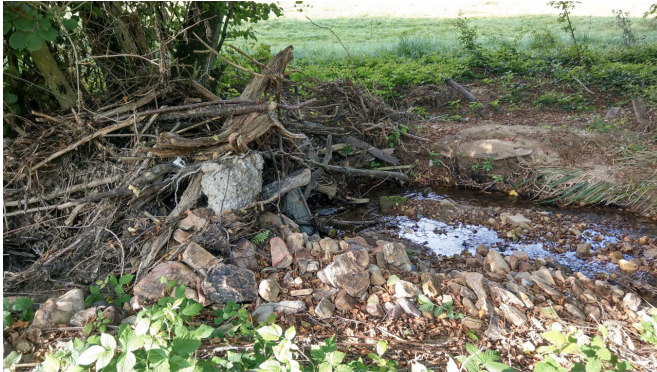
Woody debris clogging a small creek of the Ahr river, leading to temporal ponding, massive sediment deposition and overbank spillways of the flood water. Credit: M. Dietze, GFZ

In addition, the water developed enormous erosive power: On the one hand, it dug channels into the slopes and was able to flow even faster in those self-dugged pathways. On the other hand, it mobilized considerable amounts of sediment and dead wood. Once in the main valleys, the tree trunks and branches drifted towards bridges. There they became entangled and led to so-called blockages. As a result, the runoff was impeded, the water dammed up and also inundated more distal areas.

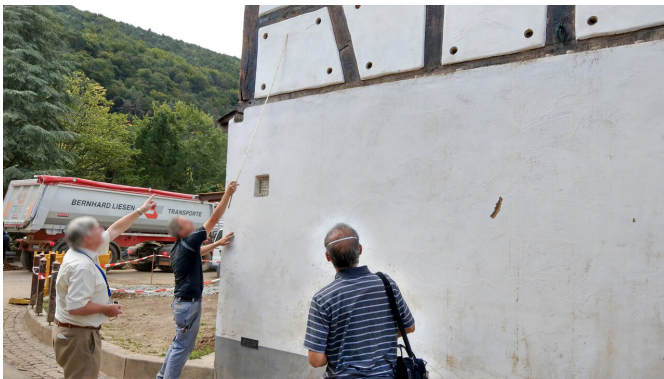
Owner showing the water level of the 14 July flood on his house in Walporzheim. Note the 2.2 m water mark of the 1804 flood and the 0.6 m mark from 2016 for comparison. Credit: Michael Dietze, GFZ
