After the flood disaster in Western Germany: Science searches for answers

September 20 2021

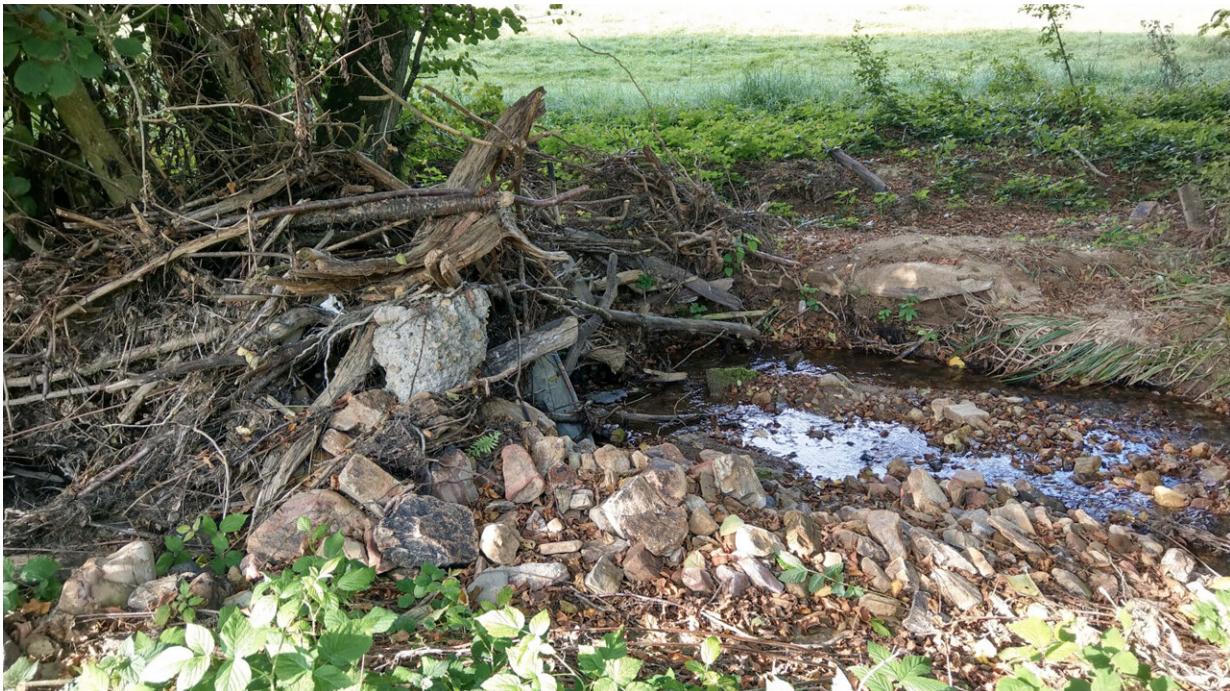
Woody debris clogging a small creek of the Ahr river, leading to temporal ponding, massive sediment deposition and overbank spillways of the flood water.
Credit: M. Dietze, GFZ

In addition, the water developed enormous erosive power: On the one hand, it dug channels into the slopes and was able to flow even faster in those self-dugged pathways. On the other hand, it mobilized considerable amounts of sediment and dead wood. Once in the main valleys, the tree trunks and branches drifted towards bridges. There they became entangled and led to so-called blockages. As a result, the runoff was impeded, the water dammed up and also inundated more distal areas.

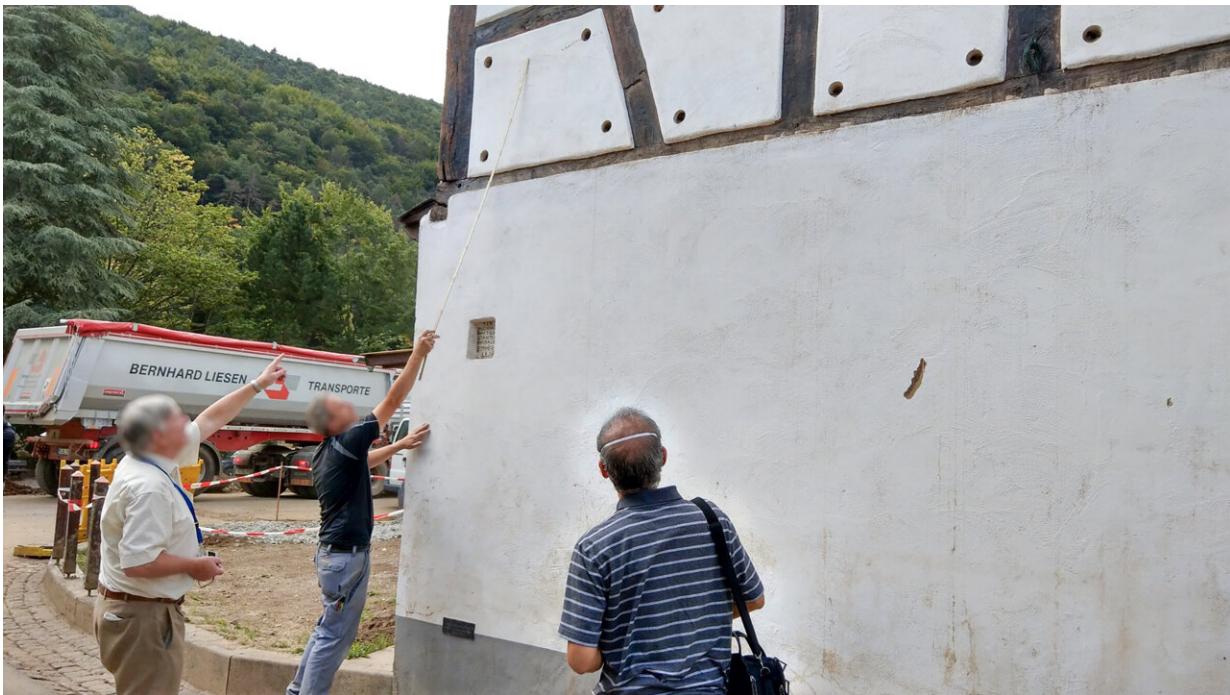
Owner showing the water level of the 14 July flood on his house in Walporzheim. Note the 2.2 m water mark of the 1804 flood and the 0.6 m mark from 2016 for comparison. Credit: Michael Dietze, GFZ
