SMART-1 impact flash and debris: Crash scene investigation

September 7 2006

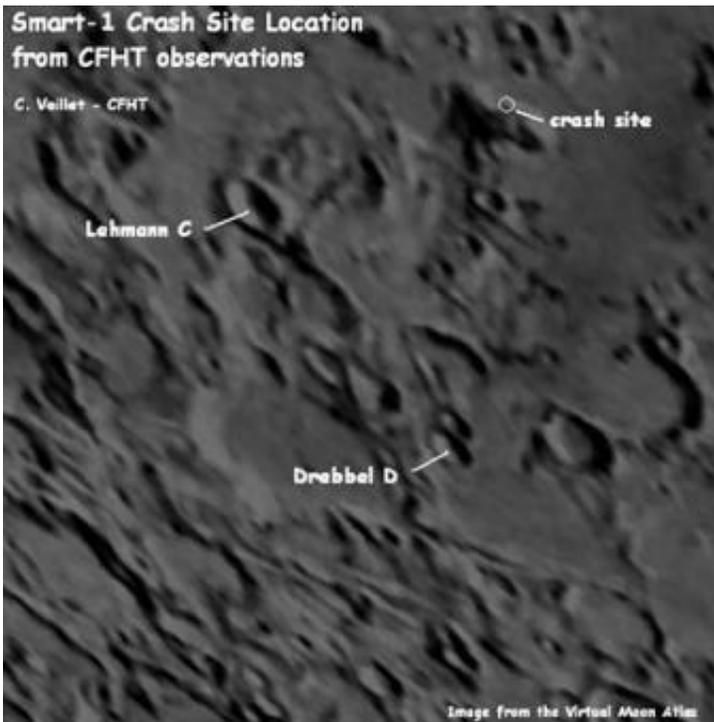
This image shows the location of the SMART-1 impact, as estimated by the Canada-France-Hawaii Telescope (CFHT). To determine the location, the CFHT scientists used the position of the flash relative to a pair of reference craters visible as bright areas on the CFHT images, and a map of the Moon as seen from Mauna Kea at the time of the impact using the Moon Virtual Atlas. A simple triangulation allowed to pinpoint the impact area within a couple of kilometres. The crash site determined from the CFHT observations is actually almost coinciding with the last ESA predictions before the impact. Courtesy of CFHT. Credits: Canada-France-Hawaii Telescope / 2006

This is also in agreement with the coordinates newly derived from the position of the infrared impact flash observed by the Canada-France-Hawaii telescope (CFHT).

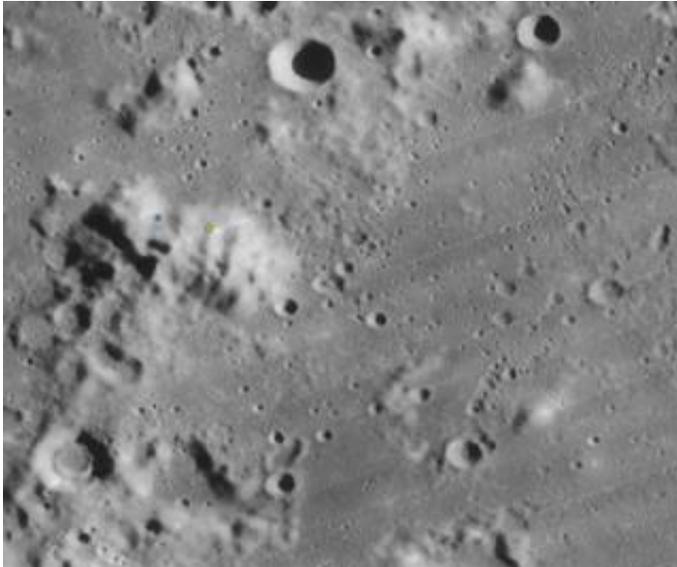
This image shows a 3D view of the SMART-1 impact location, as generated by USGS scientist Mark Rosiek. The blue star indicates the approximate impact site assuming that the coordinate system used to produce the reference Clementine Base Mosaic is correct. The yellow star indicates the approximate impact site using USGS's lunar control network revised with respect to the Clementine Base Mosaic. The distance separating the blue and yellow stars is about 7 kilometres. In this image North is up. Credits: USGS/ Mark Rosiek

earlier maps built with SMART-1 data, the satellite should have hit the Moon in the ascending slope of a mountain about 1.5 kilometres high, above the Lake of Excellence plain.
