NASA Releases Orbiting Carbon Observatory Accident Summary

July 17 2009

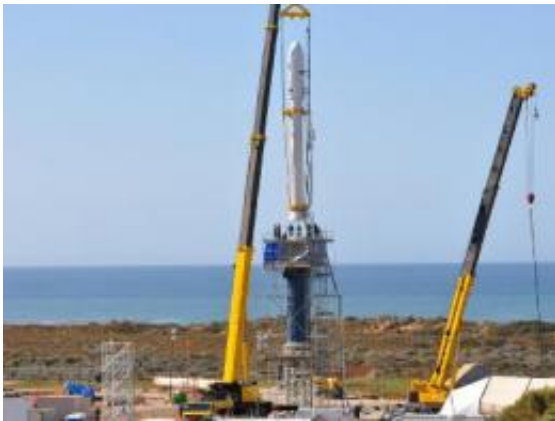
On Launch Complex 576-E at Vandenberg Air Force Base in California, NASA's Orbiting Carbon Observatory, OCO, upper stack is lowered toward the Stage 0 motor of the Taurus XL vehicle. Image credit: NASA/Randy Beaudoin
