Spirit Rover: Right-Front Wheel Rotations

December 18 2009

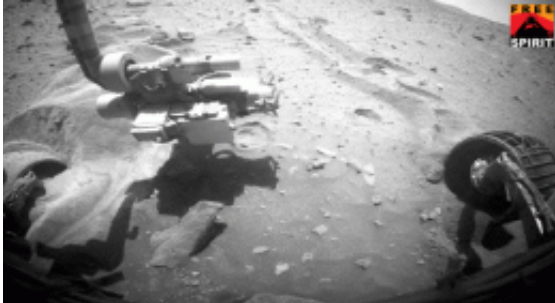
This three-frame animation aids evaluation of performance of the right-front wheel on NASA's Mars Exploration Rover Spirit during a drive on the rover's 2,117th Martian day, or sol (Dec. 16, 2009). Image credit: NASA/JPL-Caltech

(PhysOrg.com) -- Spirit's right-front wheel, which had stopped operating in March 2006, revolved with apparently normal motion during the first three of four driving segments on Sol 2117 (Wednesday, Dec. 16) but stopped early in the fourth segment of the drive.

the right-front wheel digging in as it rotated about 10 times.
