SpaceX finds failure cause, announces January 8 as target for flight resumption

January 3 2017, by Ken Kremer

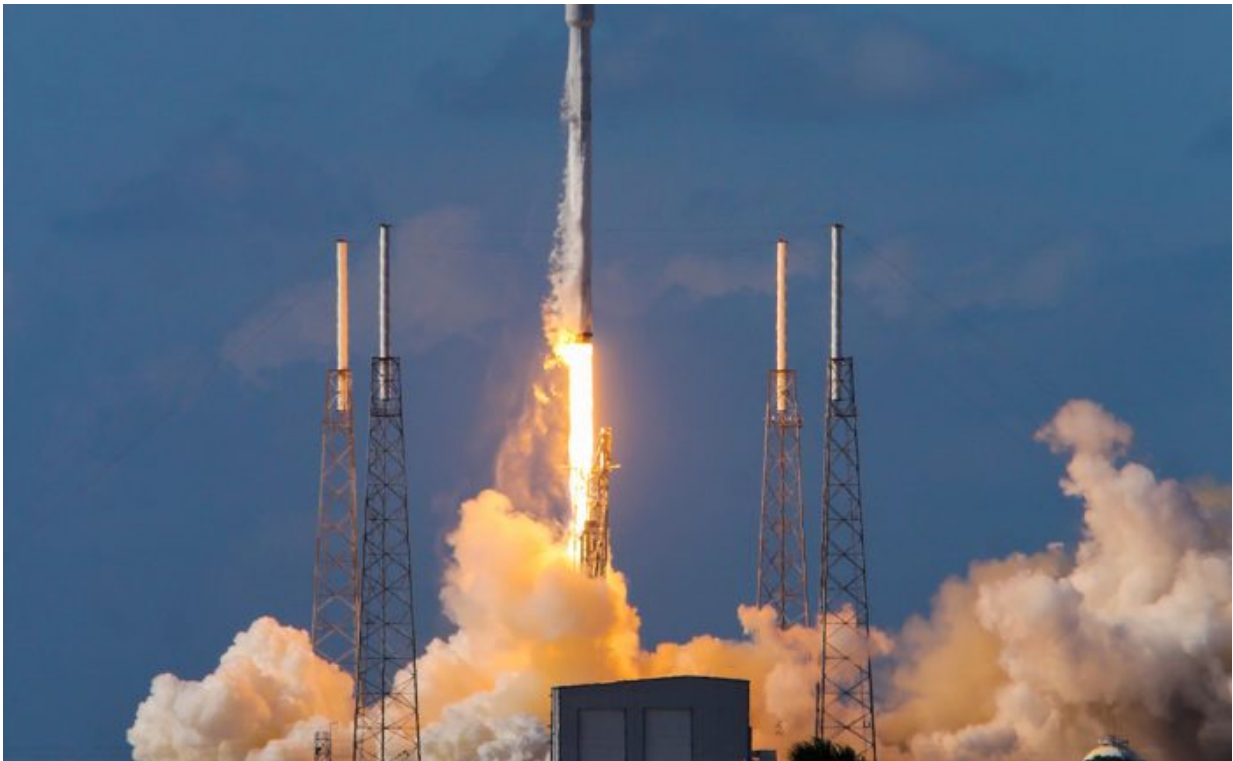
Upgraded SpaceX Falcon 9 blasts off with Thaicom-8 communications satellite on May 27, 2016 from Space Launch Complex 40 at Cape Canaveral Air Force Station, FL. 1st stage booster landed safely at sea minutes later. Credit: Ken Kremer/kenkremer.com

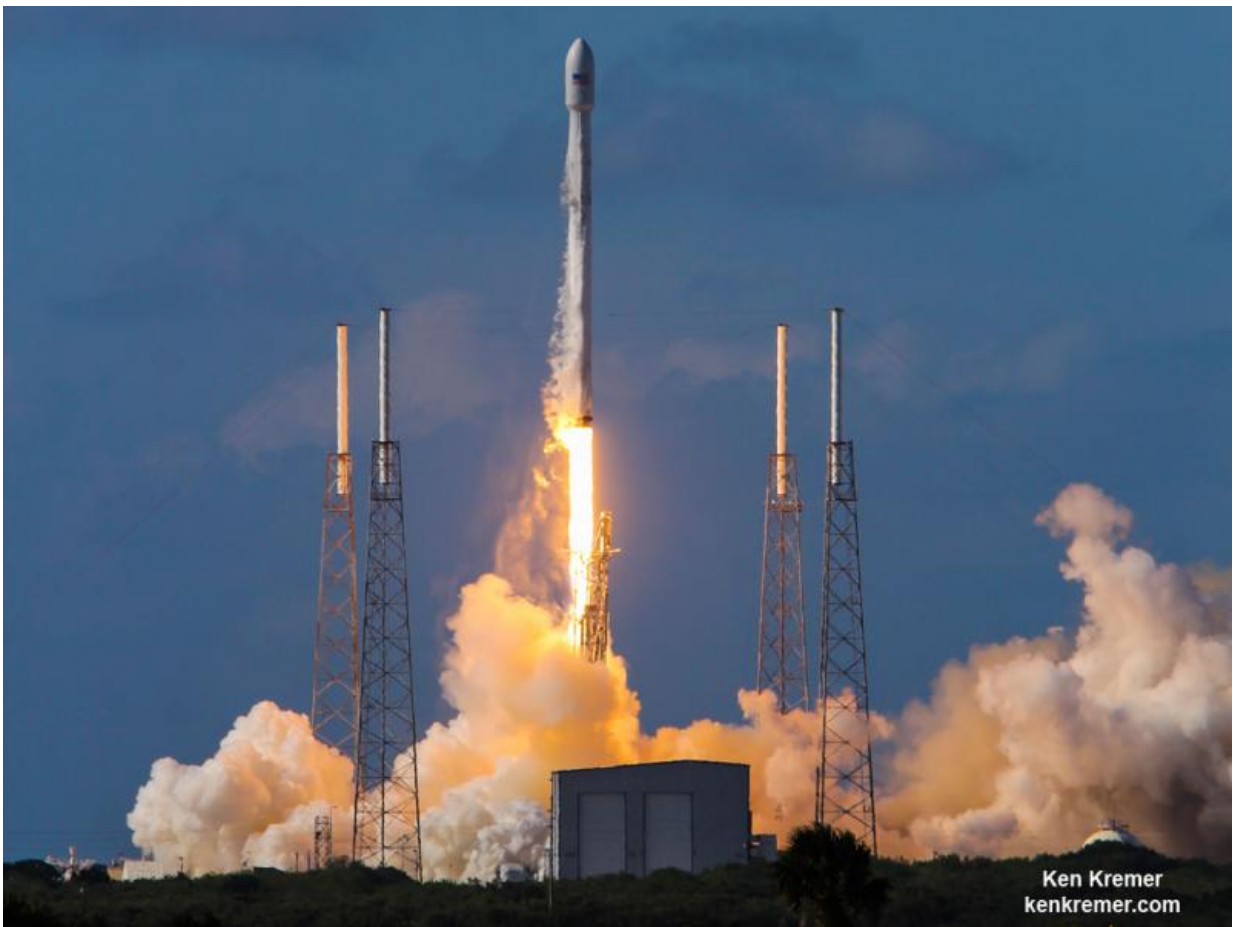
Upgraded SpaceX Falcon 9 blasts off with Thaicom-8 communications satellite on May 27, 2016 from Space Launch Complex 40 at Cape Canaveral Air Force Station, FL. 1st stage booster landed safely at sea minutes later. Credit: Ken Kremer/kenkremer.com

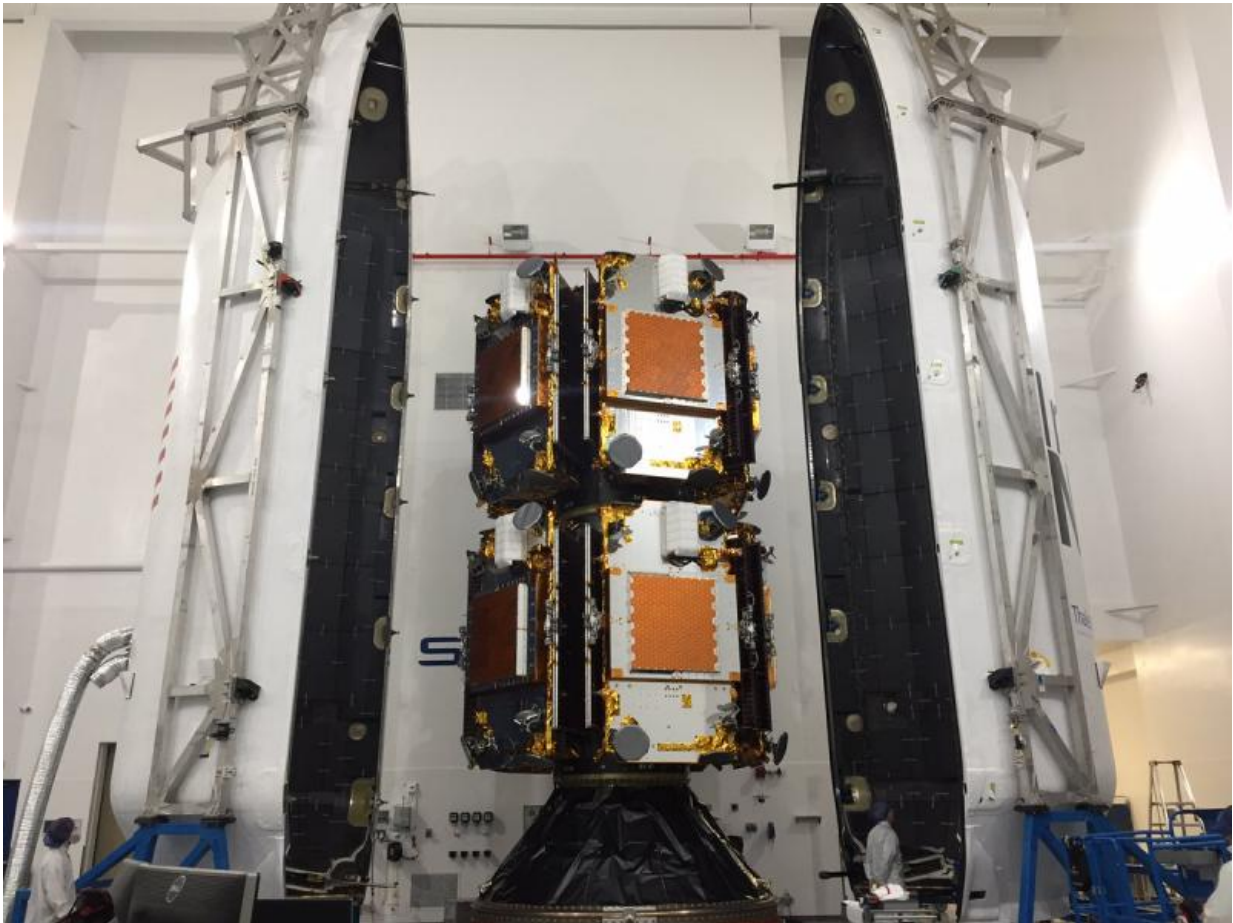
The first ten IridiumNEXT satellites are stacked and encapsulated in the Falcon 9 fairing for launch from Vandenberg Air Force Base, Ca., in early 2017. Credit: Iridium

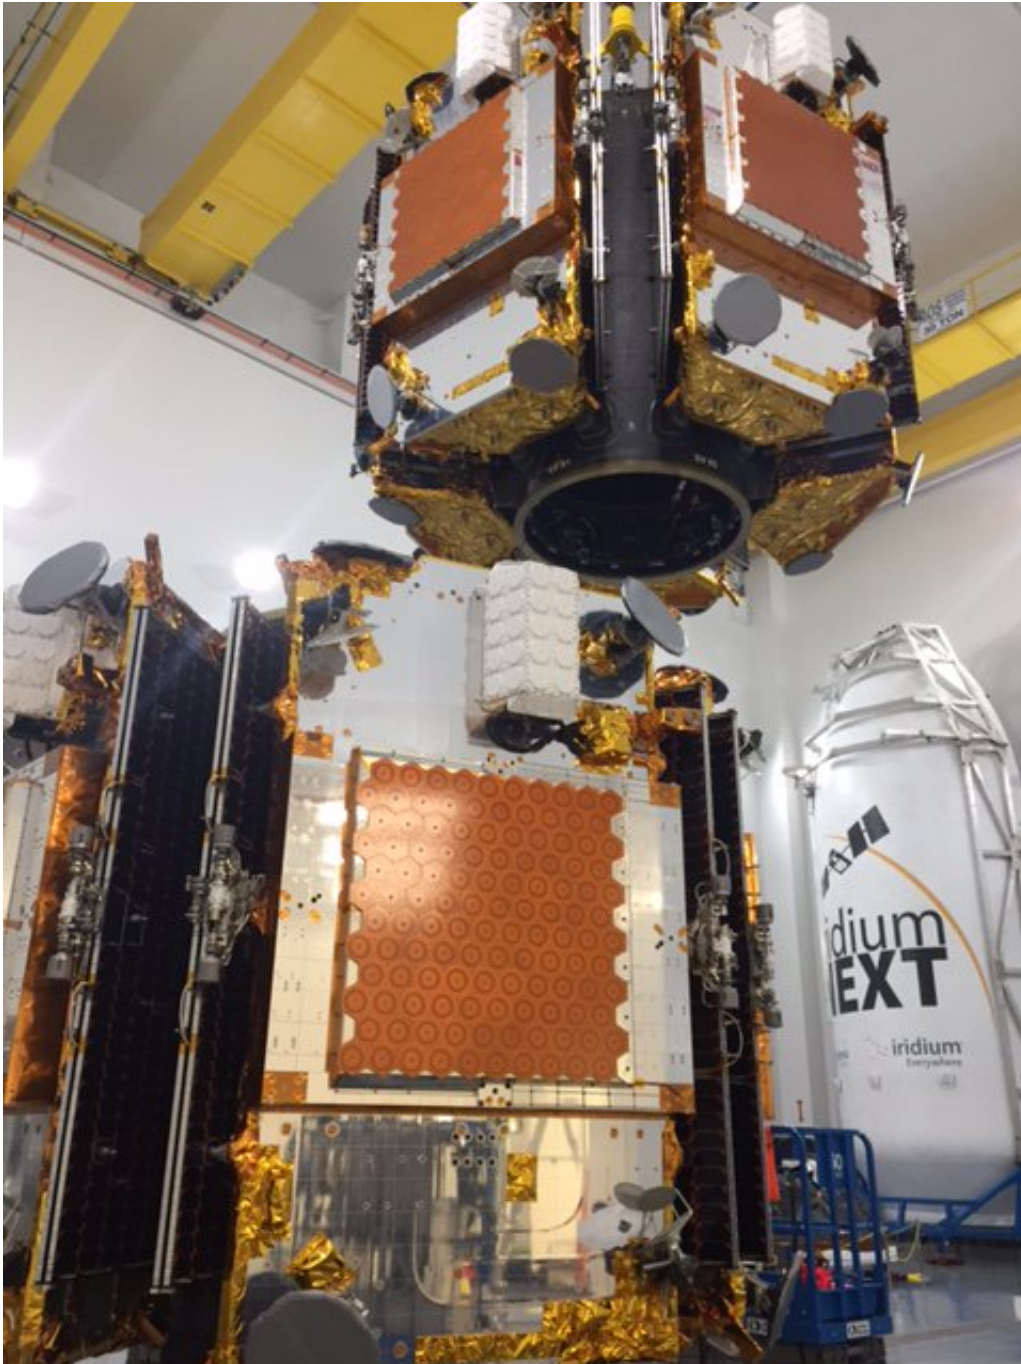
IridiumNEXT satellites being fueled, pressurized & stacked on dispenser tiers at

Vandenberg AFB for Falcon 9 launch. Credit: Iridium
