# Slow progress: NASA's still trying to get inSight's Mole working again

July 5 2019, by Evan Gough

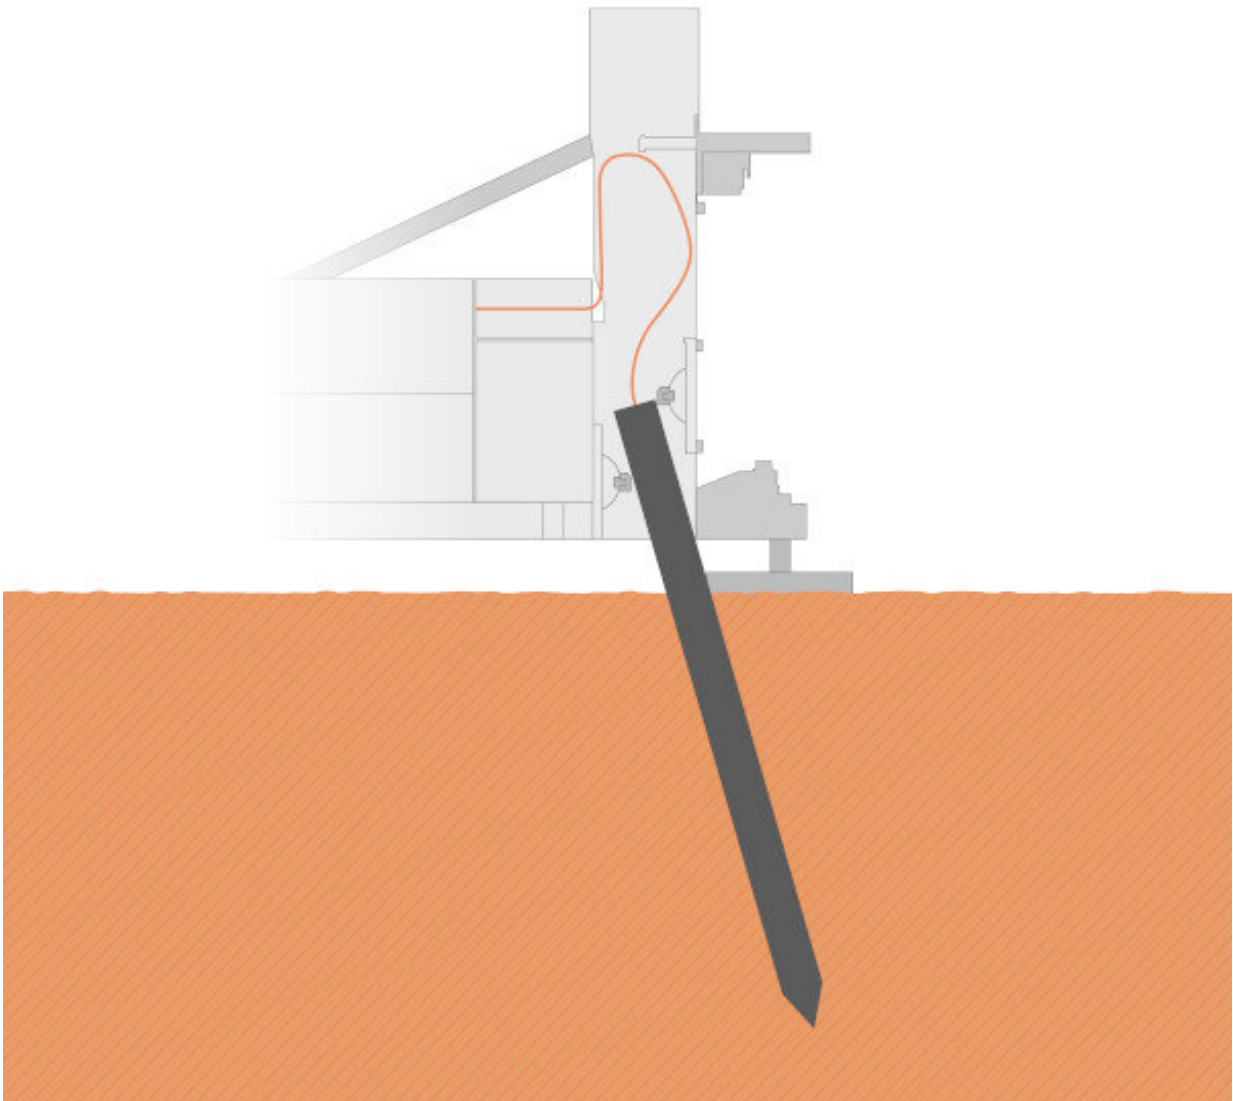
Engineers thought that the mole had hit a rock, shifted to a 15 degree angle, and become stuck. Image Credit: NASA/DLR

Initially, the InSight team thought that the mole had hit a rock and was blocked. But after analysis and experimentation with a mock-up lander at test-bed facilities, they came up with another explanation: a cavity in the soil.

The mole relies on friction with the rock surrounding it to hammer its way into the ground, and engineers thought that the mole had created a cavity around itself with its hammering motion. Without that friction, the mole will just recoil from the hammering action, and bounce around in the hole, rather than penetrate.

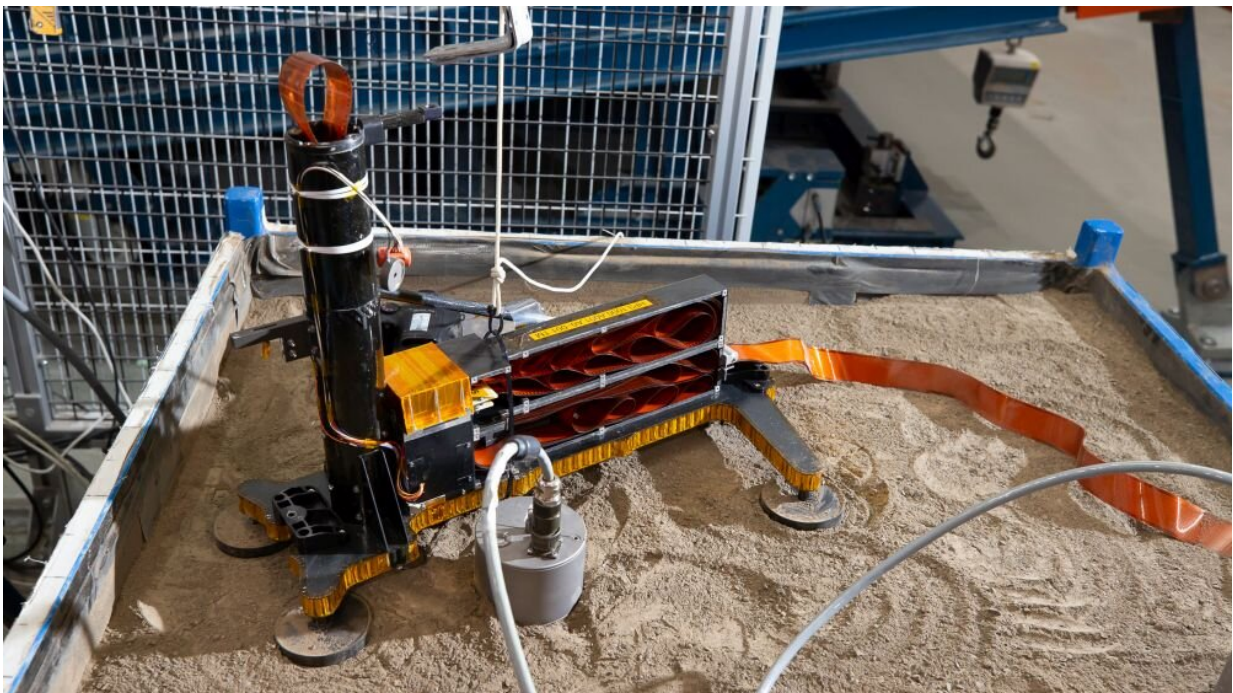
The HP3 model in its test bed in Bremen. Image Credit: DLR.

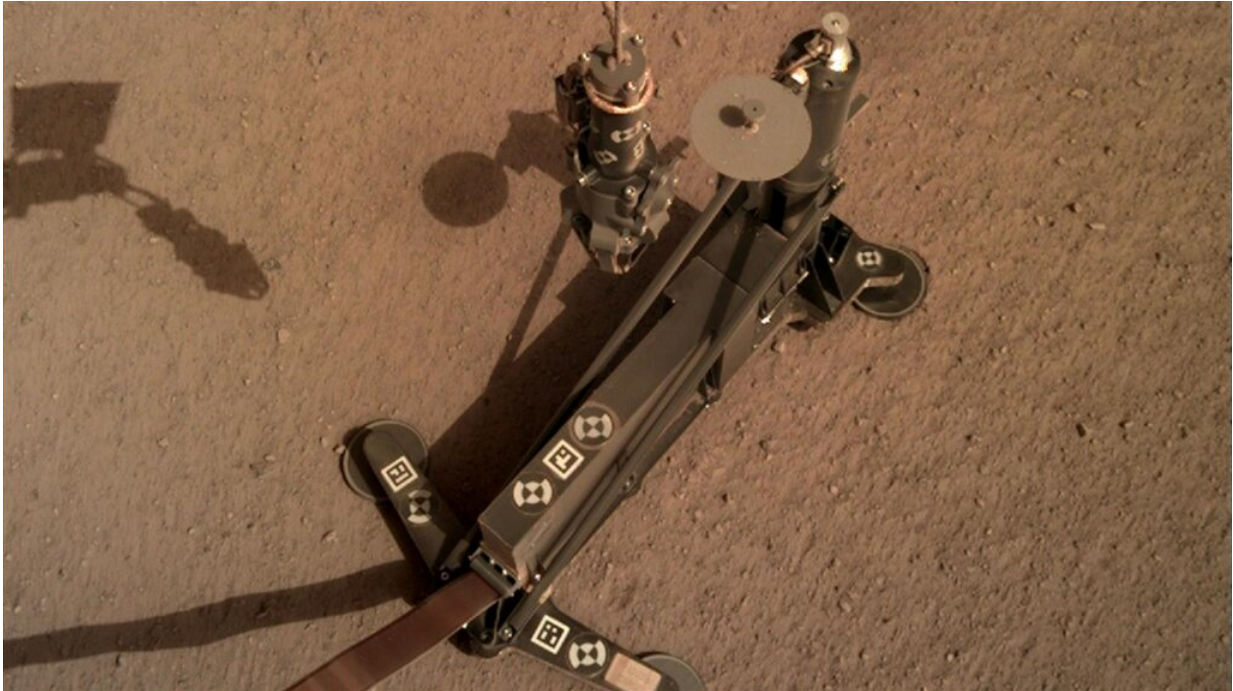
The Heat Flow and Physical Properties Package deployed on the Martian surface. Image Credit: NASA/DLR
