NASA Puts External Camera on Shuttle's Fuel Tank

August 14 2004

Space Shuttle Processing Status Report

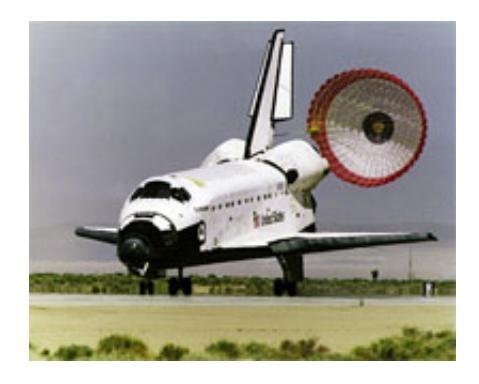
The space shuttle's external fuel tank, is getting safety upgrades for its spring 2005 flight. Now, a camera will be installed near the nose of the tank to transmit images of the shuttle for about 15 minutes after launch. The camera will stop taking pictures when the external tank is jettisoned. Then a group of NASA officials will review the images and determine how much insulating foam flew off the tank.
