Damage Detectives Inspect Shuttle on Orbit

September 15 2005

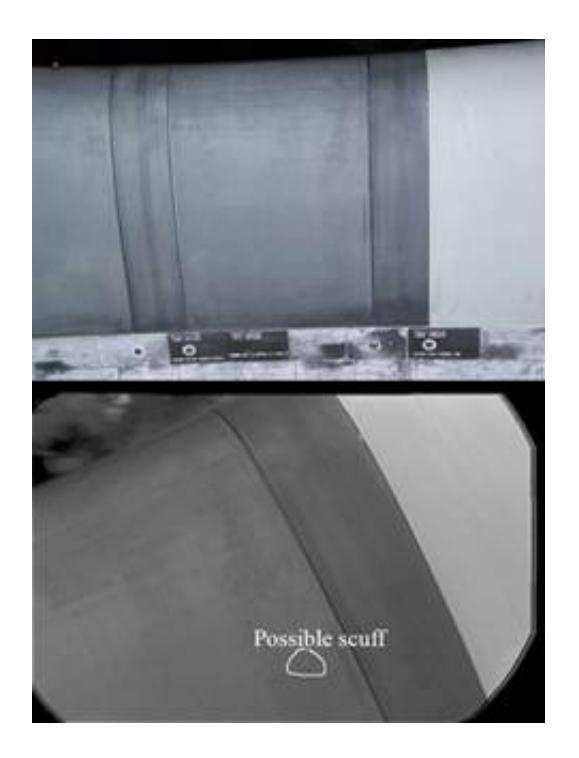
Image: When screeners compared the on-orbit photo (below) of this wing panel to the pre-flight photo (above), they saw a small white spot and flagged it as a possible scuff. Reinforced carbon-carbon experts later determined that the panel was not damaged. Credit: NASA

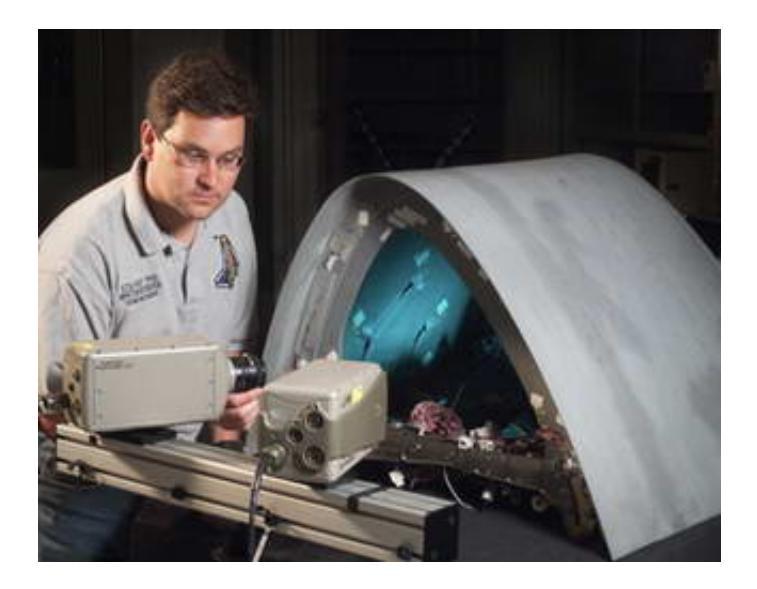
Image right: Revilock sets up a high-speed digital camera in Glenn's Ballistics Impact Laboratory to aid in testing the orbiter leading edge. Credit: NASA

The team members came from various backgrounds: some were orbital debris specialists, some were imaging experts, and others specialized in thermal structures. As an engineer at NASA Glenn's Ballistics Impact Lab, Revilock was familiar with damaged reinforced carbon-carbon. He spent more than two years shooting foam and ice at orbiter wing panels to determine the material's tolerance.

Photos of flat test wing panels shot in Glenn's Ballistic Impact Lab were among those Rollins used to train the screeners. "The flat test panels were a major asset in training," Rollins said. "They showed damage features that were very similar to what we were looking for on orbit."
