Dust Storm Passing Over Spirit

August 26 2009

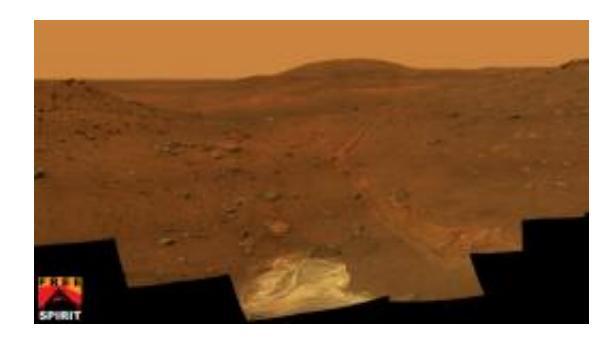
This full-circle view from the panoramic camera (Pancam) on NASA's Mars Exploration Rover Spirit shows the terrain surrounding the location called "Troy," where Spirit became embedded in soft soil during the spring of 2009.
