Helping materials handle extreme stress

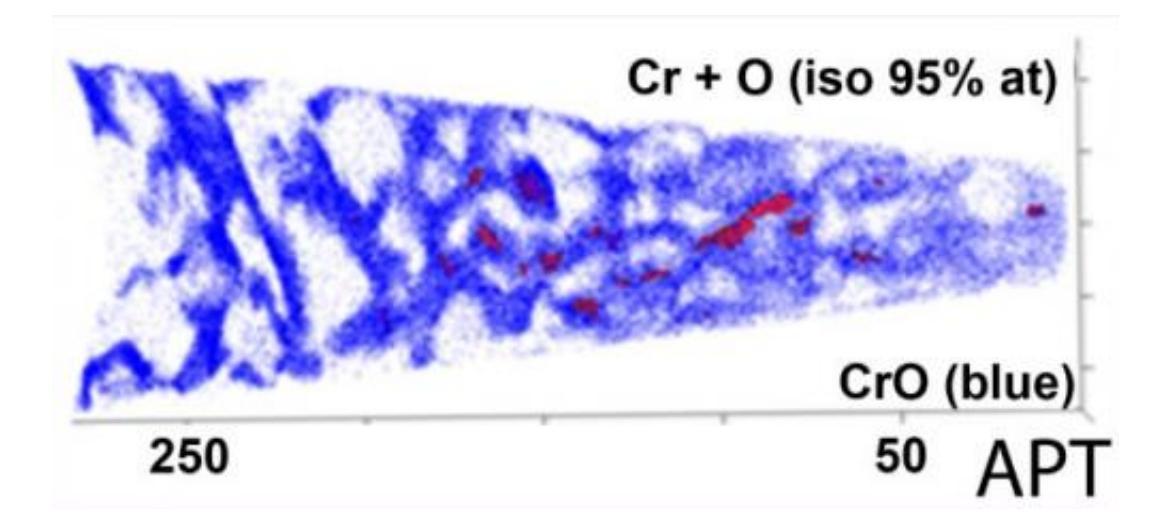
protective oxide layer on the surface.

Surprisingly, they found veins of localized <u>oxidation</u> wormed their way into the alloy 690 instead of forming the expected, chromium-rich
