Study finds failure points in firefighter protective equipment

More information: A Mensch, G Braga and N Bryner, Fire Exposures of Fire Fighter Self-Contained Breathing Apparatus Facepiece Lenses. NIST Technical Note 1724, Nov. 2011. The report can be accessed at <u>www.nist.gov/manuscript-public ... ch.cfm?pub_id=909917</u>

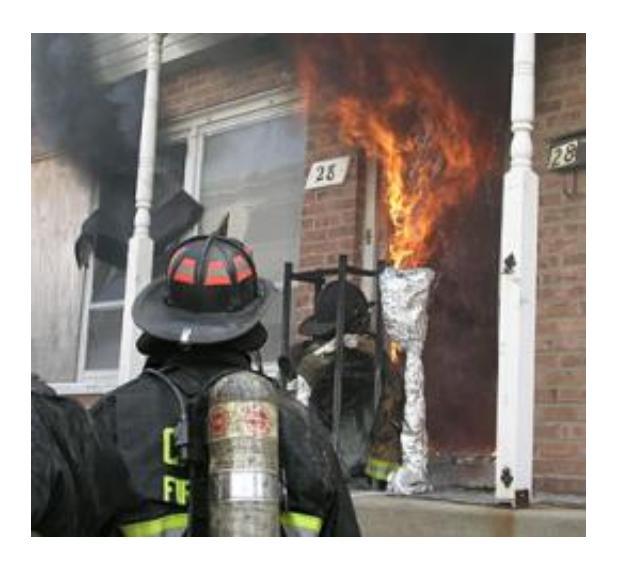
Flames from a living-room pour out the front door of a townhouse in NIST tests that studied conditions that can result in the failure of the facepiece lens of the self-contained breathing apparatus worn by firefighters. Facepieces were outfitted with devices to record temperatures and then mounted on a headform test stand placed outside doorway. The foil-wrapped equipment to the right of test set-up measured thermal heat flux. Credit: NIST

Rooms were equipped with devices to record temperatures rapidly at regular intervals between ceiling and floor. Facepieces also were equipped with sensors, on the inside and the outside of the lenses and in the immediately surrounding space. A gauge to measure <u>heat flow</u>, or flux, was positioned next to the facepieces.

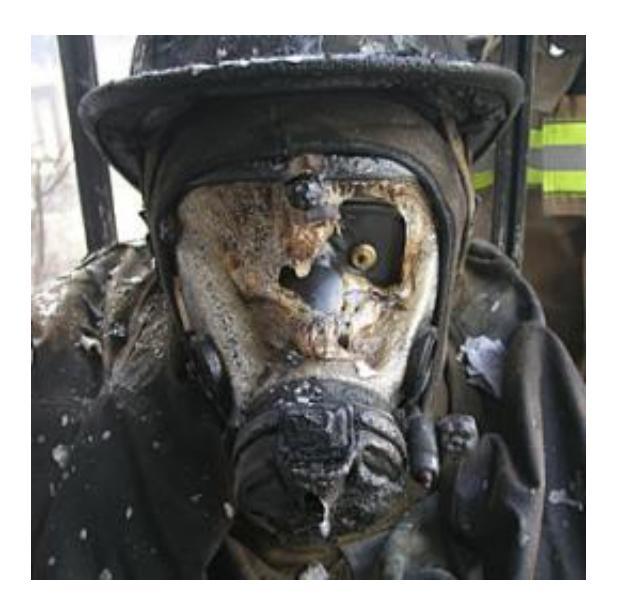
Opening the door provided additional air to a smoldering living-room fire and caused the fire to increase in burning rate and flames to extend out the doorway, resulting in high temperatures and heat flows that melted a hole in the mask. Pressure sensor (brass fitting that was mounted on the face of the headform) is visible through the hole in the lens. Credit: NIST

In two of four realistic living-room fire scenarios tested by NIST, "lenses exhibited bubbling and loss of visual acuity, as well as severe deformation, and, in one case, a hole," the NIST team says.

The researchers tested five models of SCBA facepieces, each from a different manufacturer. In all cases of lens degradation, the damage was due to temperatures and heat fluxes that exceeded performance limits of polycarbonate, the lens material commonly used in SCBA for fire fighters.

The most devastating damage occurred in a scenario akin to one in which a firefighter would enter a burning living room from a front porch. The living room fire smoldered for five minutes after ignition. Opening the front door literally breathed life into the smoldering fire. The rush of heat from the now blazing living room transformed a relatively cool environment on the porch into an inferno. The SCBA lens's exterior surface temperature reached 280 degrees Celsius (536 degrees Fahrenheit), about the midpoint of the range of published polycarbonate melt temperatures. The lens developed a significant hole, according to the NIST report.
