NIST corrosion lab tests suggest need for underground gas tank retrofits

July 30 2014, by Laura Ost

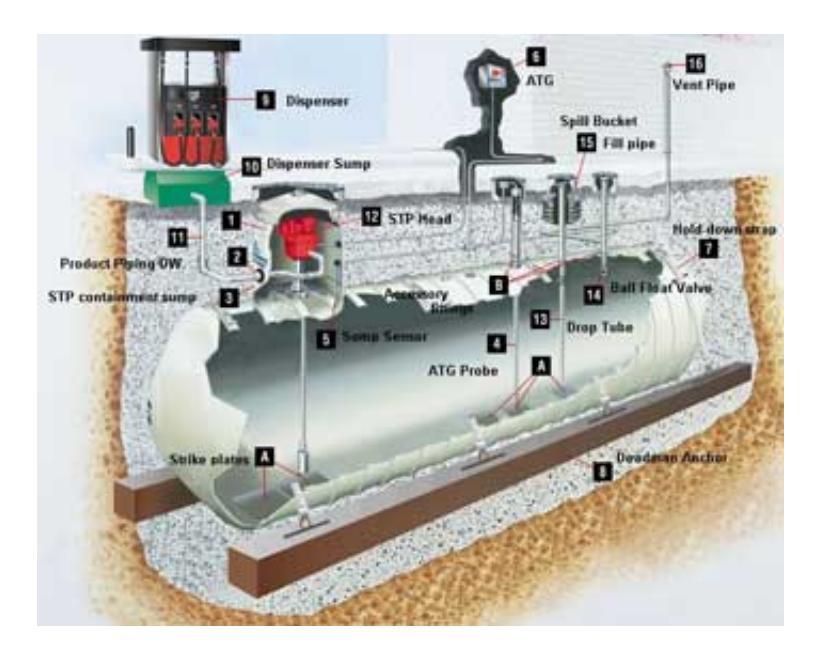
A NIST study found that corrosion may pose a hazard at underground gas storage tanks at filling stations. The study focused on sump pump components, especially the pump casings (labelled #3 in graphic), which are typically made of steel or cast iron. Credit: Environmental Protection Agency

The NIST study focused only on sump pump components, located directly below access covers at filling stations, just above and connected to underground <u>gas storage</u> tanks. The sump pumps move fuel from underground tanks to the fuel dispensers that pump gas into cars. These underground tanks and pipes also may be made of steel and could be vulnerable, too. "We know there are corrosion issues associated with the inside of some tanks. We're not sure, at this point, if that type of corrosion is caused by the bacteria," NIST co-author Jeffrey Sowards says.

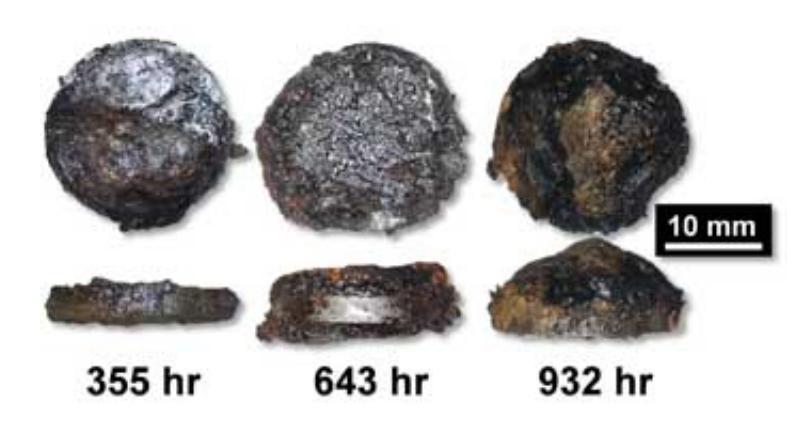
Optical micrographs of severe corrosion on steel alloy samples exposed to ethanol and acetic acid vapors -- conditions typical of underground gas storage tanks -- after 355 hours, 643 hours, and 932 hours. Credit: NIST

Following up on the inspectors' findings, a National Institute of Standards and Technology (NIST) laboratory study* has demonstrated severe corrosion—rapidly eating through 1 millimeter of wall thickness per year—on steel alloy samples exposed to ethanol and acetic acid vapors. Based on this finding, NIST researchers suggest <u>gas stations</u> may need to replace submersible pump casings, typically made of steel or cast iron, sooner than expected. Such retrofits could cost an estimated \$1,500 to \$2,500 each, and there are more than 500,000 underground gas storage tanks around the country.

The NIST study confirmed damage similar to that seen on sump pumps by field inspectors. The worst damage, with flaky iron oxide products covering corrosion, was found on steel exposed to the vapors. Copper in both the liquid and vapor environments also sustained damage, but corrosion rates were slower. Steel corroded very slowly while immersed in the liquid mixture; the NIST paper suggests bacteria may have created a biofilm that was protective in this case.
