## Workers discover fire debris in wall cavity of Thomas Jefferson's rotunda

July 28 2014, by Matt Kelly

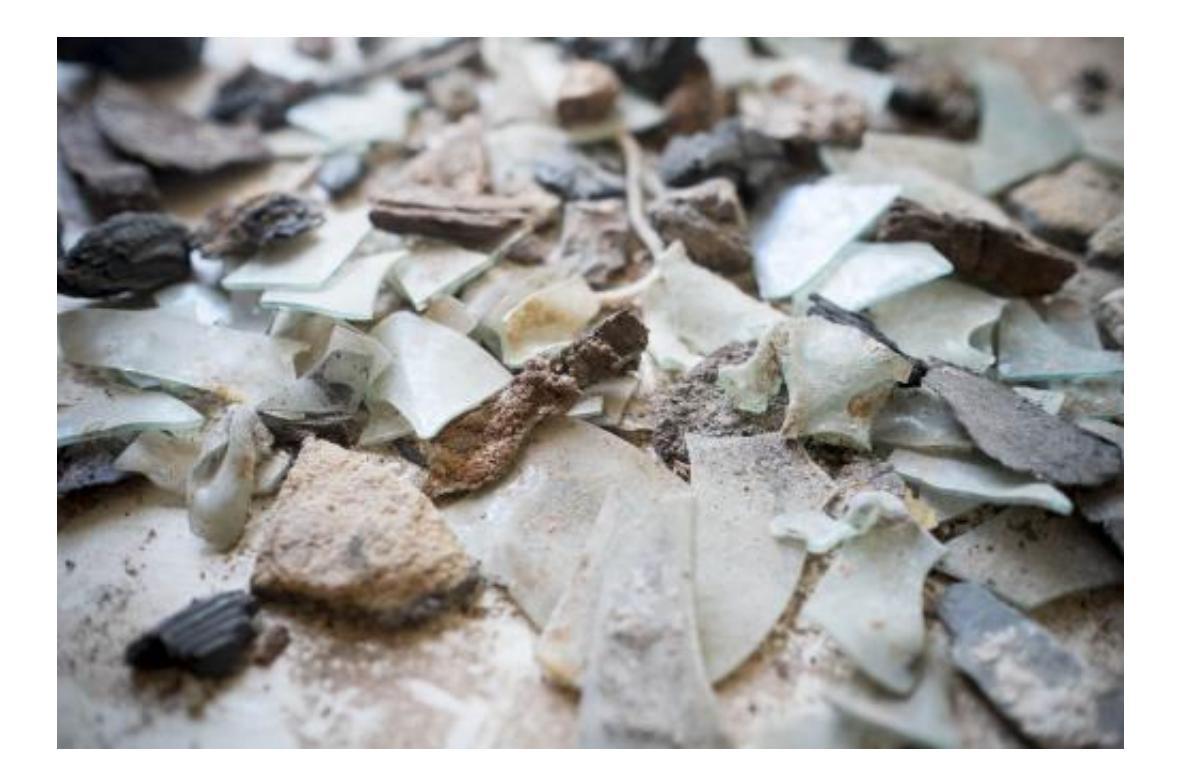
Some of the newly discovered shingle pieces appear to have been painted on both sides. Matt Scheidt, a historic architect with John G. Waite Associates of Albany, New York, which has performed historic assessments of the Rotunda and the Academical Village, suggested the dome may have been re-shingled at some point, with the second layer already painted on both sides as a protective coating.

"These shingles are ones that were on the dome right before the fire," Scheidt suggested. "If they put a new roof on, they would likely have put over the existing one, so it is possible that some of the original roof survived."

The shingle pieces Kutney found in the wall cavities were joined together with folded-over edges, a technique designed by Jefferson and used on several roofs within the Academical Village. The original dome would have started off shiny, but then would have turned a dull gray, eventually weathering to a chalky white. Some of the surviving shingles had red paint on them, indicating that at some point the dome was painted red.

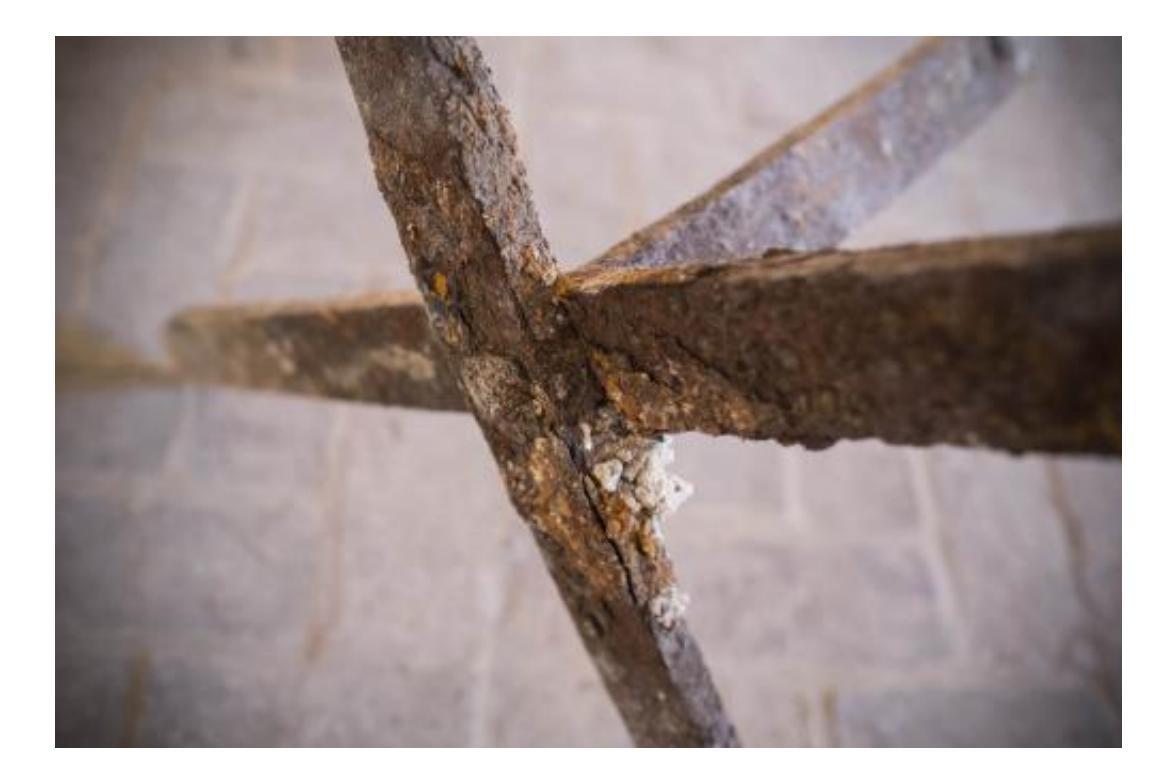
Workers also found what appears to be a timber bracket – a 52-inch piece of wrought iron that fit perpendicularly into a set of four 32-inchlong legs that would have anchored it into a brick wall. The long piece of iron had hand-cut beveled, square holes punched into it at 13-inch intervals. Kutney said there was still some plaster attached to one of the legs. The bar would have been anchored in the wall and then bolted, probably lengthwise, to a joist or beam to tie the floor framing and masonry wall together.

Scheidt speculated that the piece may have supported the ceiling joists in the one of the upper oval rooms. He thought the joists would have needed additional support because they were holding up the columns in the dome room.
