Tracking heat-driven decay in leading electric vehicle batteries

October 27 2014

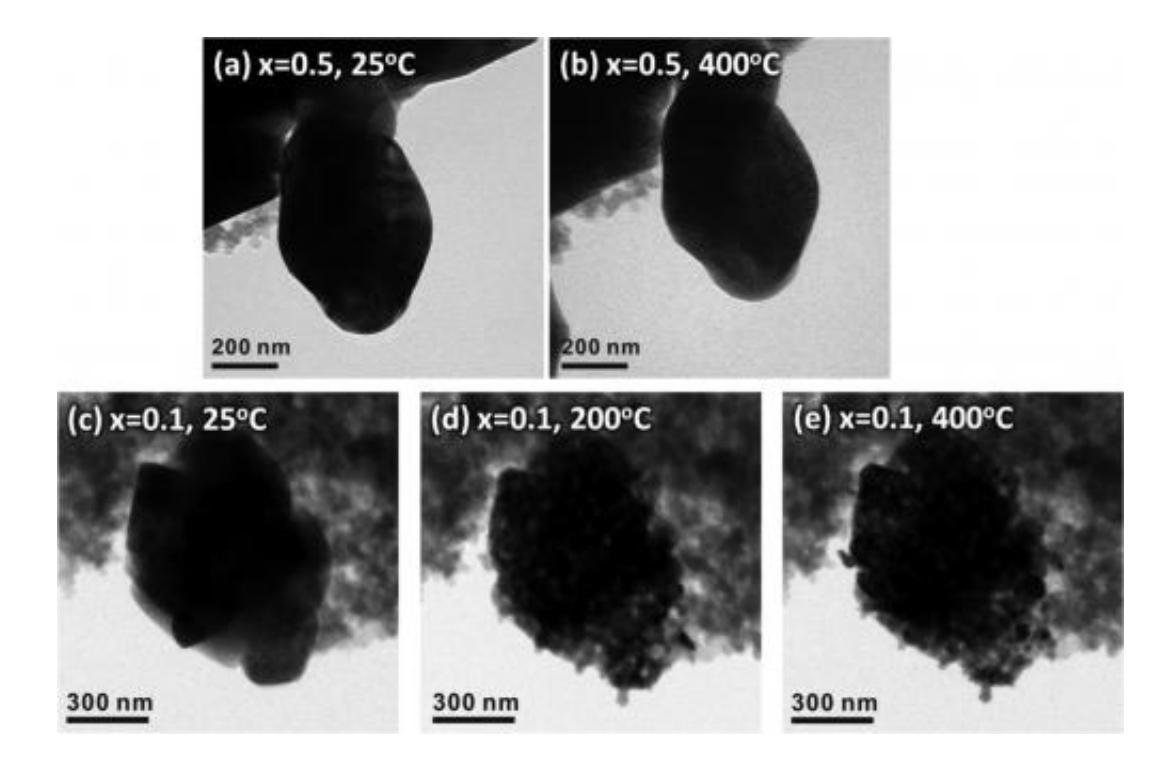
These in situ transmission electron microscopy images reveal that an uncharged NCA nanoparticle remains largely pristine as the temperature climbs from 25 to 400 degrees Celsius (top). In an overcharged sample, however, heavy structural degradation emerged and oxygen was released at ~200 degrees (bottom).

The collaboration found that even though pristine and uncharged NCA samples remained stable up to 400 degrees Celsius, charging introduced the usual decomposition and vulnerabilities. The full story, however, was

"We saw the same overall degradation patterns, but the real-time TEM revealed an unexpected twist within individual particles," Stach said. "When fully charged, some particles released oxygen and began to shift toward disorder down at temperatures below 100 degrees Celsius—definitely plausible for a lithium-ion battery's normal operation."

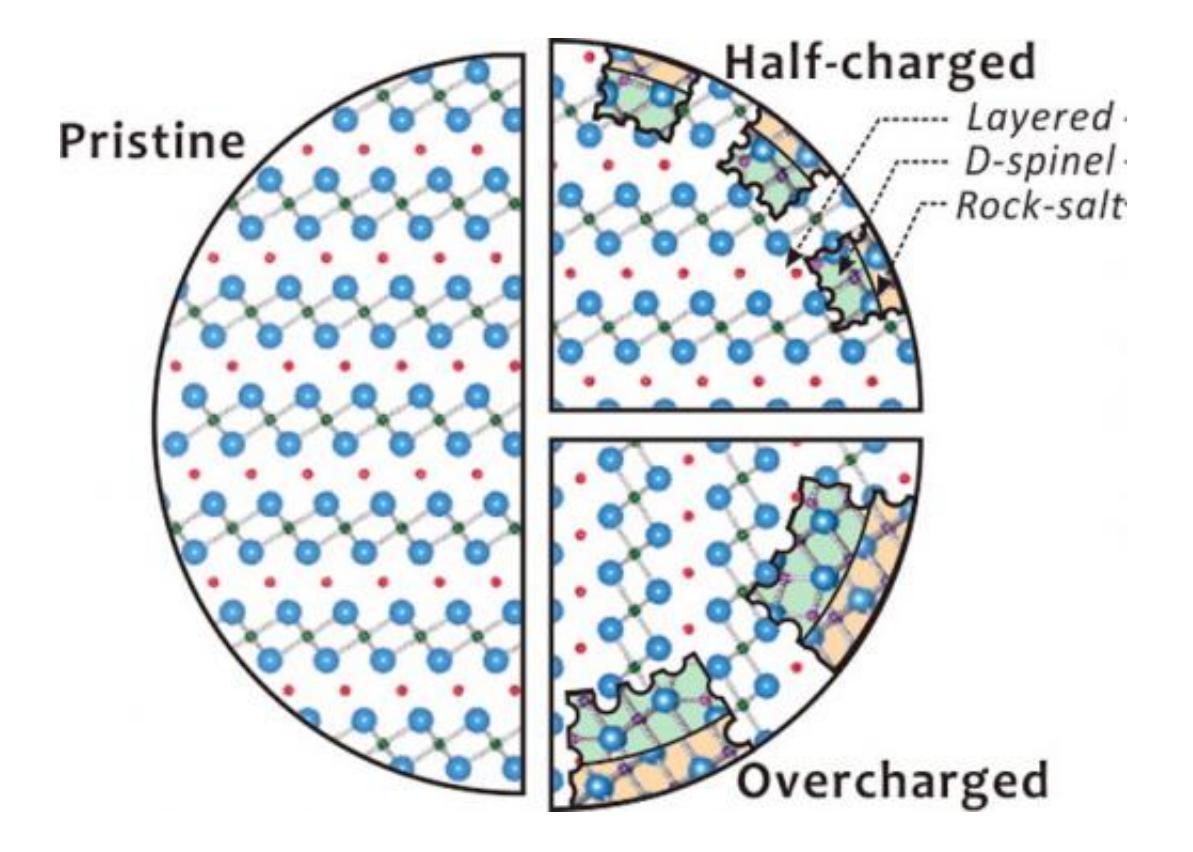
Diagram showing the NCA structural transformation from discrete layers in the pristine sample to disordered spinel and rock-salt configurations as the charge increases—largely a result of oxygen being released from the material.

"The surface changes matched the rock-salt evolution found in the x-ray study," said study coauthor Sooyeon Hwang of the Korea Institute of Science and Technology (KIST). "Even with just one charge on the NCA battery we saw changes in the crystalline structure, and it grew much worse as the charge level increased."

"We found a decrease in nickel and an increase in the electron density of oxygen," Hwang said. "This causes a charge imbalance that forces oxygen to break away and leave holes in the NCA surface, permanently damaging the battery's capacity and performance."

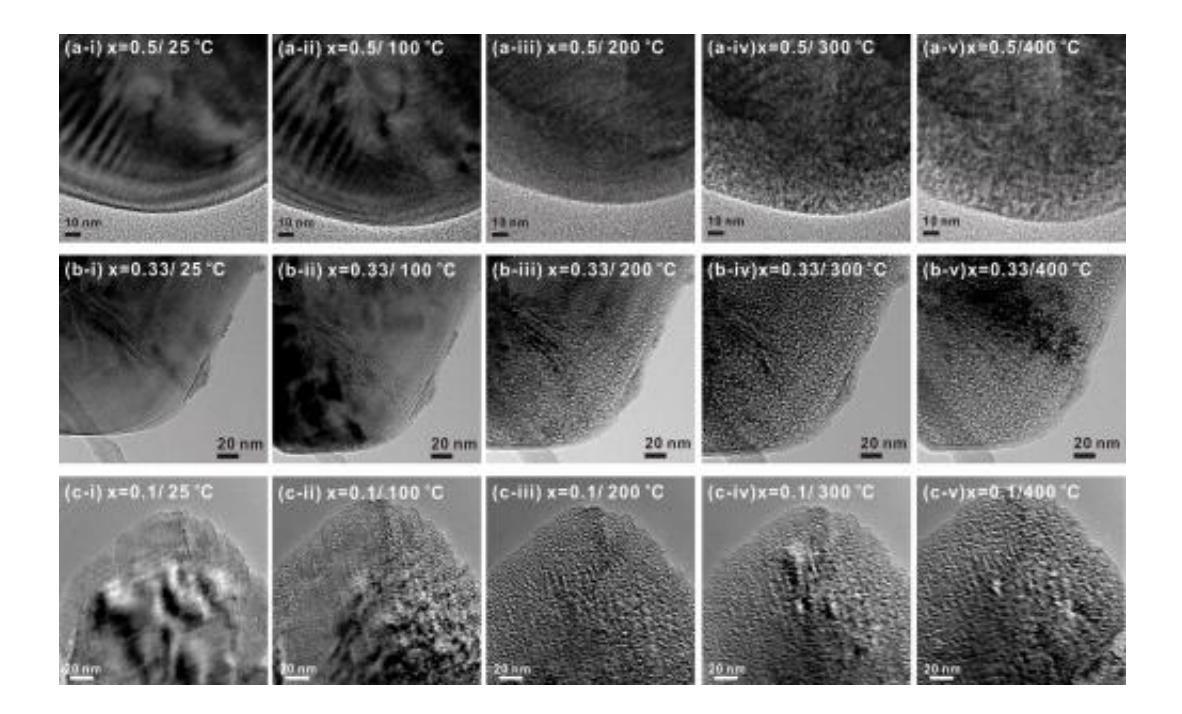
These transmission electron microscopy images reveal structural transformations in the surface of differently charged NCA nanoparticles as temperature rises from 25 to 400 degrees Celsius. The nanoscale degradation manifests at lower temperatures and more intensely in the over-charged samples (bottom), as compared to an average charge (middle) or the pristine/uncharged (top).
