Antares explosion investigation focuses on first stage propulsion failure

November 4 2014, by Ken Kremer

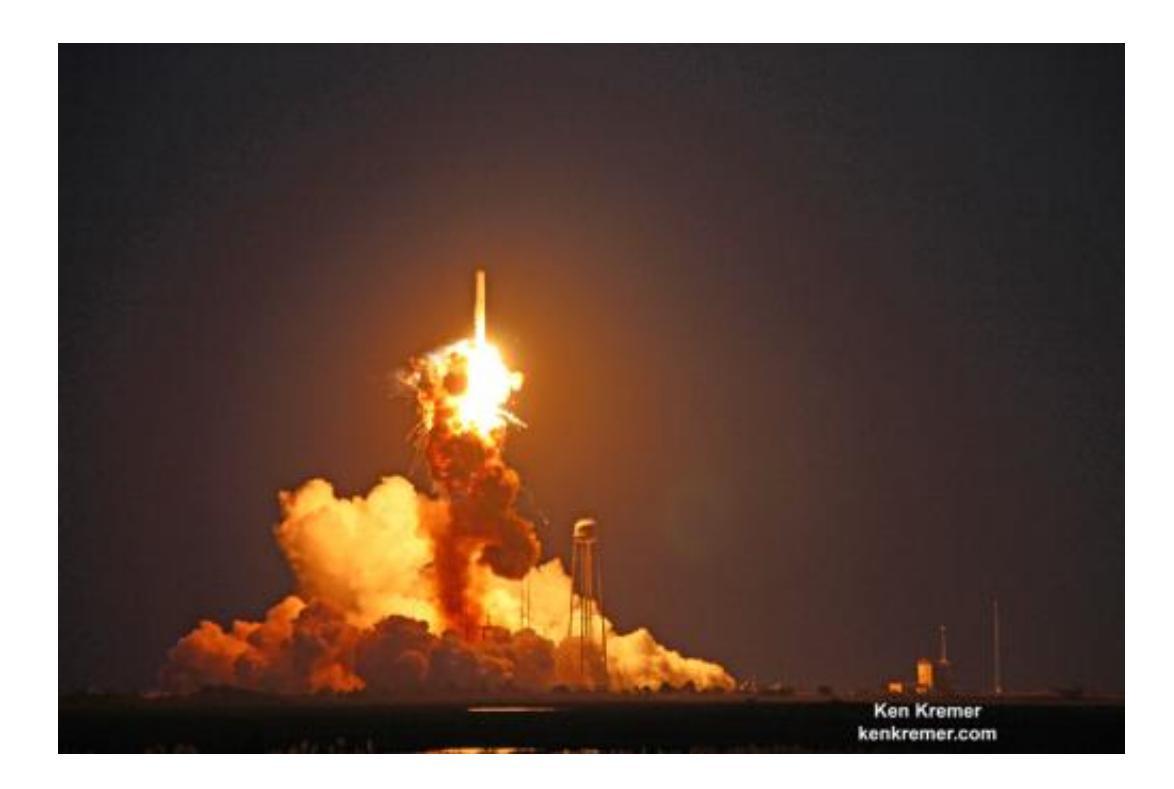
First stage propulsion system at base of Orbital Sciences Antares rocket appears to explode moments after blastoff from NASA's Wallops Flight Facility, VA, on Oct. 28, 2014, at 6:22 p.m. Credit: Ken Kremer

Numerous photos and videos from myself (see herein) and many others clearly show a violent explosion emanating from the base of the two stage rocket. The remainder of the first stage and the entire upper stage was clearly intact at that point.

"Evidence suggests the failure initiated in the first stage after which the vehicle lost its propulsive capability and fell back to the ground impacting near, but not on, the launch pad," Orbital said in a statement.

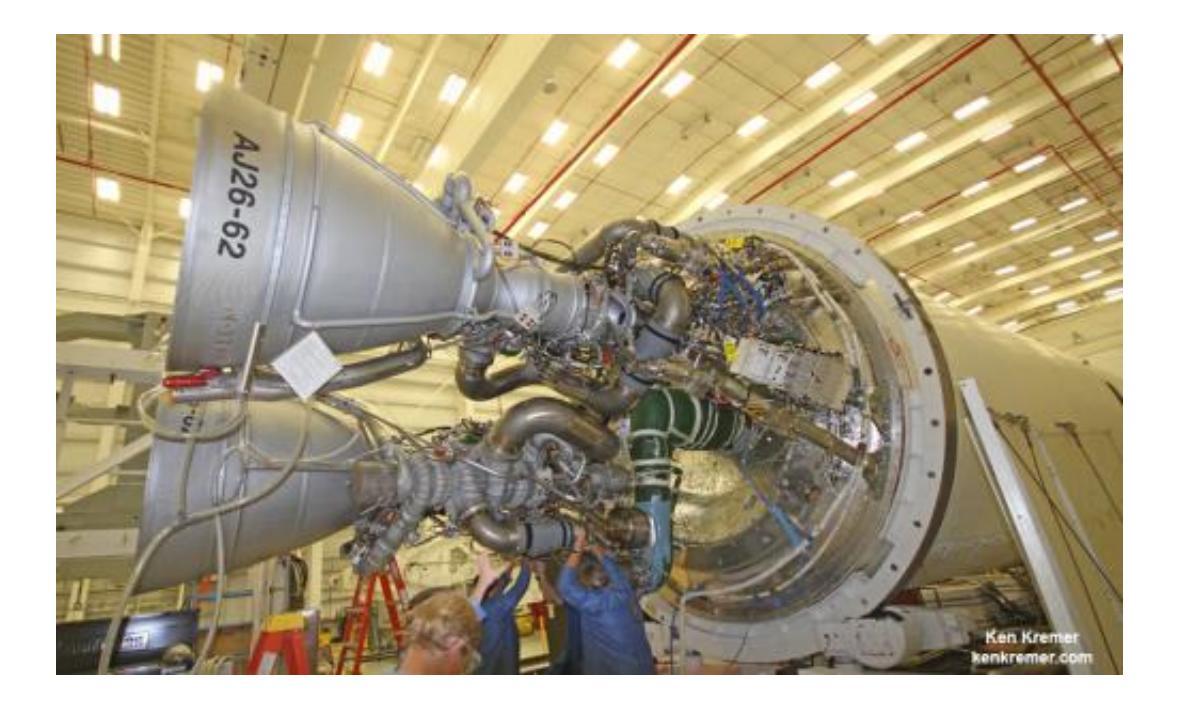
Orbital Sciences technicians at work on two AJ26 first stage engines at the base of an Antares rocket during exclusive visit by Ken Kremer/Universe Today at NASA Wallaps. These engines powered the successful Antares liftoff on Jan. 9, 2014 at NASA Wallops, Virginia bound for the ISS. Credit: Ken Kremer

The 14 story Antares rocket is a two stage vehicle. The liquid fueled first stage is filled with about 550,000 pounds (250,000 kg) of Liquid Oxygen and Refined Petroleum (LOX/RP) and powered by a pair of AJ26 engines originally manufactured some 40 years ago in the then Soviet Union and designated as the NK-33.

Earlier this year an AJ26 engine failed and exploded during acceptance testing on May 22, 2014 at NASA's Stennis Space Center in Mississippi. An extensive analysis and recheck by Orbital Sciences was conducted to clear this pair for flight.

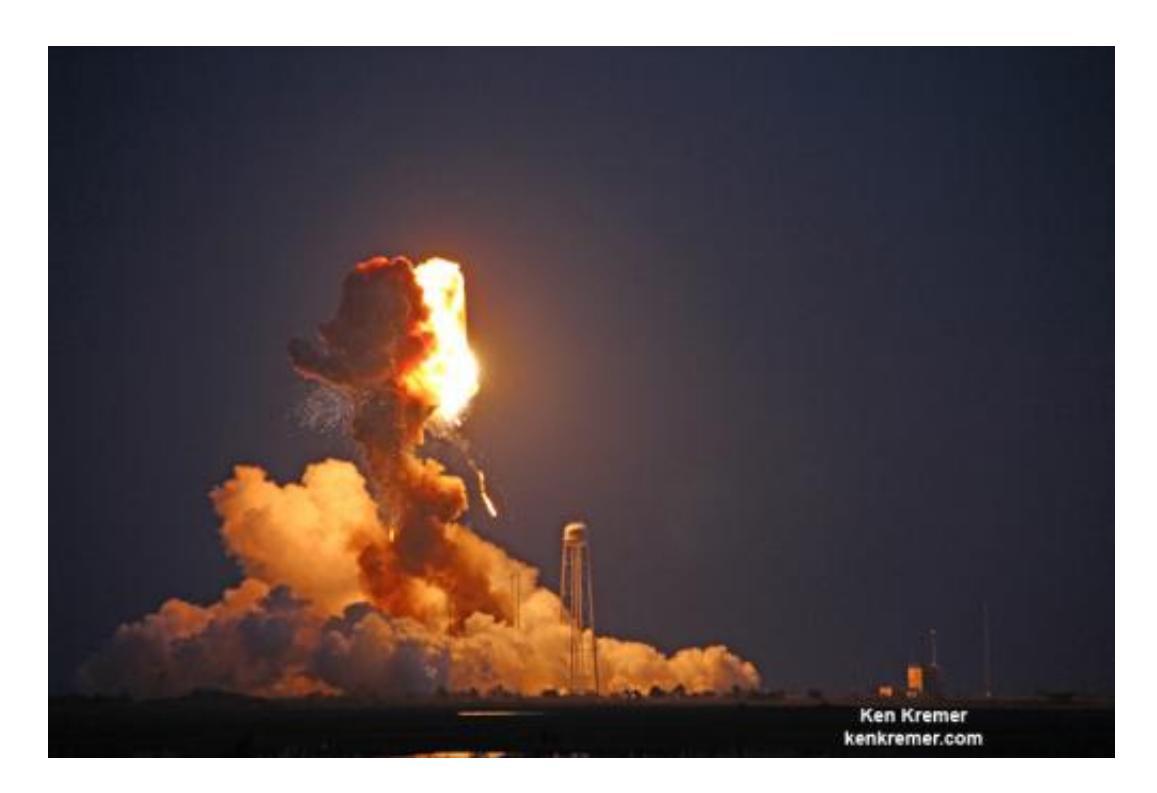
Orbital Sciences Antares rocket explodes moments after blastoff from NASA's Wallops Flight Facility, VA, on Oct. 28, 2014, at 6:22 p.m. Credit: Ken Kremer
