Rescuing farmland after a flood

January 13 2015

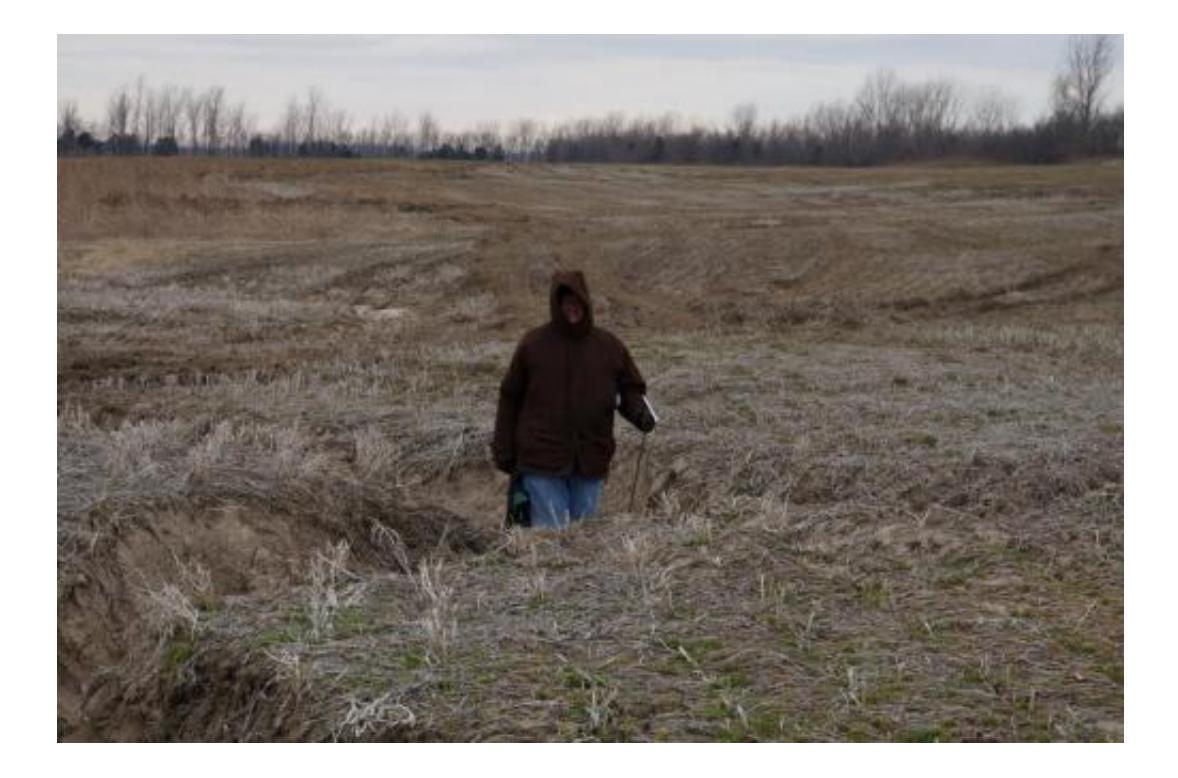
U of I soil scientist Ken Olson measuring agully at O'Bryan Ridge. Credit: University of Illinois

Olson led a team of scientists in a study of a 195-acre O'Bryan Ridge gully field area in Missouri and found that the area suffered a permanent loss of 30 percent of its agricultural productive capacity.
