New method to understand steel fracturing

February 9 2015

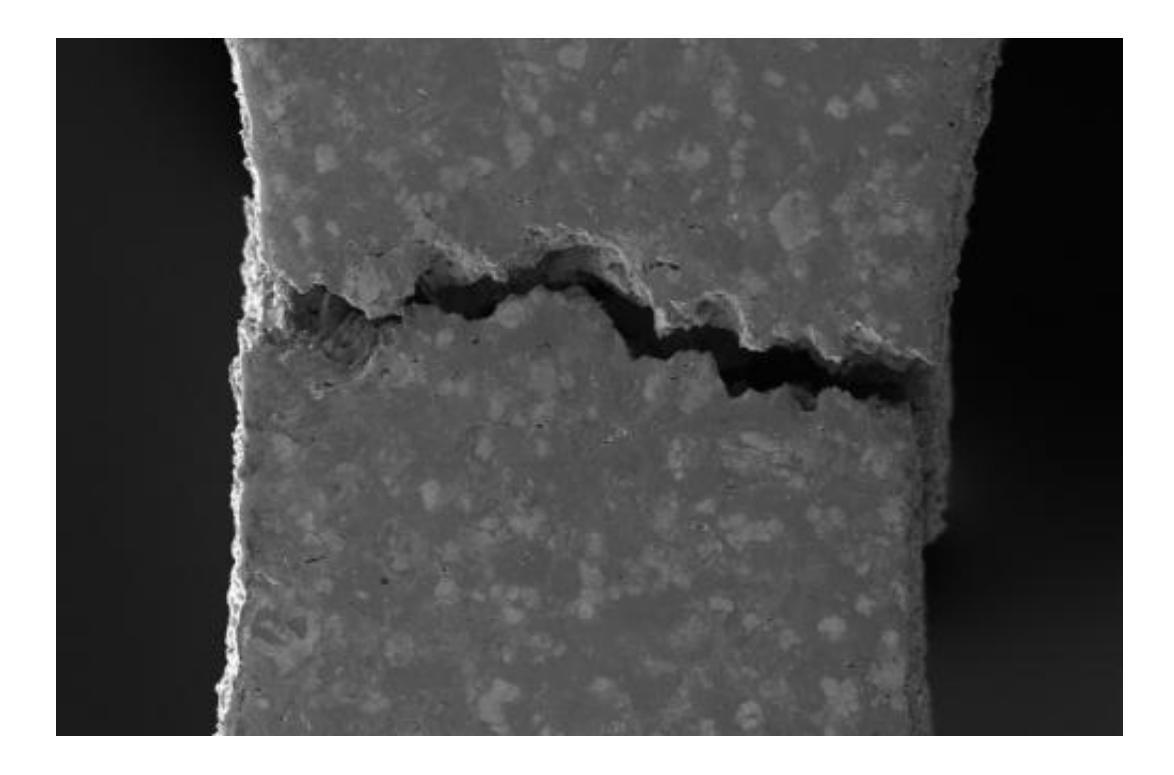
Researchers from the Universidad Carlos III de Madrid (UC3M) have visualized step-by-step and on a microscopic level how certain steels fracture when extreme loads are applied to them. This could help to improve these materials, which are used in the automobile industry. Credit: uc3m

Scientists from the UC3M Powder Technology Group (initialled GTP in Spanish) have carried out this research using a scanning electron microscope to obtain high-resolution images (around 10 nanometers; a nanometer is one millionth of a millimeter). The application of new techniques to characterize materials has made it possible to better understand the behavior of sintered steels (those produced from powders) on fracturing. In this way, they have been able to discover where the first cracks "'nucleate' and where they particularly extend to," the GTP researchers explain.

In this study, published in the journal *Powder Metallurgy*, several steels currently on the market were evaluated. Specifically, an Fe-C steel, a steel pre-alloyed with molybdenum (Astaloy Mo grade, Höganäs AB) and the well-known Distaloy AE (Höganäs AB), which is iron alloyed by diffusion with copper, nickel and molybdenum, were analyzed. The results have helped in understanding the connection between microstructure and properties, which in these <u>materials</u> entails a technological challenge, as not only the phases but also the residual porosity that composes their microstructure come into play. José Manuel Torralba, full professor in the UC3M department of Materials Science and Engineering and Deputy Director of the IMDEA Materials Institute, stresses the fundamental role of porosity in these steels: "The research has revealed, among other things, that the most angular and irregular pores are the first points of 'nucleation,' that is, those that initiate the
