Innovative technology to recover performance of CMOS devices damaged by hot carrier injection

May 26 2015

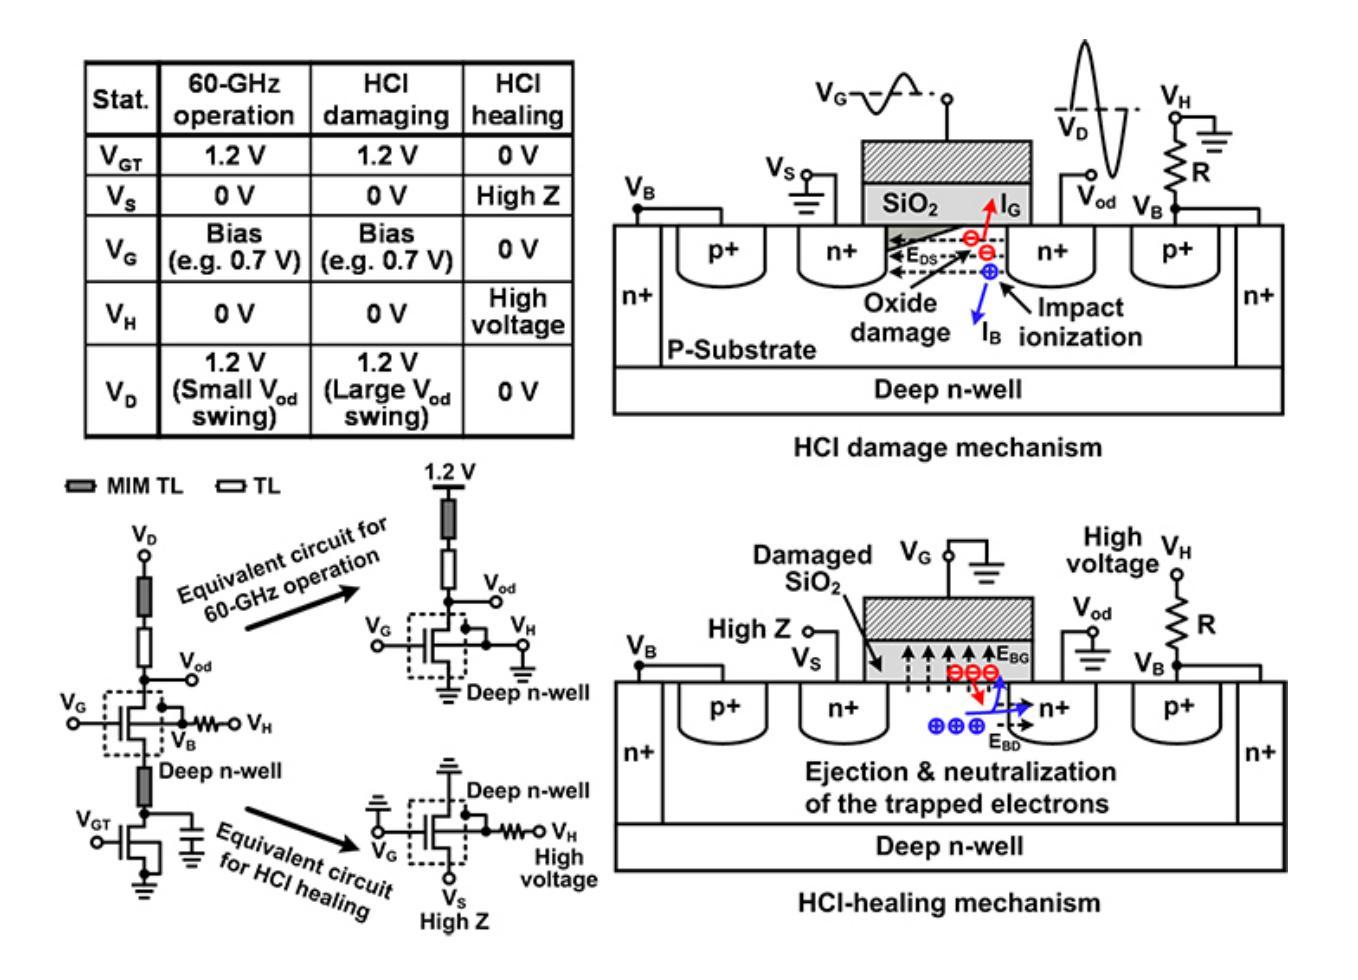
Figure 1: Proposed HCI damage healing technique for PA.

- Experiment to recovery the performance of 60-GHz CMOS transceiver damaged by hot carrier injection (HCI).
- Performance recovery technology applied to a millimeter-wave power amplifier as shown in Figure 1.
- The transistor module consists of a core NMOSFET with deep nwell, a tail switching transistor, a MIM transmission line (MIM TL) with a MIM capacitor array attached alongside, and a high-

density decoupling capacitor.

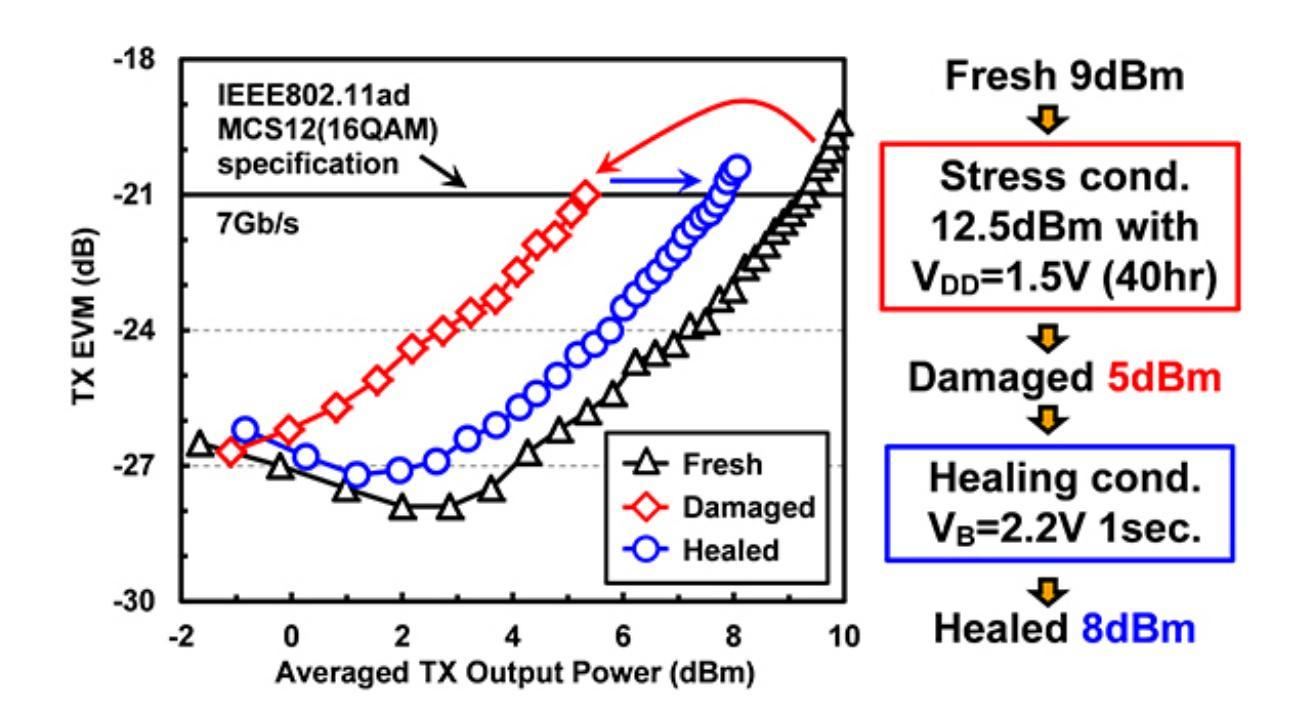
Figure 2: Measured TX EVM and output power of 60GHz Transceiver.

- Figure 2 demonstrates the recovery from hot carrier injection for a 60-GHz CMOS transceiver. After the recovery operation is applied, a significant recovery of the output power is observed.
- Figure 3 shows the die micrograph. The transceiver is fabricated in a 65nm CMOS technology. The core areas of the transmitter, receiver, PLL and control logic are 0.79mm², 1.01mm², 0.27mm², and 0.21mm², respectively.

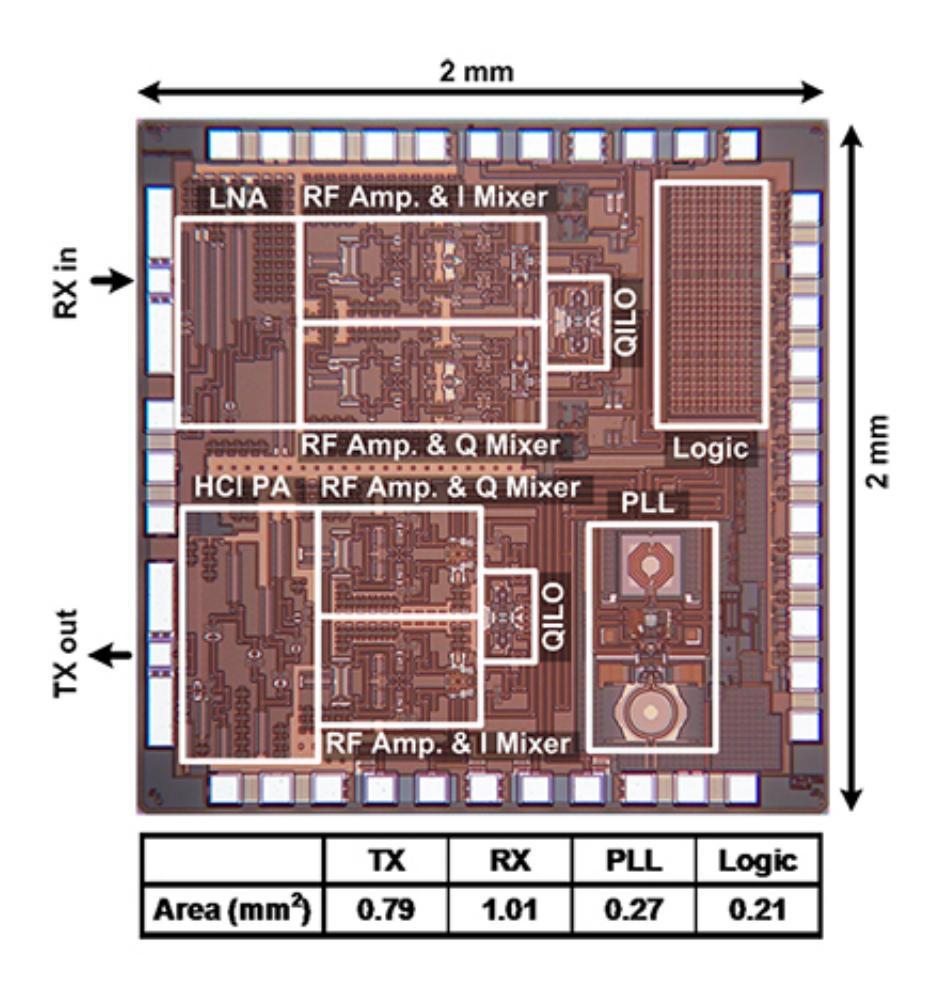
Figure 3: Die micrograph.
